Expertise

Protocol number: 48111107
Order No. / Reference: 27100245
Inspection date: 13 Oct 2026

Manufacturer: Seat	Model: Tarraco 2.0 TDI SCR DSG Xperience
VIN: VSSZZZKN4PW014354

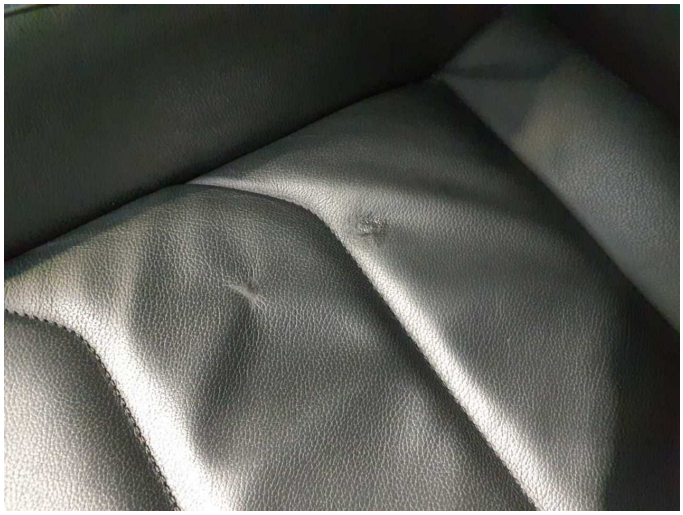
Damage 5: Seat - front: Seat cover - left side - Burn hole (cigarettes) - Loss in value

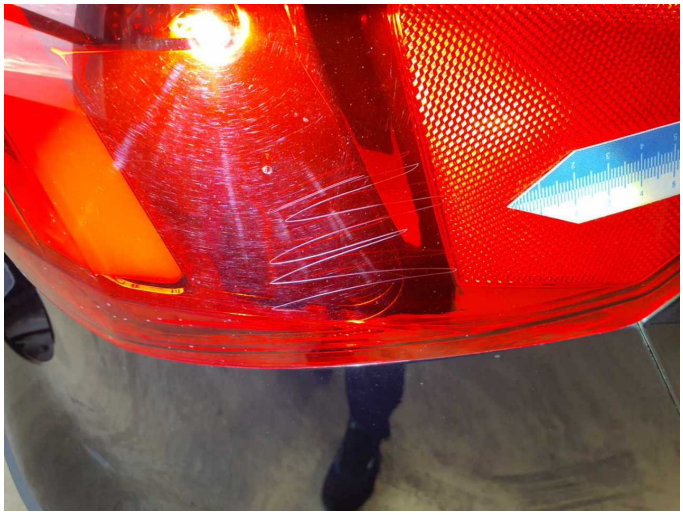
Damage 8: Tail light: Tail lamp - right side - Scratch(es) - Replace

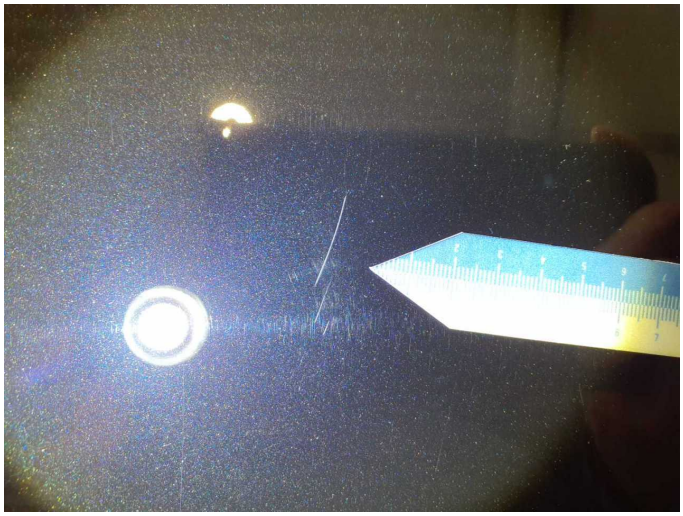
Damage 10: Bonnet: Bonnet - Scratch(es) - Paint

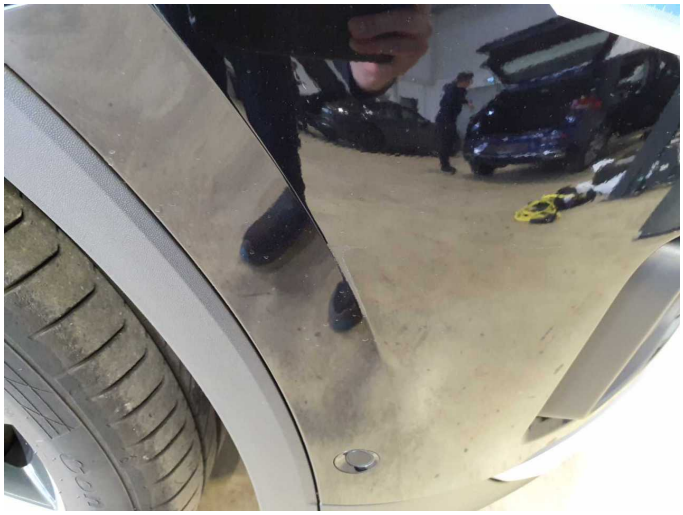
Damage 11: Front bumper: Front bumper - Dent / paintcoat damage - Repair and paint

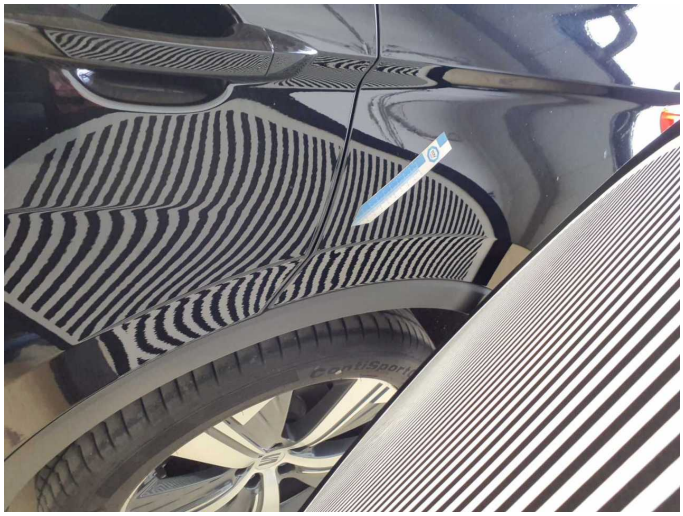
Wear and tear 4: Wheel / tyres: Alloy rim - rear left side - Scratch(es) - No deduction

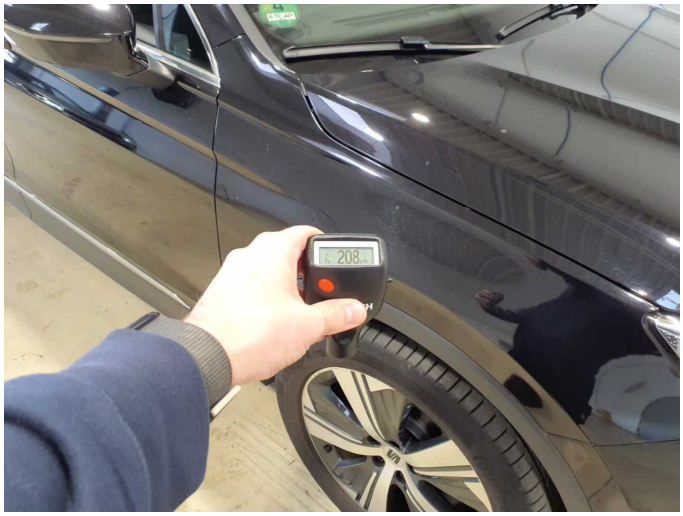
Wear and tear 5: Wheel / tyres: Alloy rim - front left side - Scratch(es) - No deduction

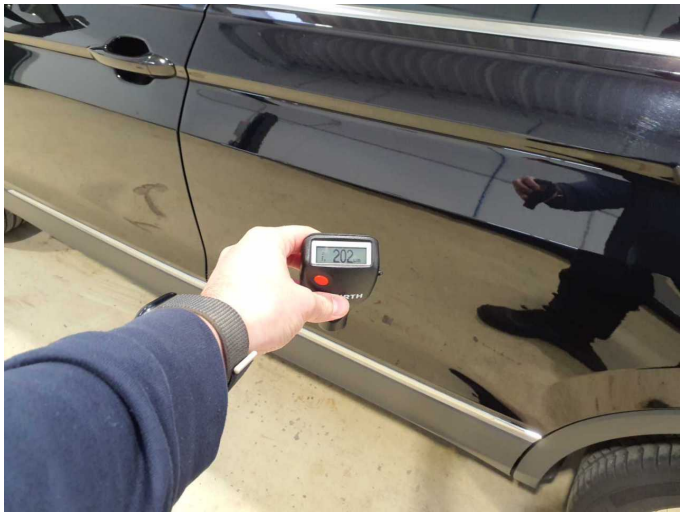
Repainting 2: Side panel - rear right side
