Expertise

Protocol number: 47693337
Order No. / Reference: 26981725
Inspection date: 21 Sept 2026

Manufacturer: Mercedes-Benz	Model: GLC 300 de 4Matic 9G-TRONIC AMG Line
VIN: W1N2539111V377018

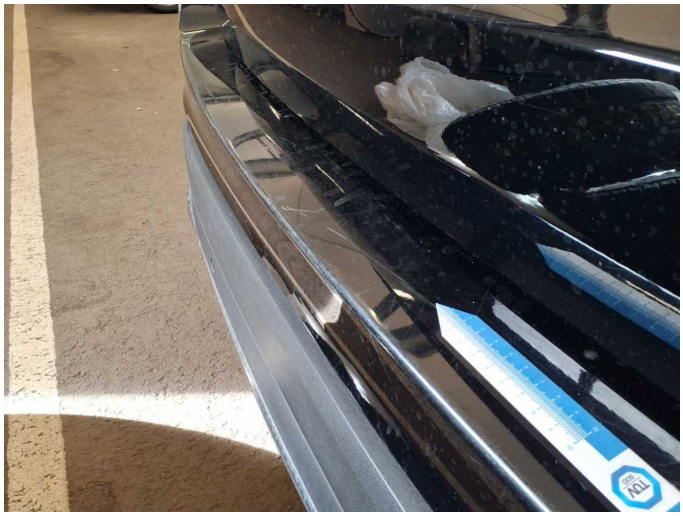
No.	Component group	Description
1	Door - rear left side	Door - Dent / paintcoat damage - Smart repair
2	Wheel / tyres	Alloy rim - rear left side - Scratch(es) - Loss in value
3	Wheel / tyres	Alloy rim - rear right side - Scratch(es) - Loss in value
4	Rear bumper	Rear bumper - Scratch(es) - Paint

Damage 4: Rear bumper: Rear bumper - Scratch(es) - Paint
