Ford Mustang '19 BEV

Vehicle information

Damage summary

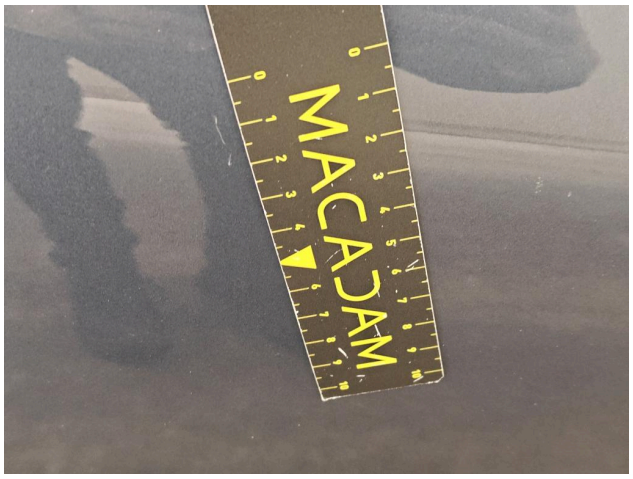
Door FL
Bad repair
Repair and paint (complete)
Left

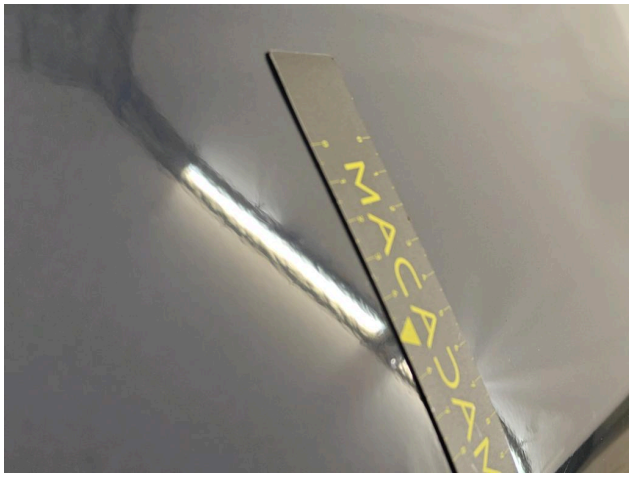
Door FR
Scratch(es)
Repair and paint (partial)
Right
