TÜV SÜD Auto Partner GmbH
Wiesenring 2
04159 Leipzig

Expertise

Protocol number: 48286523
Order No. / Reference: 27144845
Inspection date: 23 Oct 2026

Manufacturer: Volkswagen	Model: ID. Buzz Pro
VIN: WV2ZZZEB7PH025163

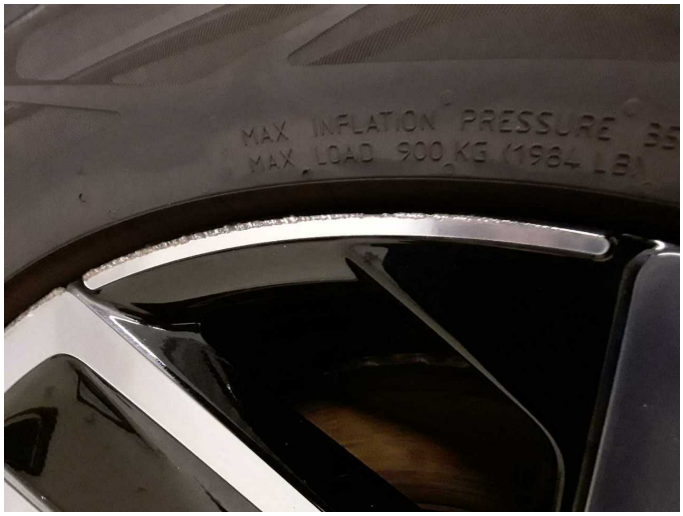
Damage 4: Wheel / tyres: Alloy rim - front left side - Scratched - Loss in value

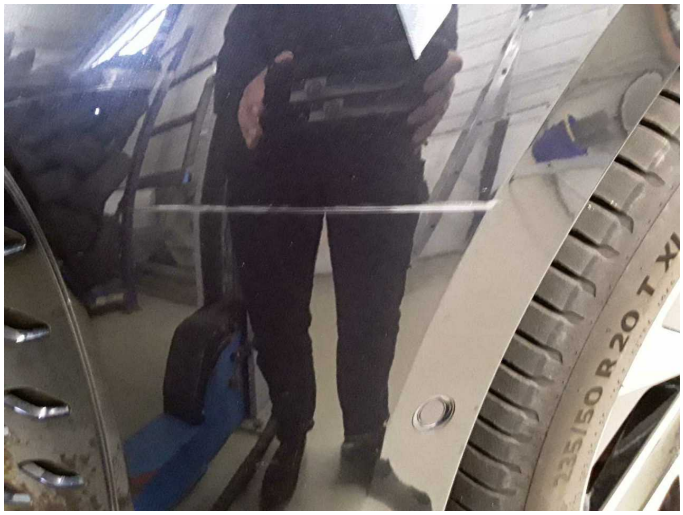
Damage 6: Front bumper: Bumper with Parktronic - Scratch(es) - Paint

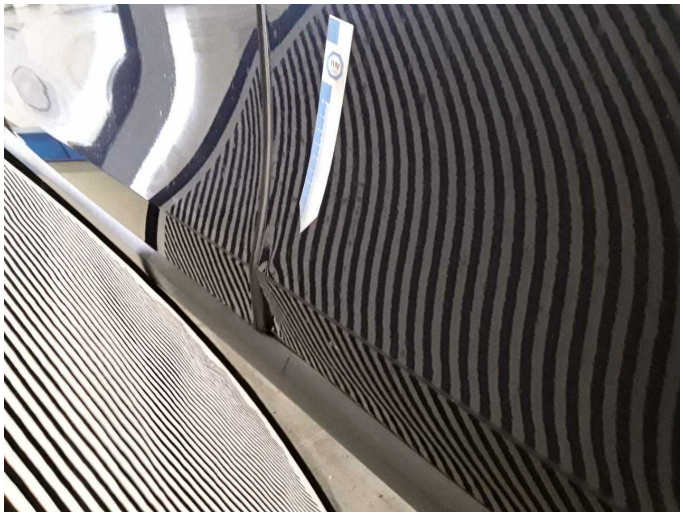
Damage 9: Door - front right side: Door - Deformed - Repair and paint
