TÜV SÜD Auto Partner GmbH
Wiesenring 2
04159 Leipzig

Expertise

Protocol number: 48588554
Order No. / Reference: 27279732
Inspection date: 9 Nov 2026

Manufacturer: Mercedes-Benz	Model: 311 CDI Sprinter Kompakt VA
VIN: W1V9076311P215102

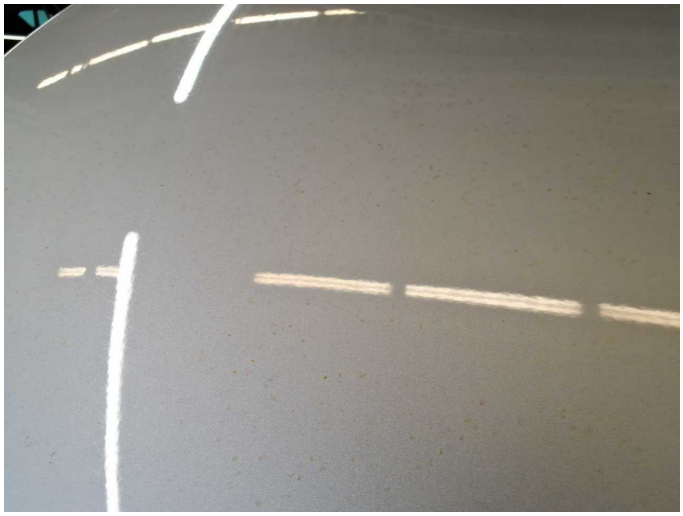
Damage 8: Body: Body (Flugrost-Mehrkosten möglich) - Soiled - Conditioning
