Expertise

Protocol number: 48459458
Order No. / Reference: 27112788
Inspection date: 3 Nov 2026

Manufacturer: Mercedes-Benz	Model: B 220 d 8G-DCT Progressive Line Advanced Plus
VIN: W1K4F1EB5PJ511729

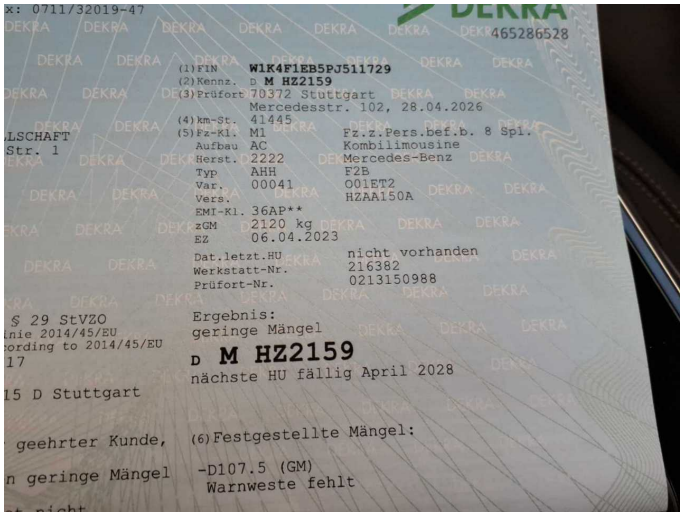
Figure 12: Documents

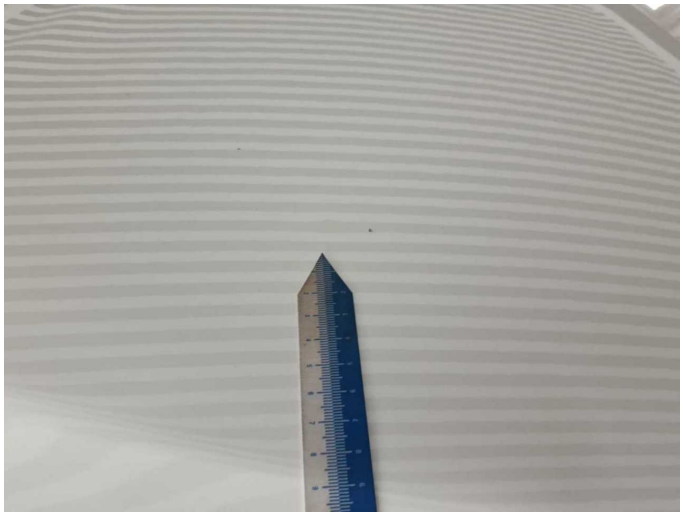
Damage 1: Bonnet: Bonnet - dent(s) - Smooth repair work

Damage 2: Door - rear left side: Door - Scratch(es) - Smart repair

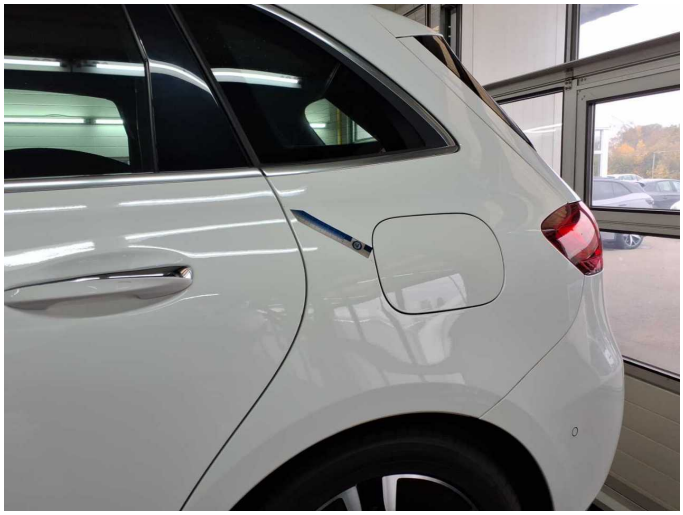
Damage 2: Door - rear left side: Door - Scratch(es) - Smart repair

Damage 3: Side panel - rear left side: Side panel - Scratch(es) - Smart repair

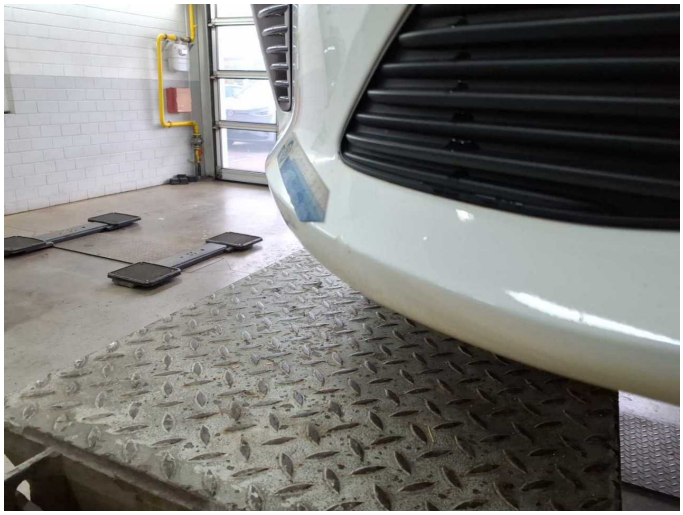
Damage 6: Front bumper: Front bumper (Steinschläge) - dent(s) - Repair and paint

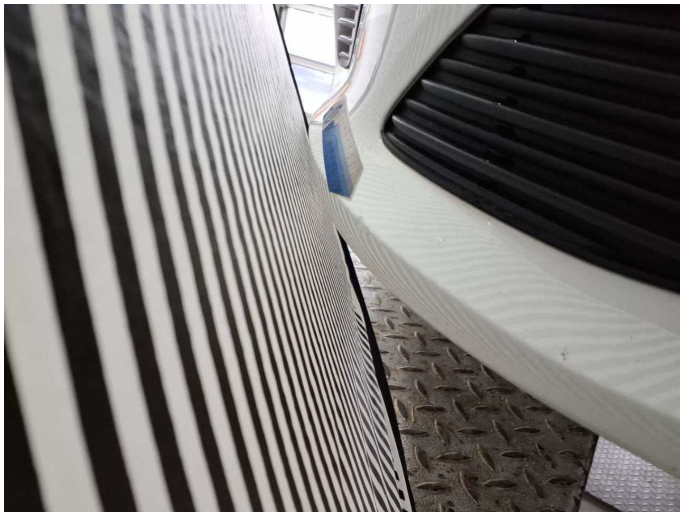
Damage 6: Front bumper: Front bumper (Steinschläge) - dent(s) - Repair and paint
