TÜV SÜD Auto Partner GmbH
Wiesenring 2
04159 Leipzig

Expertise

Protocol number: 48379953
Order No. / Reference: 27205169
Inspection date: 26 Oct 2026

Manufacturer: Opel	Model: Insignia Sports Tourer 2.0 Diesel Aut. Business
VIN: W0VZT8EP4N1000982

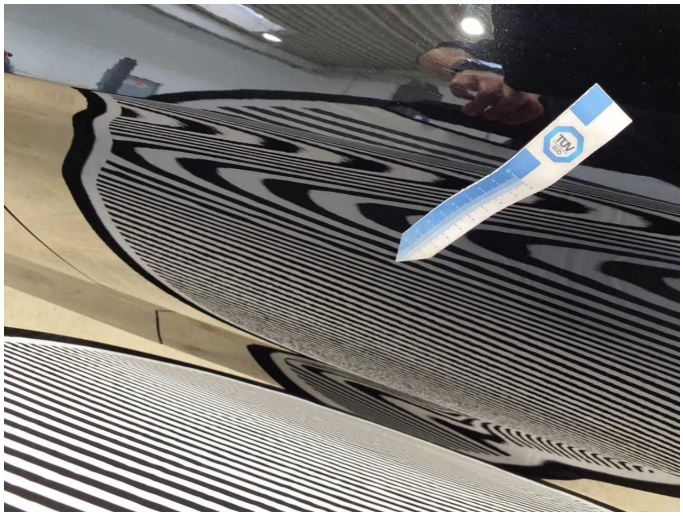
Damage 4: Door - rear left side: Door - dent(s) - Smooth repair work

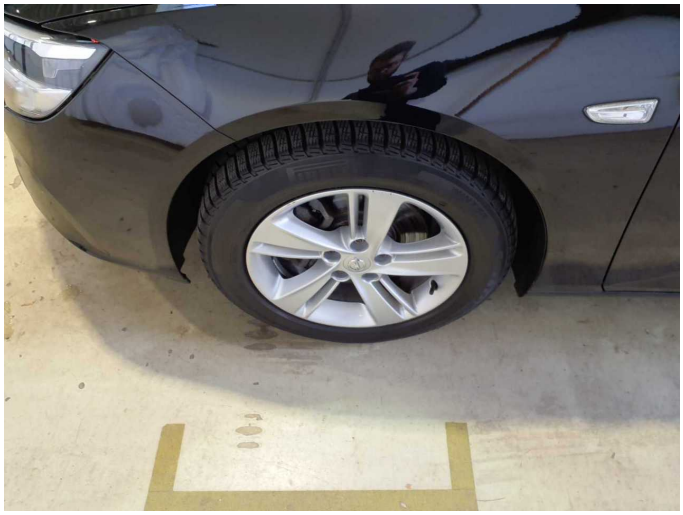
Damage 5: Trim / covers: Door trim - front left side - Scratch(es) - Loss in value

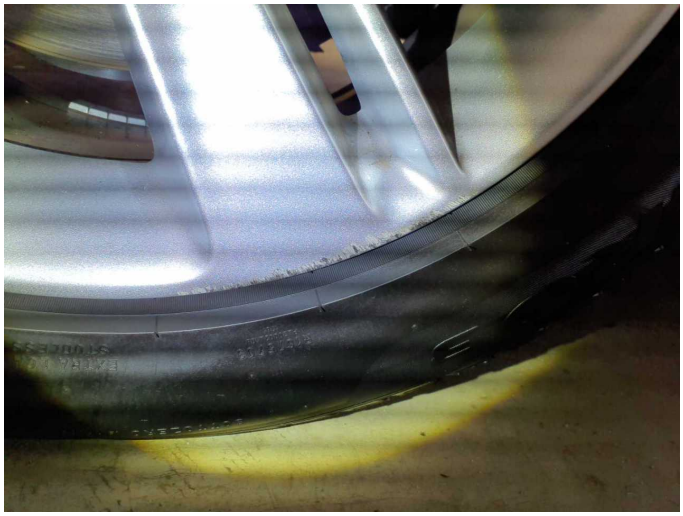
Damage 6: Wheel / tyres: Alloy rim - front left side - Scratch(es) - Loss in value

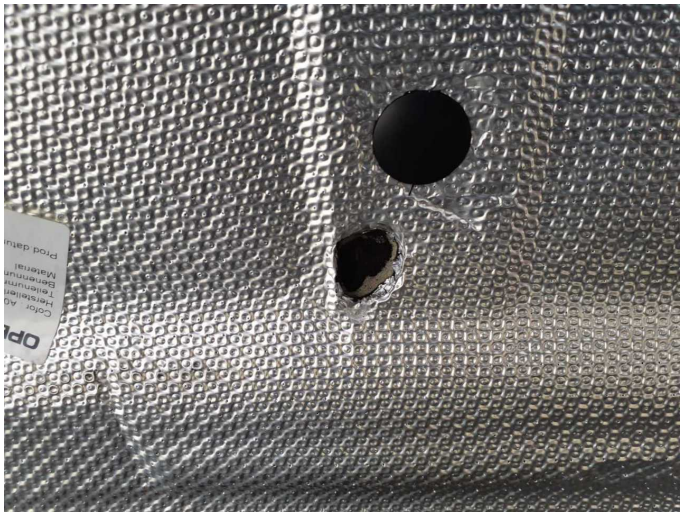
Damage 9: Wheel / tyres: Tyre - front left side - Broken / torn - Replace

Damage 10: Bonnet: Insulation lining - Broken / torn - Replace

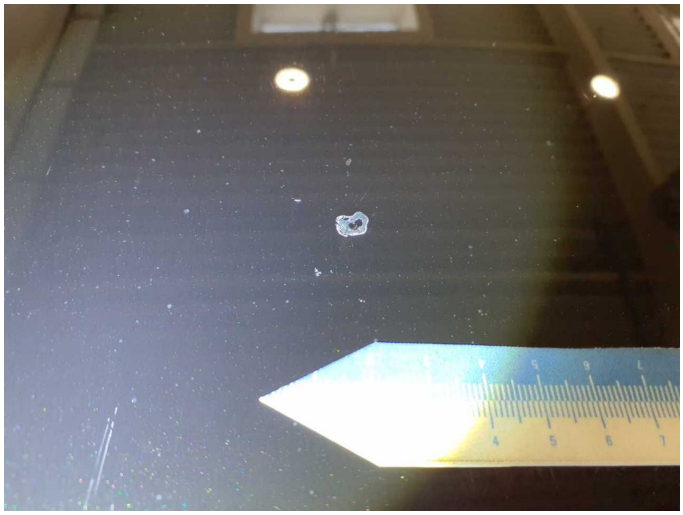
Damage 11: Boot lid / rear door: Rear spoiler (Anätzung) - Paint defect - Paint

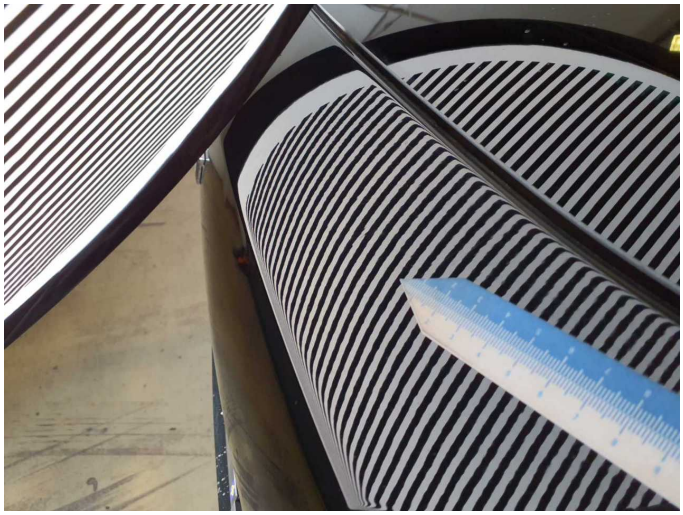
Damage 13: Mudguard - left side: Mudguard - left side (Lackkante) - Paint defect - Repair and paint

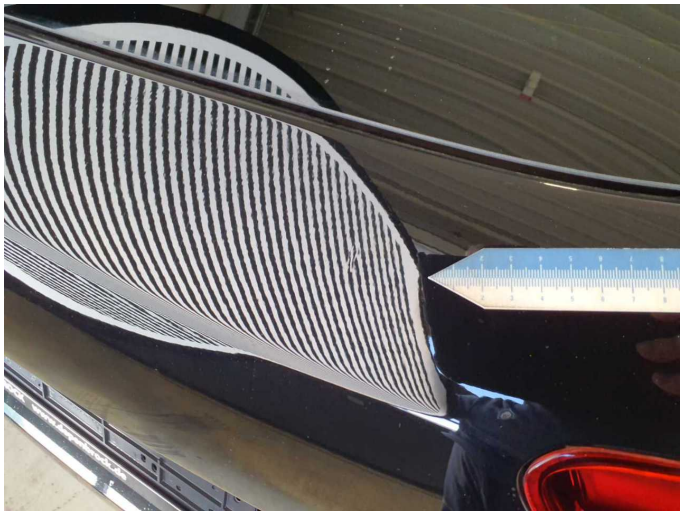
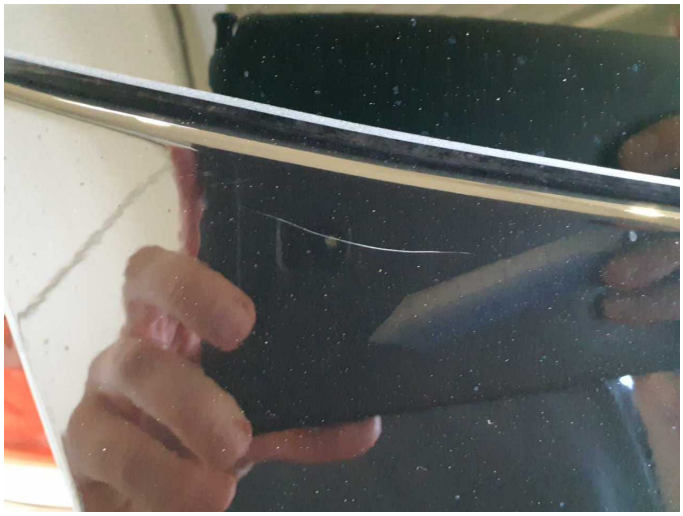
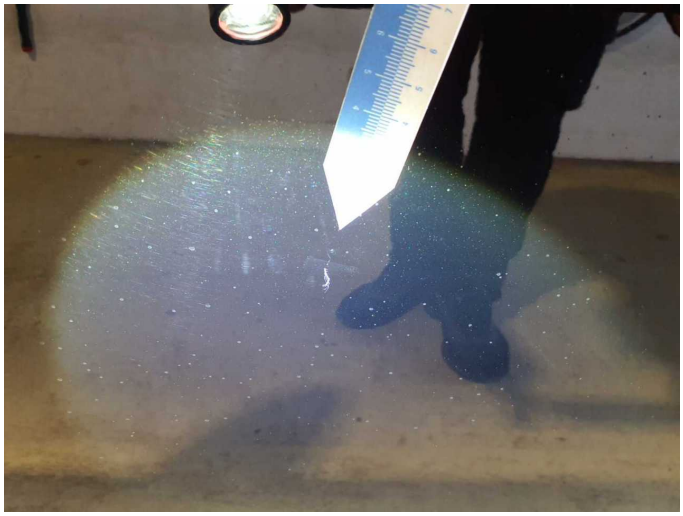
Damage 14: Boot lid / rear door: Boot lid (Anätzung) - Paint defect - Paint

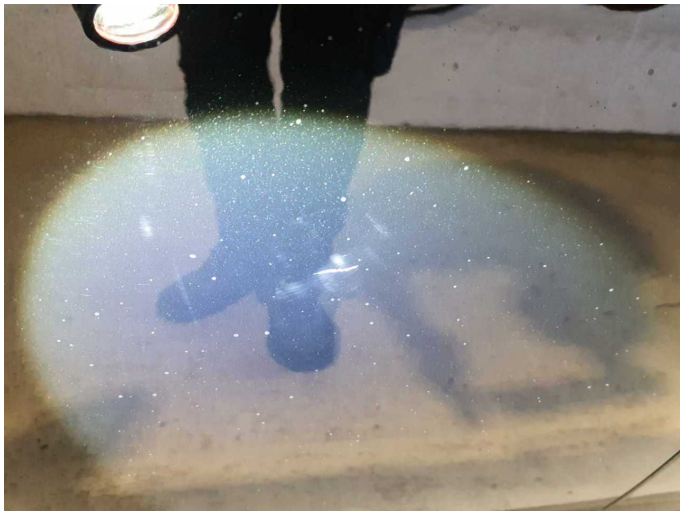
Damage 15: Door - front left side: Door - Scratch(es) - Paint

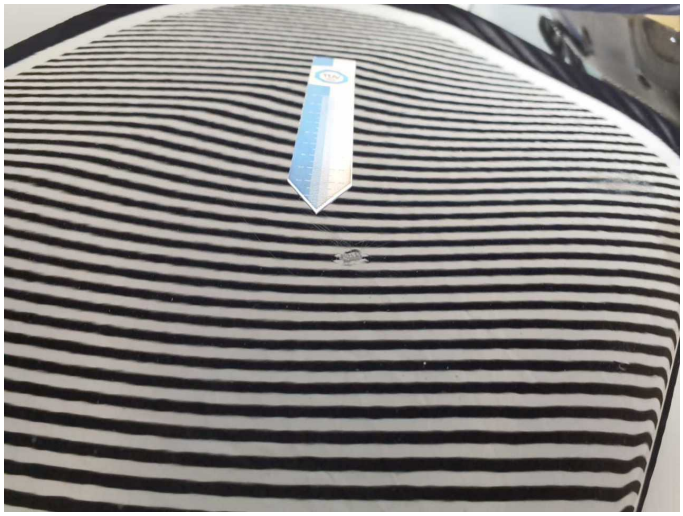
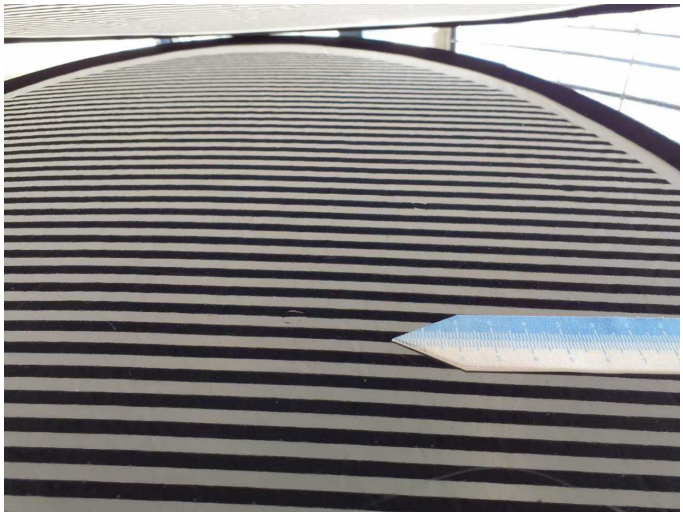
Damage 16: Bonnet: Bonnet - Paint defect - Paint

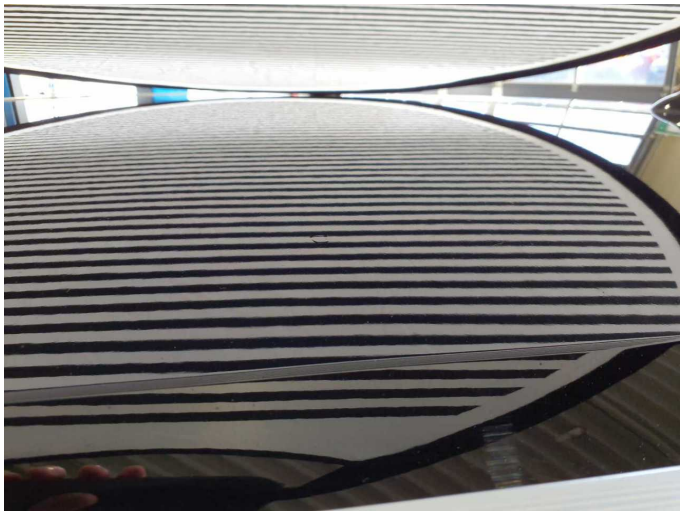
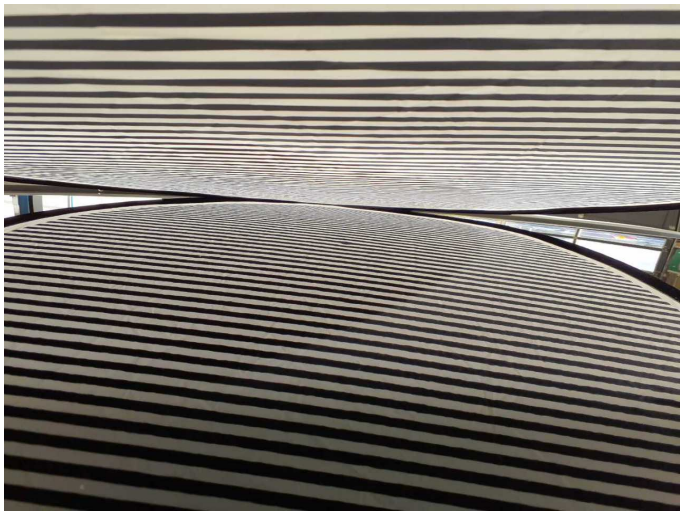
Damage 17: Roof: Roof (Anätzung) - Paint defect - Repair and paint

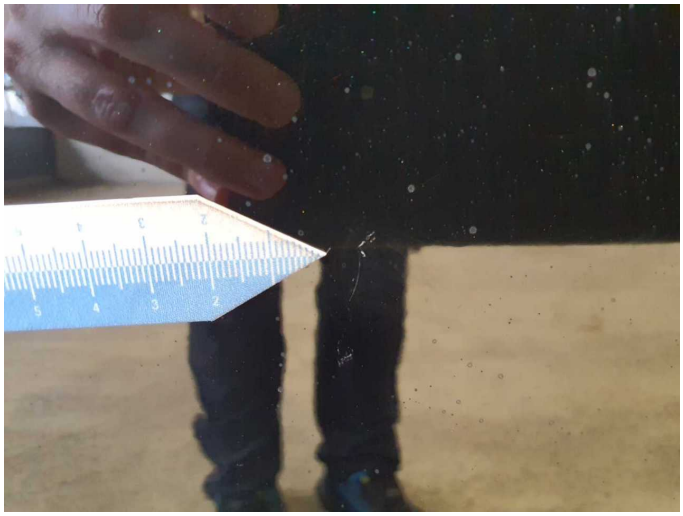
Wear and tear 4: Side panel - rear right side: Side panel - Dent / paintcoat damage - No deduction

Wear and tear 5: Door - front right side: Door - Scratch(es) - No deduction
