TÜV SÜD Auto Partner GmbH
Gutenbergstraße 13
70771 Leinfelden-Echterdingen

Expertise

Protocol number: 48591528
Order No. / Reference: 27206402
Inspection date: 9 Nov 2026

Manufacturer: Audi	Model: A5 Sportback 35 TDI S tronic
VIN: WAUZZZF57PA065904

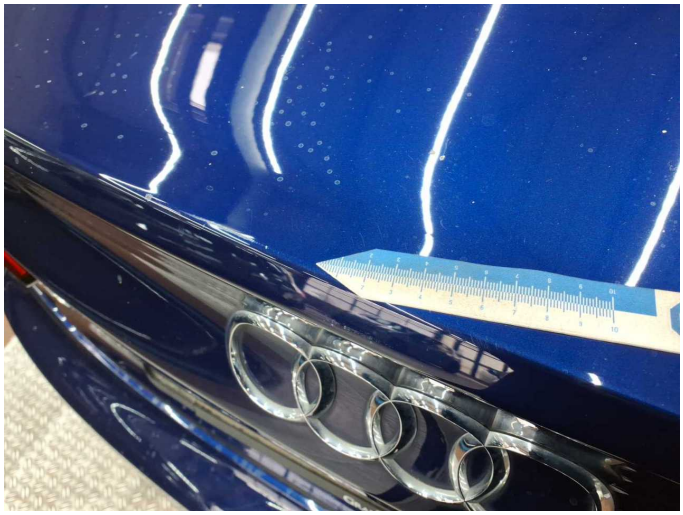
Damage 4: Boot lid / rear door: Boot lid - Scratch(es) - Paint

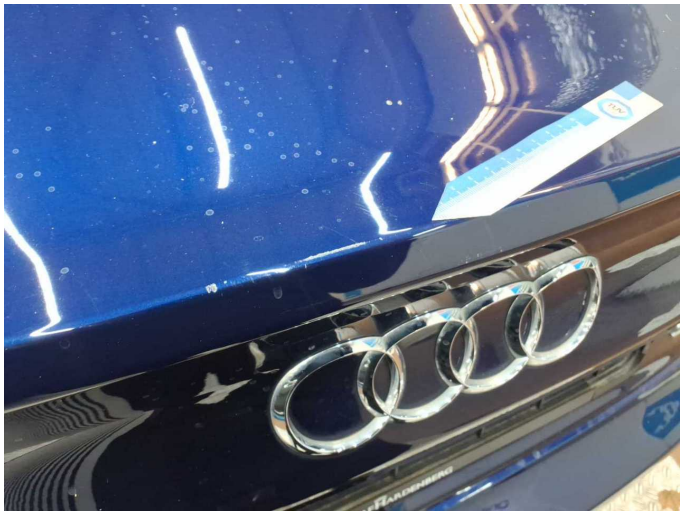
Damage 4: Boot lid / rear door: Boot lid - Scratch(es) - Paint

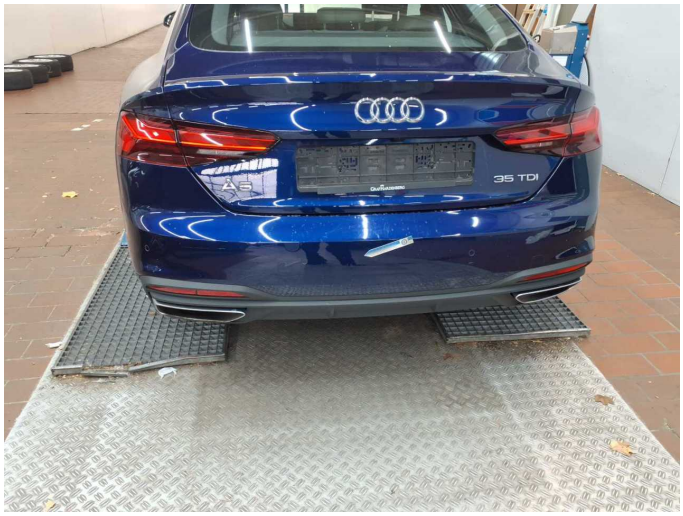
Damage 4: Boot lid / rear door: Boot lid - Scratch(es) - Paint

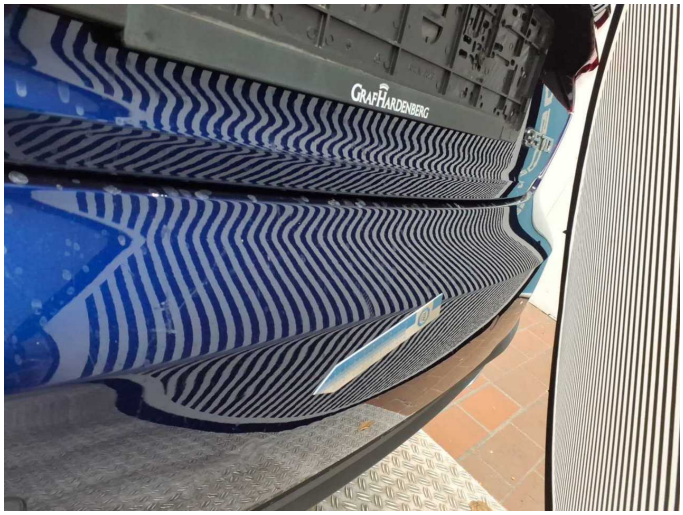
Damage 5: Rear bumper: Rear bumper - Dent / paintcoat damage - Repair and paint

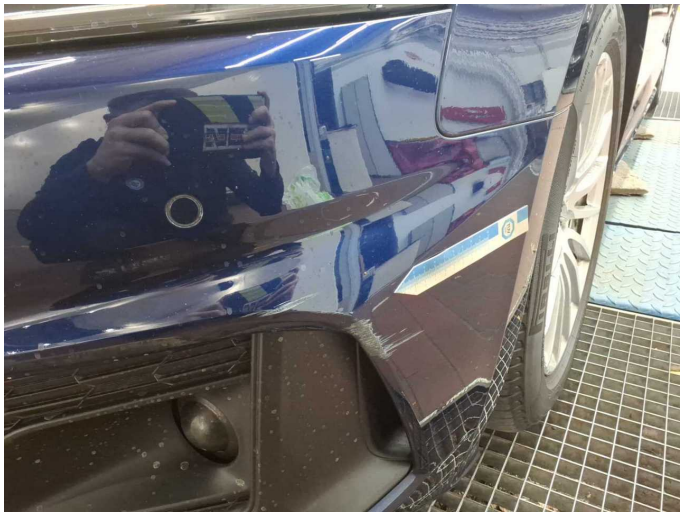
Damage 6: Front bumper: Front bumper - Scratch(es) - Paint
