Expertise

Protocol number: 48199553
Order No. / Reference: 27130183
Inspection date: 19 Oct 2026

Manufacturer: Mercedes-Benz	Model: EQE 350 AMG Line
VIN: W1KEG2FBXPF030982

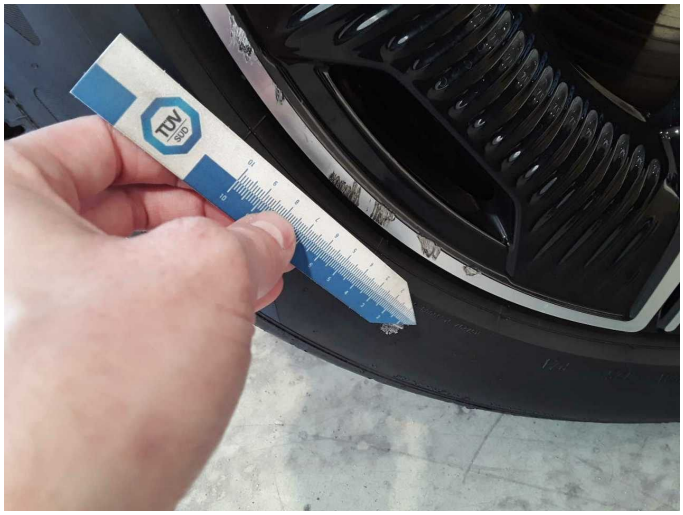
Damage 4: Wheel / tyres: Alloy rim - rear left side - Scratch(es) - Replace

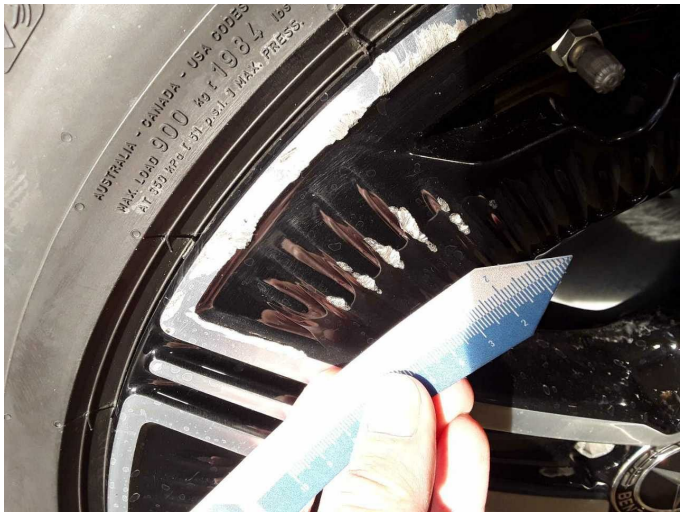
Damage 5: Wheel / tyres: Alloy rim - rear right side - Scratch(es) - Replace
