TÜV SÜD Auto Partner GmbH
Wiesenring 2
04159 Leipzig

Expertise

Protocol number: 48420364
Order No. / Reference: 27248413
Inspection date: 29 Oct 2026

Manufacturer: Mercedes-Benz	Model: 311 CDI Sprinter Kompakt VA
VIN: W1V9076311P215629

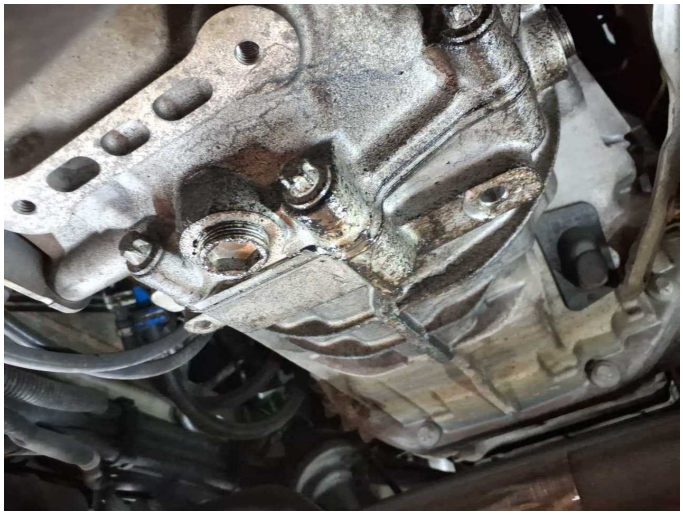
No.	Component group	Description
1	Body	Wheel well - front left side (Dämmung, hängt lose) - Damage caused by marten / rodent - Loss in value
2	Gearbox	Gearbox (Tröpfchenbildung) - Leaking - Perform diagnosis
3	Body	Wheel well - front right side (Schalle) - Broken / torn - Replace
4	Bonnet	Radiator grille - Scratch(es) - Loss in value
5	Roof	Roof (Vorderteil) - Corrosion - Loss in value

Damage 1: Body: Wheel well - front left side (Dämmung, hängt lose) - Damage caused by marten / rodent - Loss in value

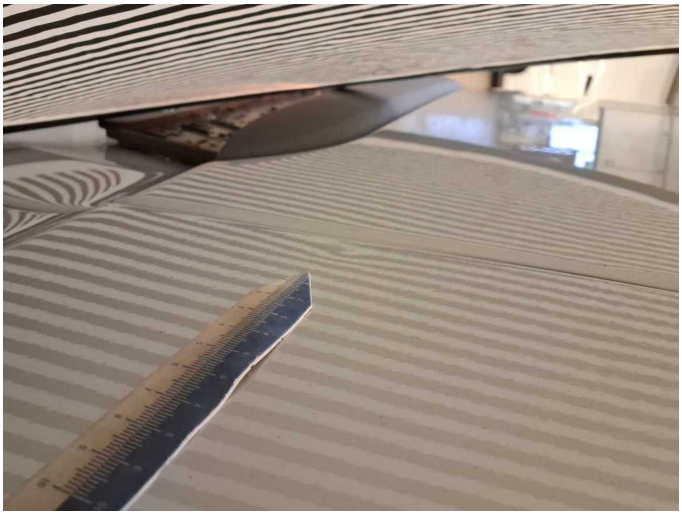
Damage 5: Roof: Roof (Vorderteil) - Corrosion - Loss in value

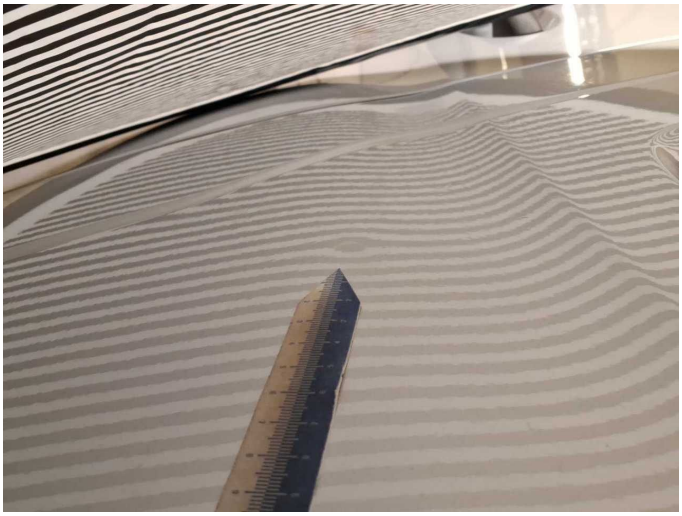
Wear and tear 3: Boot lid / rear door: Rear door - right side - dent(s) - No deduction
