Expertise

Protocol number: 48537580
Order No. / Reference: 27284394
Inspection date: 6 Nov 2026

Manufacturer: Opel	Model: Astra Sports Tourer 1.5 D Automatik Business Edition
VIN: VXKFCYHZTP1061782

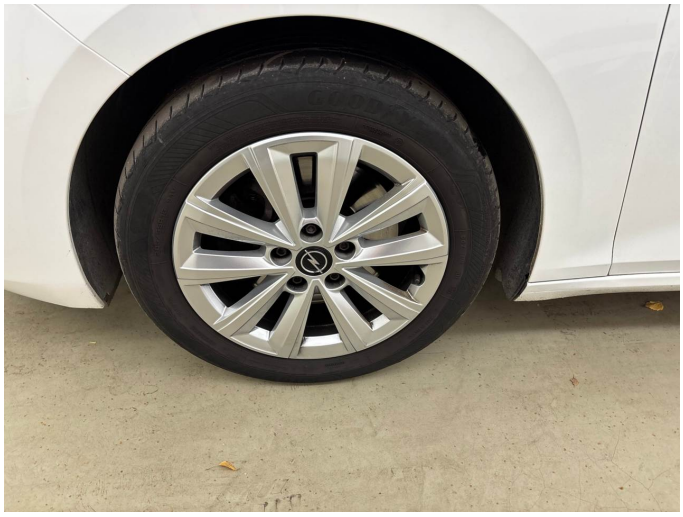
Figure 12: Mounted tyres

#	Tyre size	Type of tyre	Manufacturer	Tread depth
1)	205/55 R16 91V	Summer tyres on Light alloy	Goodyear	6mm / 6mm
2)	205/55 R16 91V	Summer tyres on Light alloy	Goodyear	6mm / 6mm

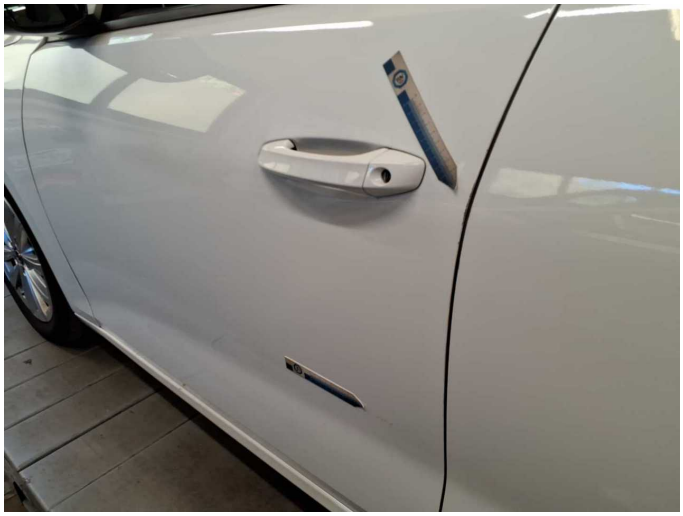
Damage 6: Door - rear left side: Door - Dent / paintcoat damage - Paint
