MACADAM
Polestar Polestar 2 '19 BEV

Vehicle information

Damage summary

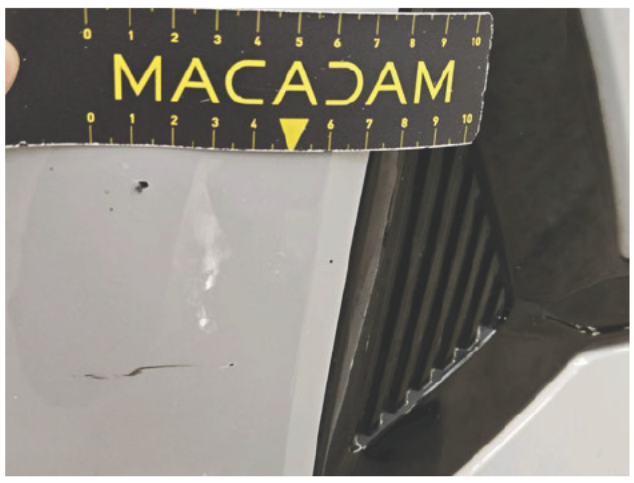
Boot cover
Broken
Replace
Rear

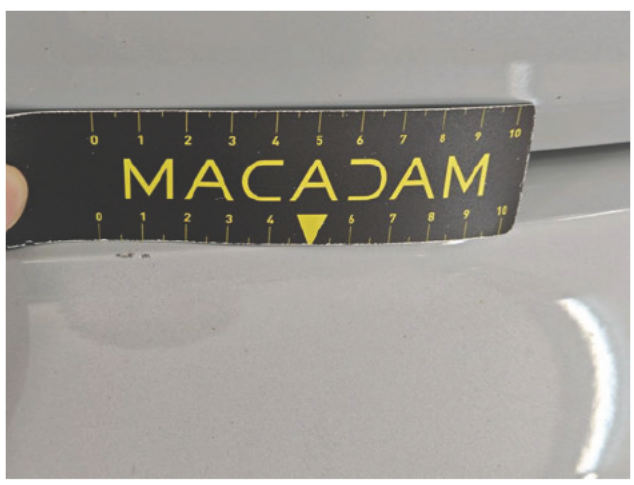
Bumper F
Scratch(es)
Repair and paint (complete)
Front

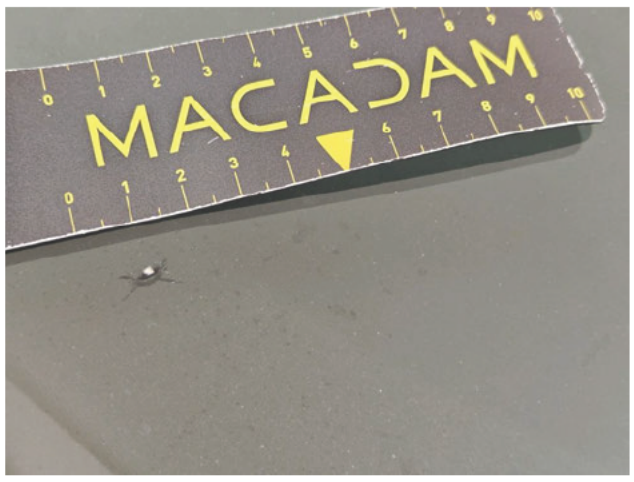
Bumper R
Scratch(es)
Repair and paint (complete)
Rear
