Expertise

Protocol number: 48412535
Order No. / Reference: 27162595
Inspection date: 21 Oct 2026

Manufacturer: Volkswagen	Model: Crafter 35 TDI Autm. 4MOTION
VIN: WV1ZZZSYXN9050546

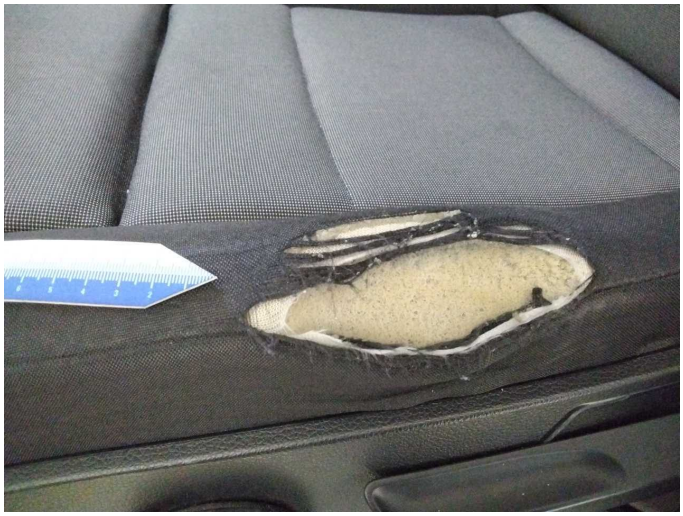
Damage 3: Seat - front: Seat cover - left side - Porous / cracked - Replace

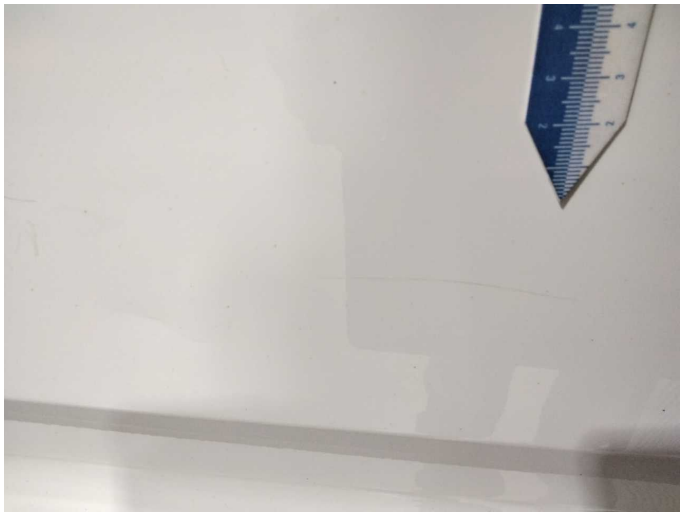
Damage 4: Door - front right side: Door - Dent / paintcoat damage - Repair and paint

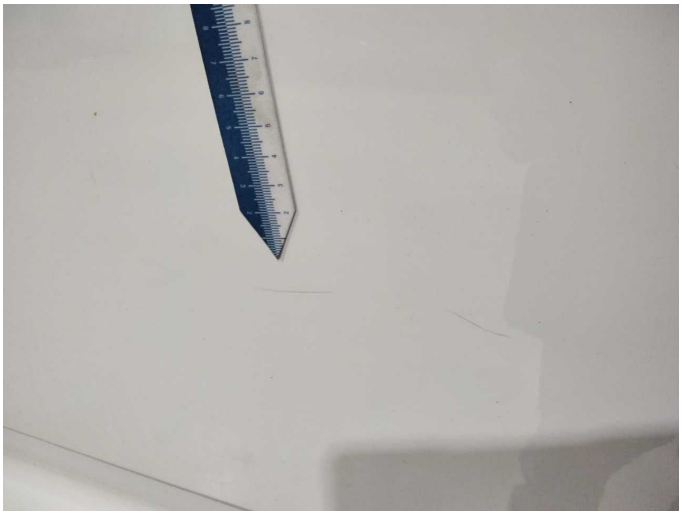
Damage 4: Door - front right side: Door - Dent / paintcoat damage - Repair and paint

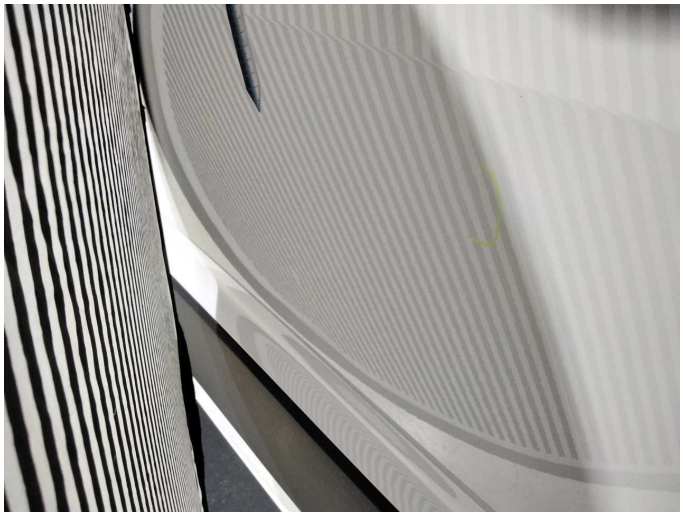
Damage 4: Door - front right side: Door - Dent / paintcoat damage - Repair and paint

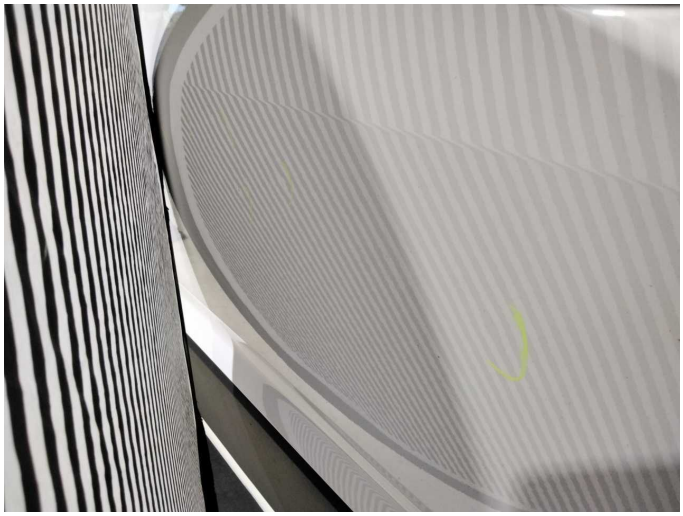
Damage 6: Sliding door, right: Sliding door - Dent / paintcoat damage - Repair and paint
