Expertise

Protocol number: 48516170
Order No. / Reference: 27251535
Inspection date: 3 Nov 2026

Manufacturer: Volkswagen	Model: ID.3 PRO S 150 KW 5-Sitzer
VIN: WVWZZZE1ZPP055357

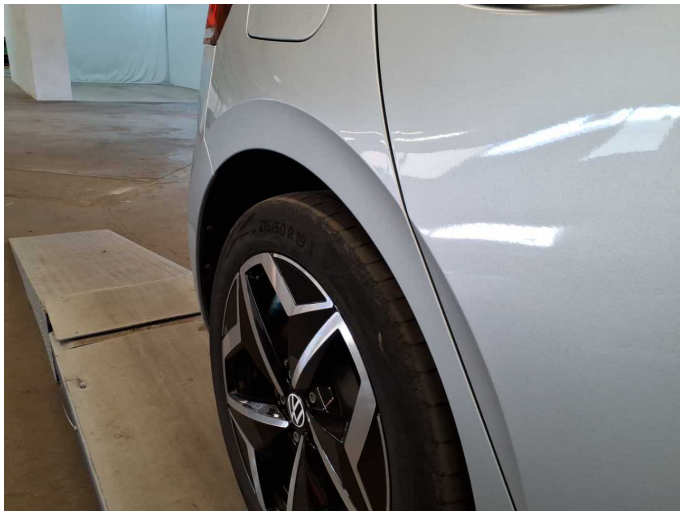
Damage 1: Side panel - rear right side: Side panel - Stone chips - Smart repair

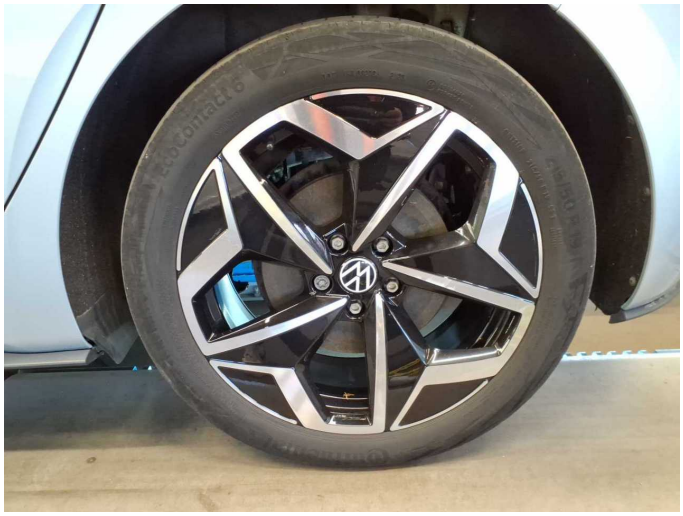
Damage 3: Measurement: Undercarriage - Malposition - Measure

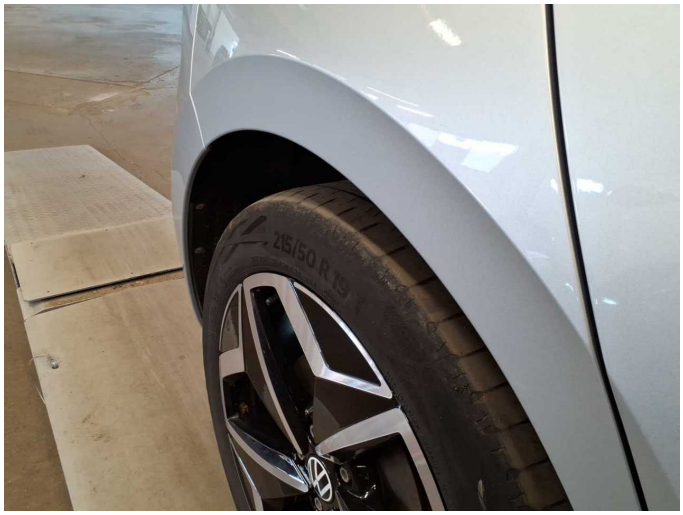
Damage 4: Wheel / tyres: Alloy rim - rear left side - Scratch(es) - Loss in value

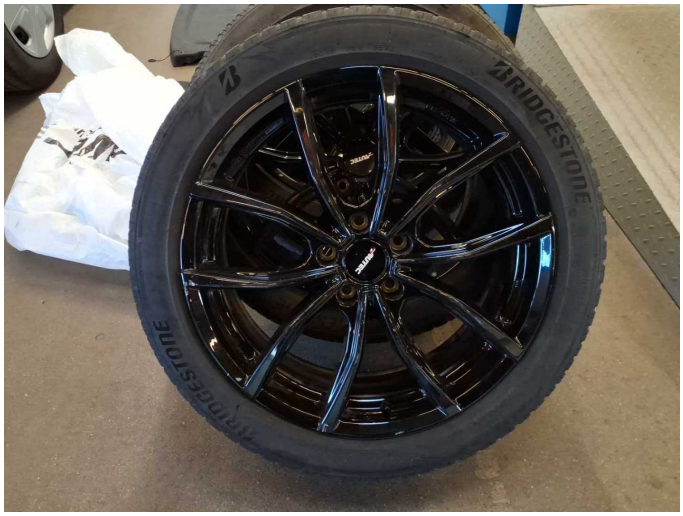
Damage 5: Wheel / tyres: Tyres - complete set (Einseitig abgefahren) - Worn - Replace

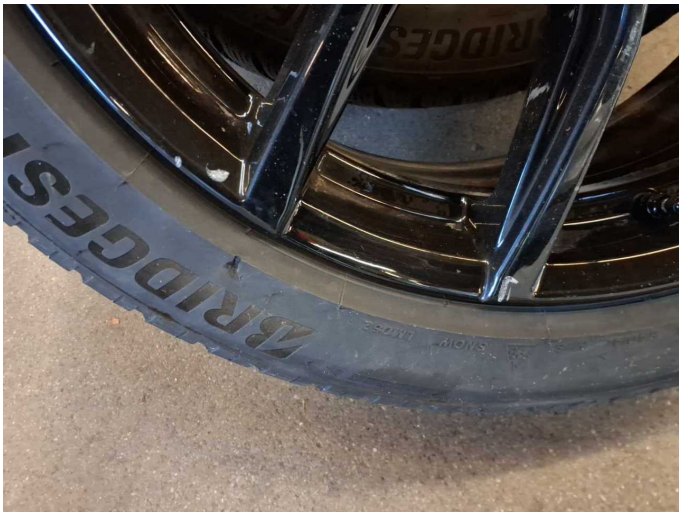
Wear and tear 2: 2nd wheel set: 1 alloy rim - Scratch(es) - No deduction
