Expertise

Protocol number: 48514918
Order No. / Reference: 27230359
Inspection date: 3 Nov 2026

Manufacturer: Skoda	Model: Octavia Combi 2.0 TDI DSG Style
VIN: TMBJJ8NX6PY150793

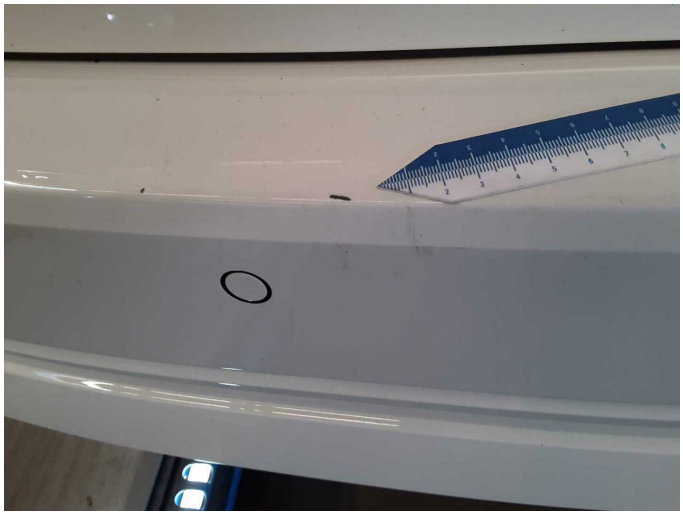
No.	Component group	Description
1	Body	Underbody panelling - Malposition - Set / adjust
2	Roof	Roof - dent(s) - Smooth repair work
3	Rear bumper	Rear bumper - Scratch(es) - Paint

Damage 3: Rear bumper: Rear bumper - Scratch(es) - Paint
