TÜV SÜD Auto Partner GmbH
Wiesenring 2
04159 Leipzig

Expertise

Protocol number: 48418957
Order No. / Reference: 27210016
Inspection date: 30 Oct 2026

Manufacturer: Mercedes-Benz	Model: C 200 4Matic T All-Terrain 9G-TRONIC Avantgarde Advanced
VIN: W1KAH4FB2RF135512

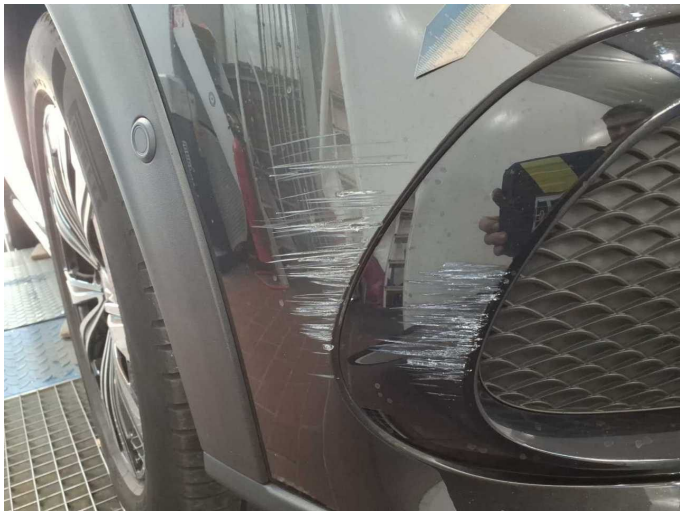
Die beigefügte Reparaturkostenkalkulation wurde nach bestem Wissen und Gewissen unter eingeschränkten Besichtigungsbedingung im demontagefreien Zustand erstellt. Es können aufgrund verdeckter Beschädigung, Mehrkosten und somit Abweichung der für die Stoßstange ausgewiesenen Reparaturkosten nicht ausgeschlossen werden.

Damage 6: Front bumper: Front bumper (Mit Blende.) - Scratch(es) - repair according to calculation
