TÜV SÜD Auto Partner GmbH
Wiesenring 2
04159 Leipzig

Expertise

Protocol number: 48080845
Order No. / Reference: 26920437
Inspection date: 13 Oct 2026

Manufacturer: Seat	Model: Leon 2.0 TDI Reference
VIN: VSSZZZKL1PR000117

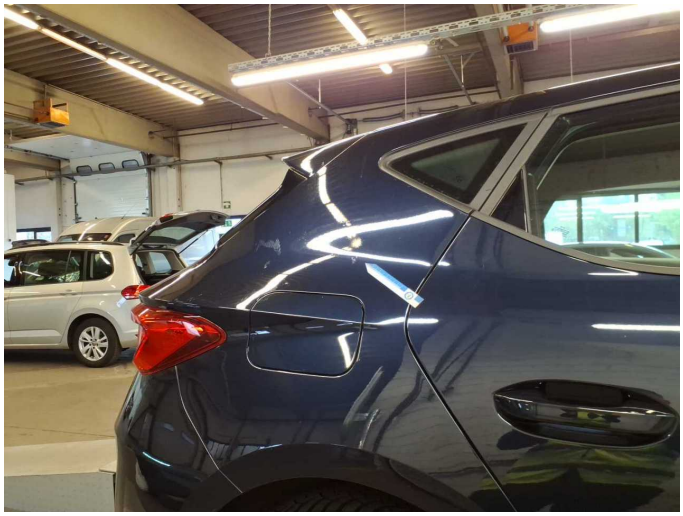
Damage 3: Side panel - rear right side: Side panel (Vogelkotverätzung) - Paint defect - Paint

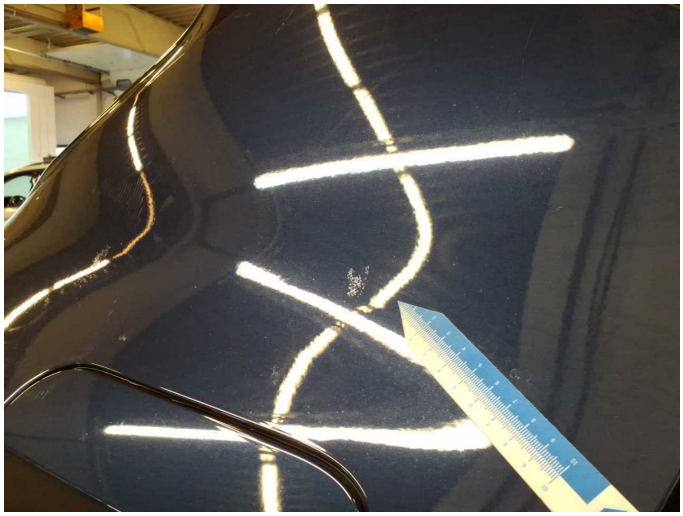
Damage 3: Side panel - rear right side: Side panel (Vogelkotverätzung) - Paint defect - Paint
