Expertise

Protocol number: 48026830
Order No. / Reference: 27099211
Inspection date: 8 Oct 2026

Manufacturer: Seat	Model: Tarraco 1.4 e-Hybrid DSG FR
VIN: VSSZZZKNXRW500010

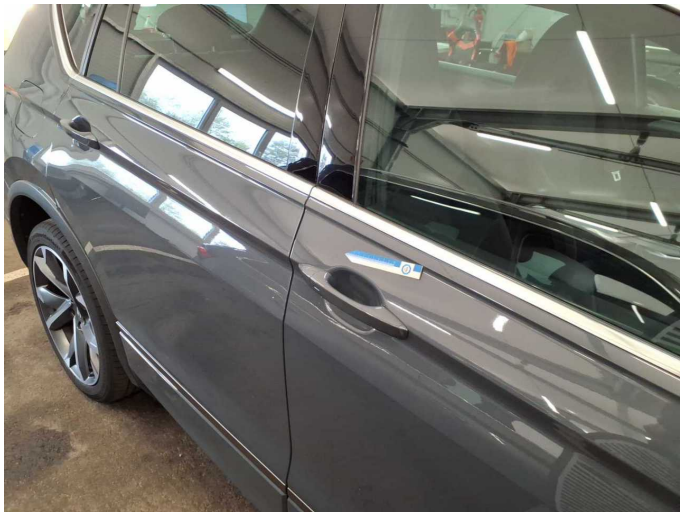
Damage 3: Side panel - rear left side: Side panel - dent(s) - Smooth repair work
