TÜV SÜD Auto Partner GmbH
Wiesenring 2
04159 Leipzig

Expertise

Protocol number: 48474169
Order No. / Reference: 27275371
Inspection date: 2 Nov 2026

Manufacturer: Ford	Model: Kuga 2.5 Duratec PHEV ST-LINE X
VIN: WF0FXXWPMHSC71575

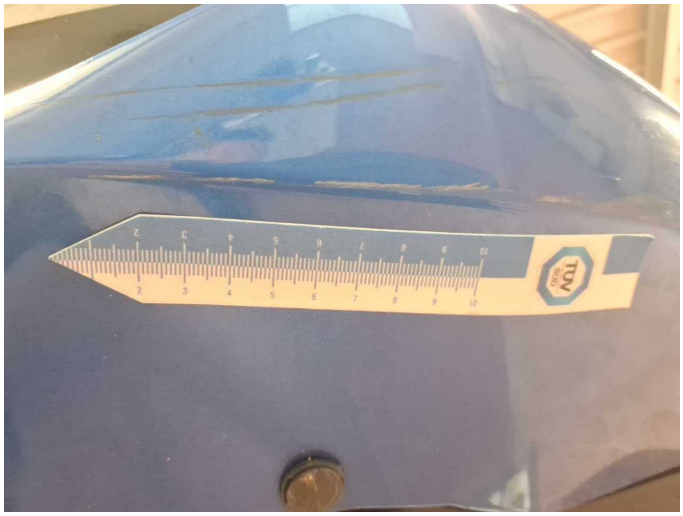
No.	Component group	Description
1	Misc.	Inspection / maintenance (bei 30000 km) - No evidence - No deduction
2	Body	Underbody panelling (Vorne unt) - Loose - Un- / install
3	Front bumper	Bumper with Parktronic (Rechts unten) - Scratch(es) - Smart repair
4	Rear bumper	Bumper with Parktronic - Scratched - Paint

Damage 3: Front bumper: Bumper with Parktronic (Rechts unten) - Scratch(es) - Smart repair

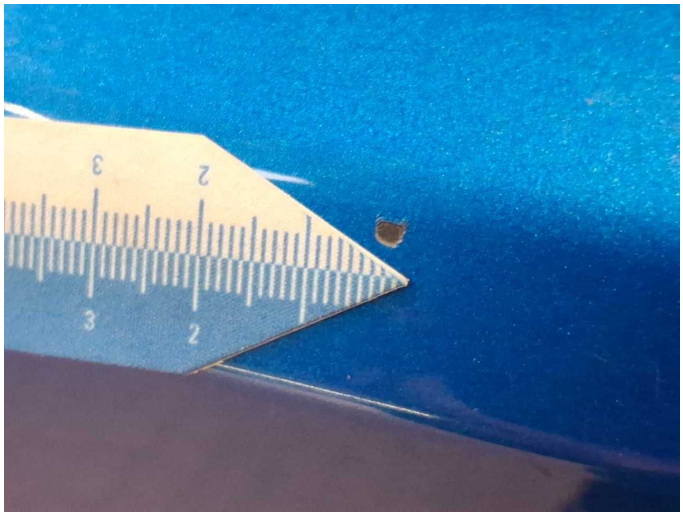
Damage 3: Front bumper: Bumper with Parktronic (Rechts unten) - Scratch(es) - Smart repair

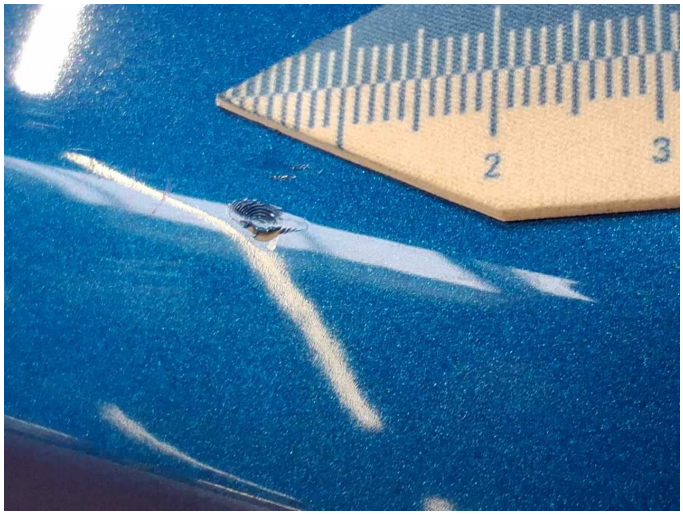
Damage 4: Rear bumper: Bumper with Parktronic - Scratched - Paint

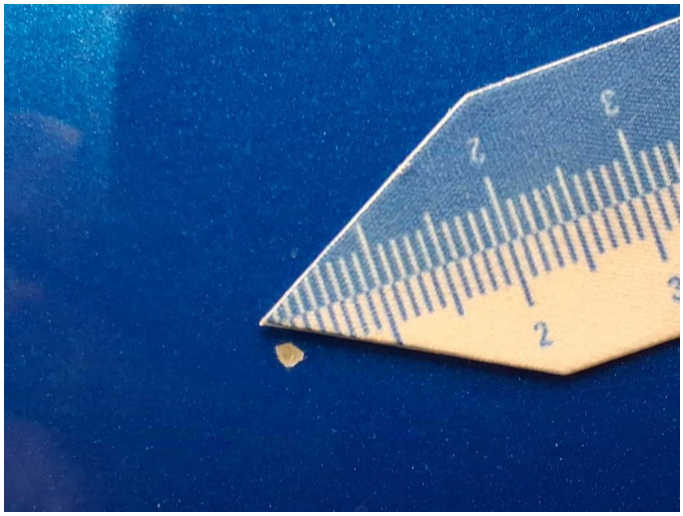
No.	Component group	Description
1	Bonnet	Bonnet - Stone chips - No deduction

Wear and tear 1: Bonnet: Bonnet - Stone chips - No deduction
