Expertise

Protocol number: 48566906
Order No. / Reference: 27226130
Inspection date: 9 Nov 2026

Manufacturer: Skoda	Model: Enyaq iV 80
VIN: TMBJC9NY8PF087636

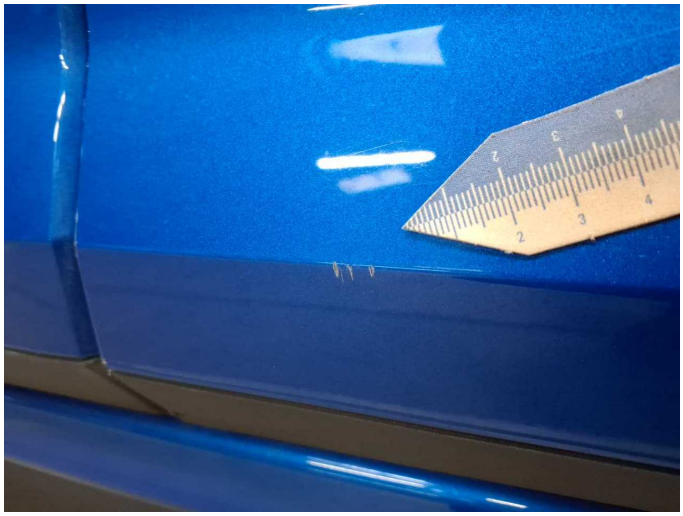
No.	Component group	Description
1	Wing mirror - right side	Cap - Scratch(es) - Smart repair
2	Door - front right side	Door edge - Scratch(es) - Smart repair
3	Wing mirror - right side	Mirror housing (Materialabtrag) - Scratch(es) - Replace
4	Door - front right side	Brightware - lower - Scratch(es) - Paint

Damage 4: Door - front right side: Brightware - lower - Scratch(es) - Paint

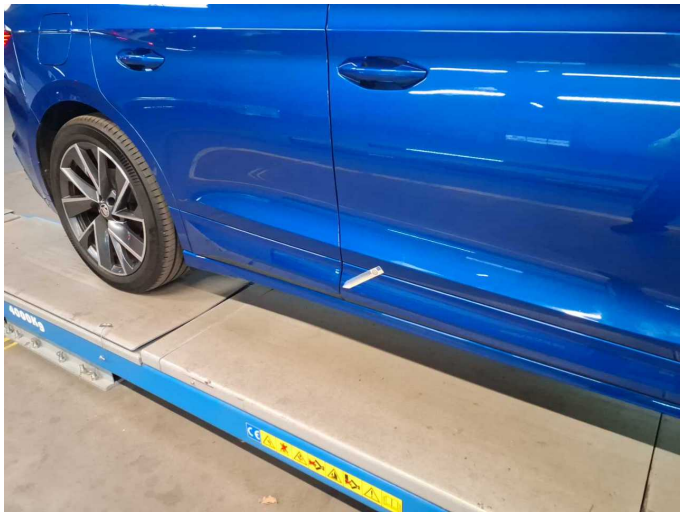
Damage 4: Door - front right side: Brightware - lower - Scratch(es) - Paint

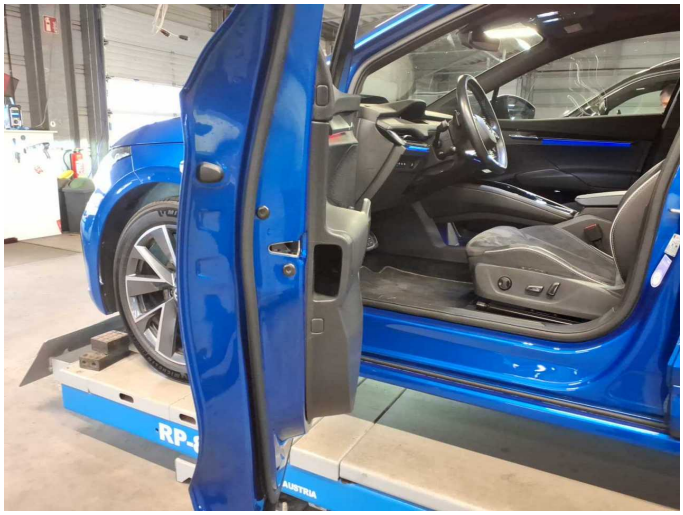
Damage 4: Door - front right side: Brightware - lower - Scratch(es) - Paint
