Expertise

Protocol number: 48458604
Order No. / Reference: 27218694
Inspection date: 2 Nov 2026

Manufacturer: Ford	Model: Kuga 2.5 Duratec PHEV ST-LINE
VIN: WF0FXXWPMHPJ84188

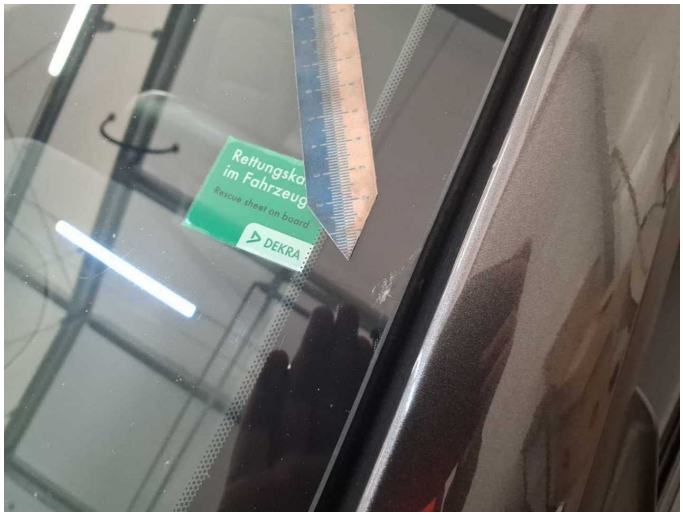
No.	Component group	Description
1	Vehicle glazing	Windscreen - Broken / torn - Replace

Damage 1: Vehicle glazing: Windscreen - Broken / torn - Replace

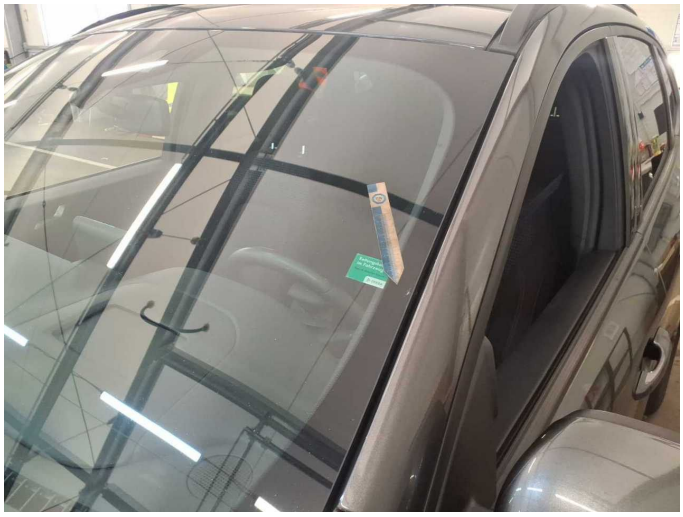
Damage 1: Vehicle glazing: Windscreen - Broken / torn - Replace

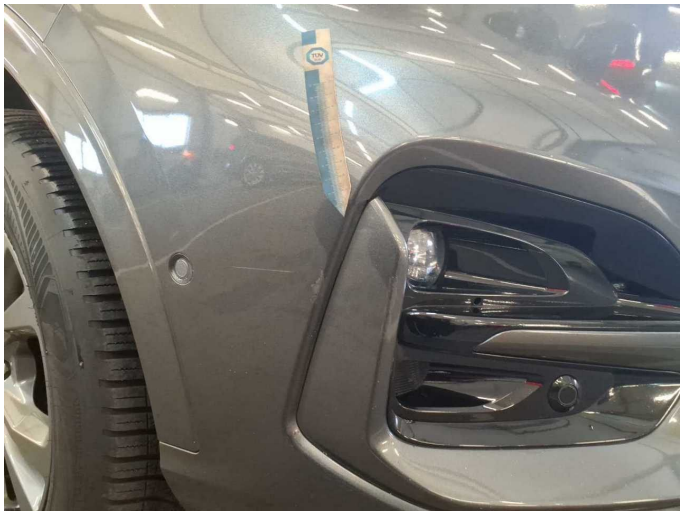
No.	Accident
1	Front

Non-repaired previous damages were found at the vehicle. The necessary repair costs are listed in the expert report or if necessary, are listed in detail in a separately enclosed repair cost calculation.

Accident 1: Front

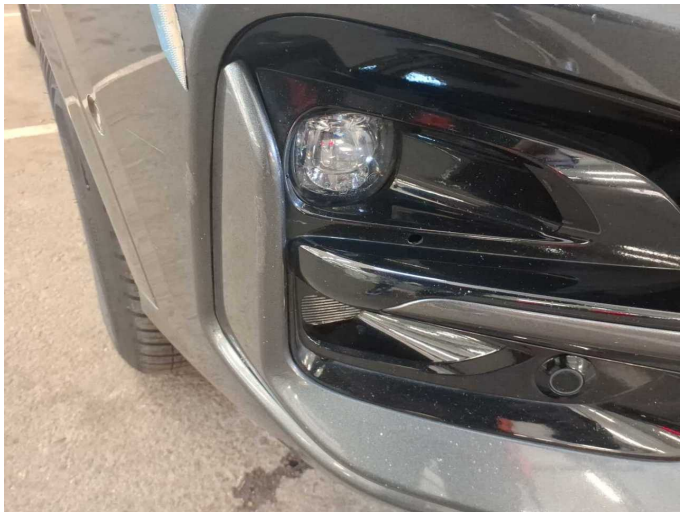
Accident 1: Front
