Expertise

Protocol number: 48463740
Order No. / Reference: 27186680
Inspection date: 26 Oct 2026

Manufacturer: Ford	Model: Focus Turnier 1.5 EcoBlue Start-Stopp-System Aut. TITANIUM
VIN: WF0PXXGCHPPL02820

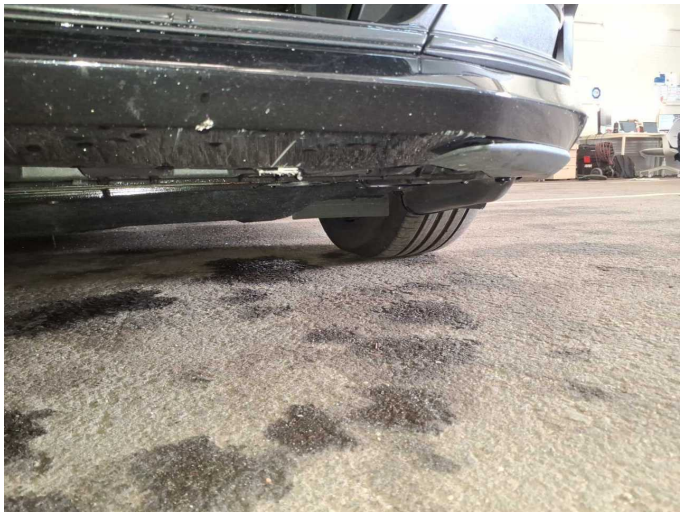
Damage 1: Front bumper: Spoiler (Links) - Malposition - Un- / install

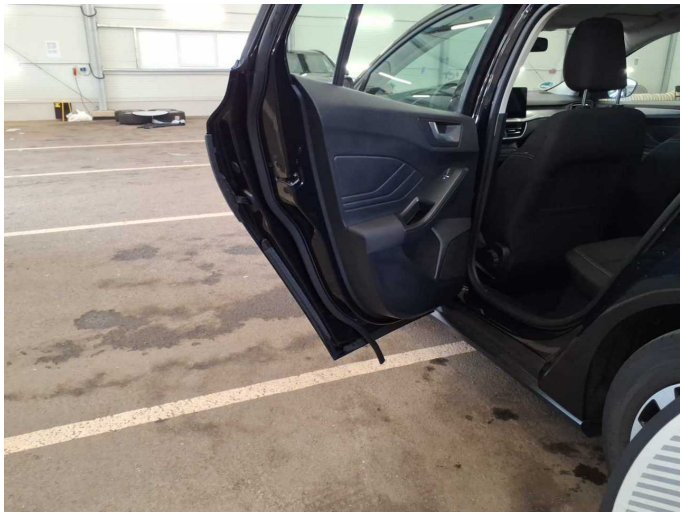
Damage 5: Door - rear left side: Door seal (Kleberablösung) - Damaged - Replace

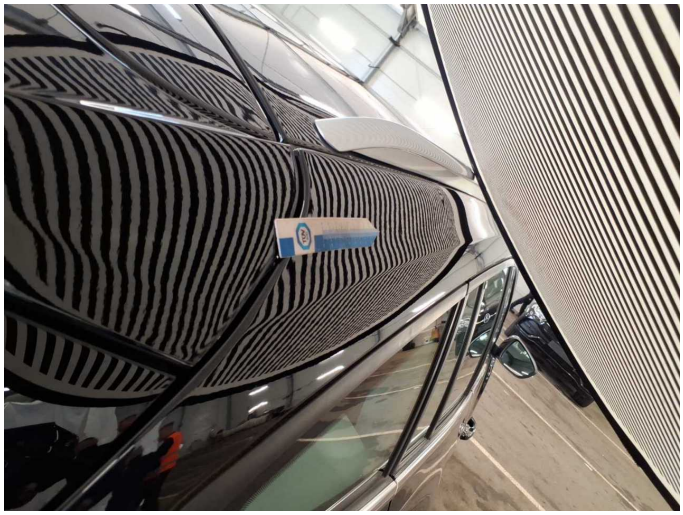
Damage 6: Roof: Roof rail - right side - dent(s) - Smooth repair work

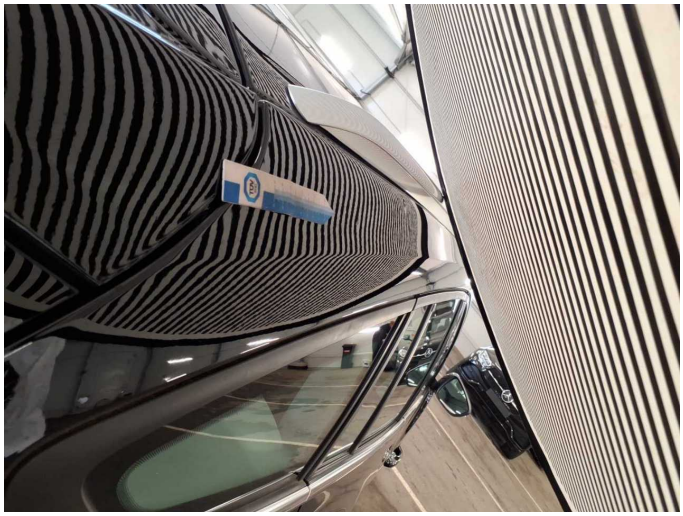
Damage 6: Roof: Roof rail - right side - dent(s) - Smooth repair work

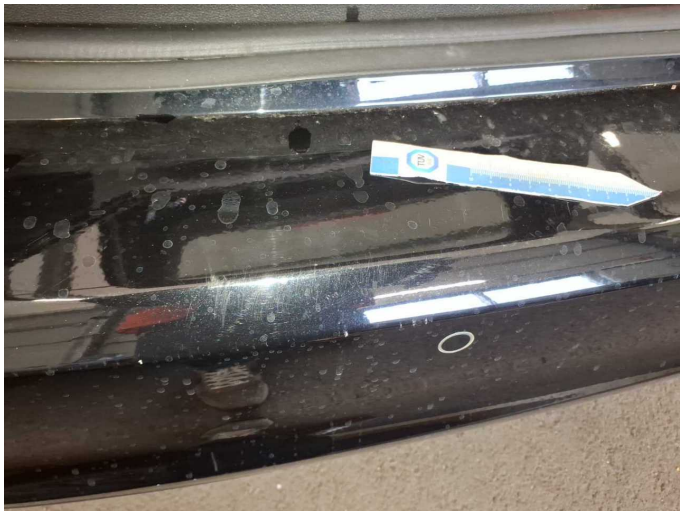
Damage 7: Rear bumper: Rear bumper - Scratched - Smart repair

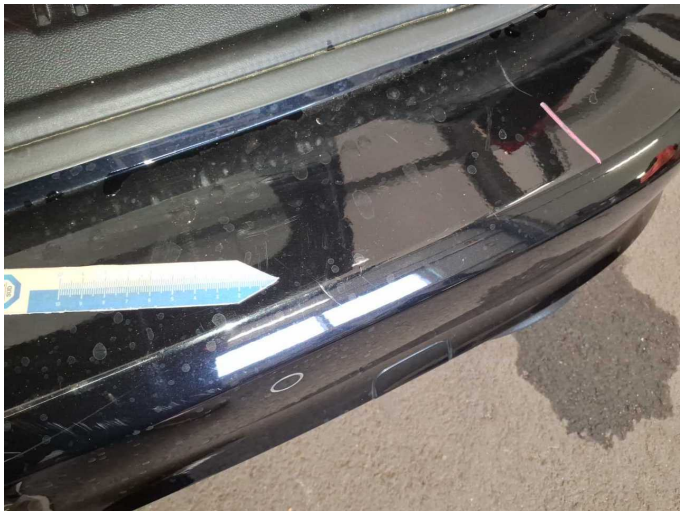
Damage 7: Rear bumper: Rear bumper - Scratched - Smart repair

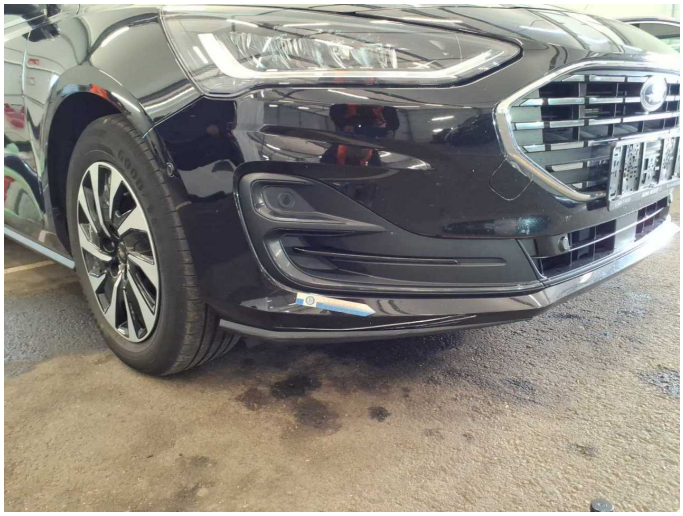
Damage 9: Front bumper: Front bumper - Scratched - Repair and paint

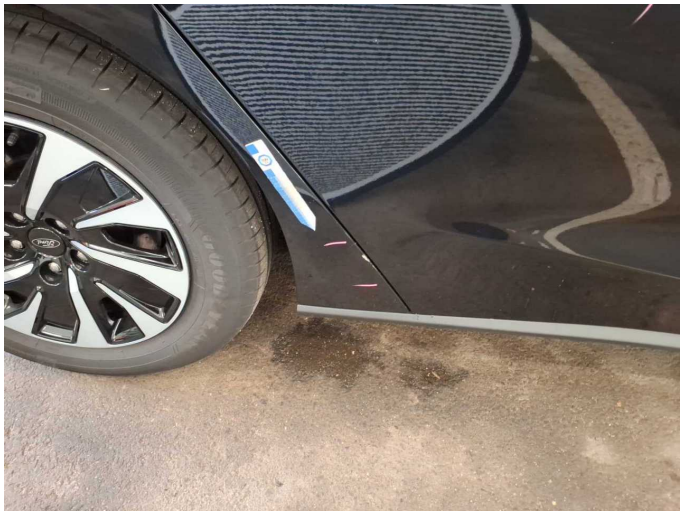
Damage 10: Side panel - rear right side: Side panel - Scratched - Repair and paint

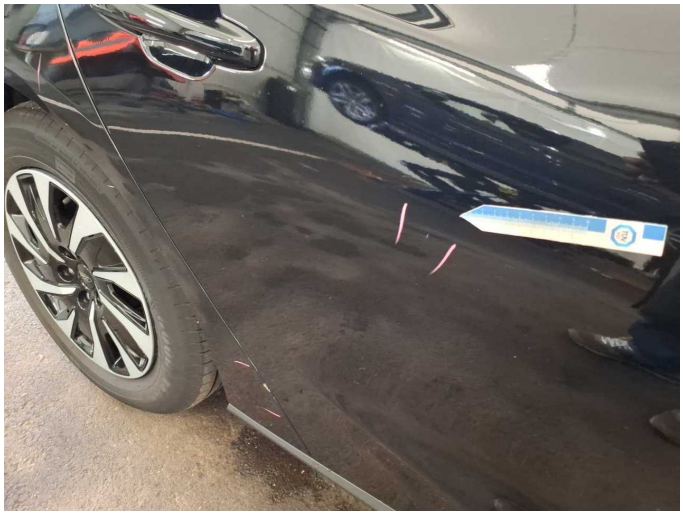
Damage 10: Side panel - rear right side: Side panel - Scratched - Repair and paint

Wear and tear 1: Door - rear right side: Door handle - outside - Scratch(es) - No deduction

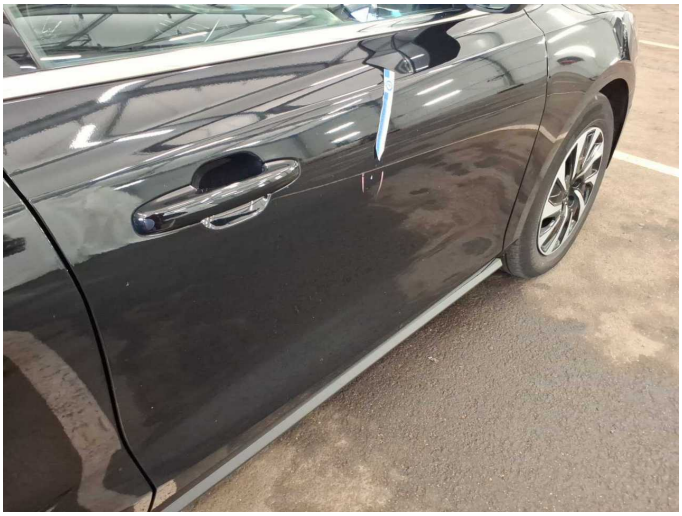
Wear and tear 4: Door - rear right side: Door - Scratch(es) - No deduction
