Expertise

Protocol number: 48482921
Order No. / Reference: 27192610
Inspection date: 28 Oct 2026

Manufacturer: Skoda	Model: Octavia Combi 2.0 TDI Style
VIN: TMBJJ7NXXNY119473

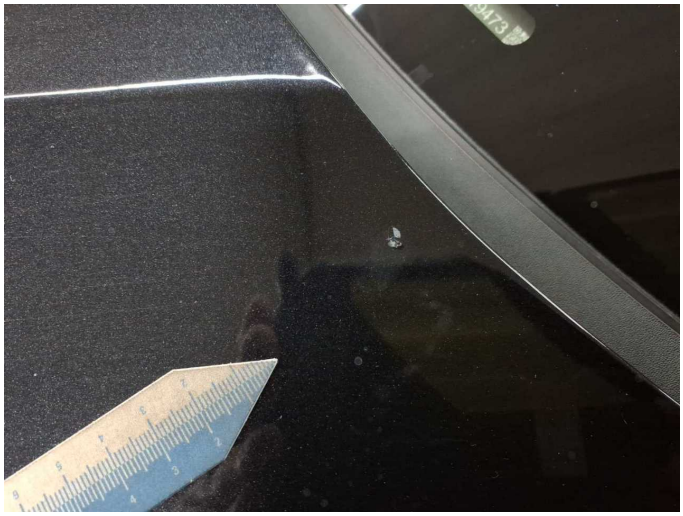
Damage 6: Bonnet: Bonnet (Delle) - Stone chips - Paint
