Expertise

Protocol number: 48030671
Order No. / Reference: 27020193
Inspection date: 8 Oct 2026

Manufacturer: Audi	Model: A3 40 TFSI Sportback quattro S tronic S line
VIN: WAUZZZGY0NA093047

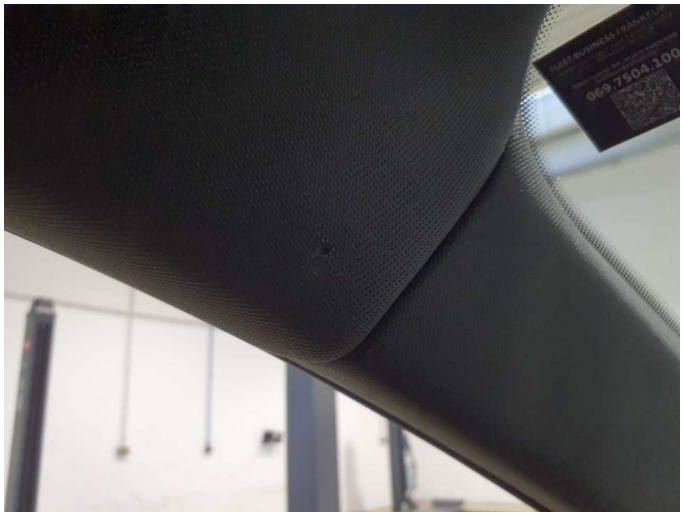
Damage 7: Trim / covers: Roof lining - Holes - Smart repair

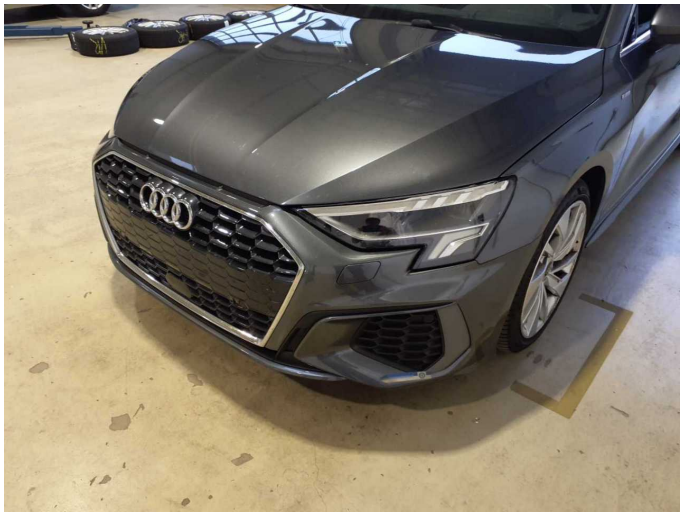
Damage 12: Front bumper: Front bumper - Scratch(es) - Paint
