Expertise

Protocol number: 48541920
Order No. / Reference: 27260932
Inspection date: 5 Nov 2026

Manufacturer: Mercedes-Benz	Model: 311 CDI Sprinter Kompakt HA Kasten
VIN: W1V9076311P215628

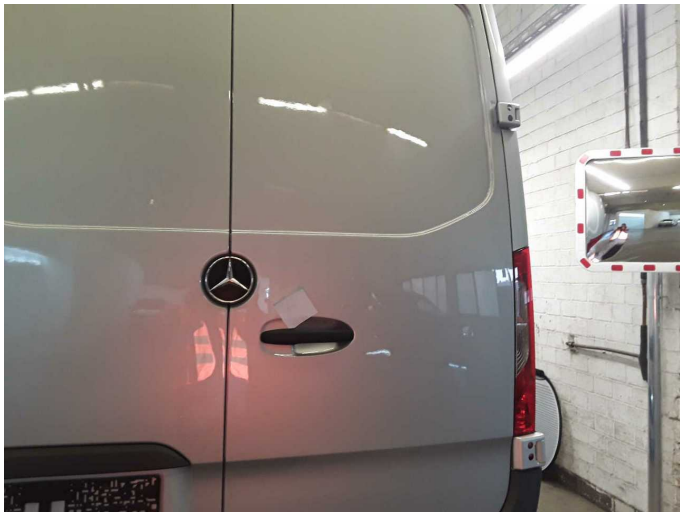
No.	Repainting
1	Boot lid / rear door, Side panel - rear right side, Door - front right side

Boot lid / rear door	240.61 µm	Side panel - rear right side	222 µm
Door - rear right side	317 µm	Door - front right side	178 µm

Repainting 1: Boot lid / rear door, Side panel - rear right side, Door - front right side
