VOLVO XC90

Vehicle information

Summary of damages

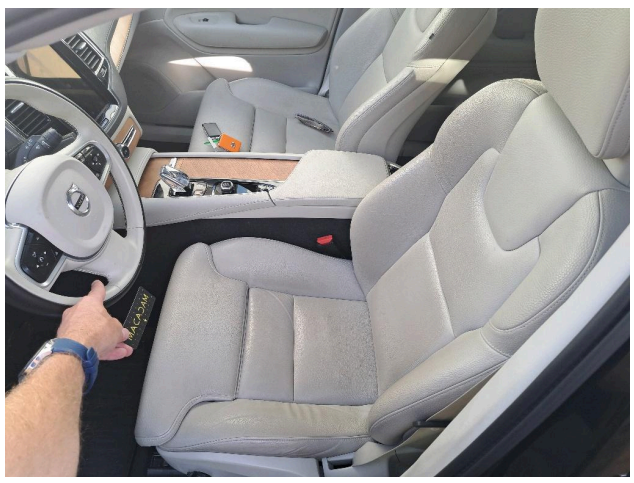
Damaged **Interior**
- Acceptable
Interior

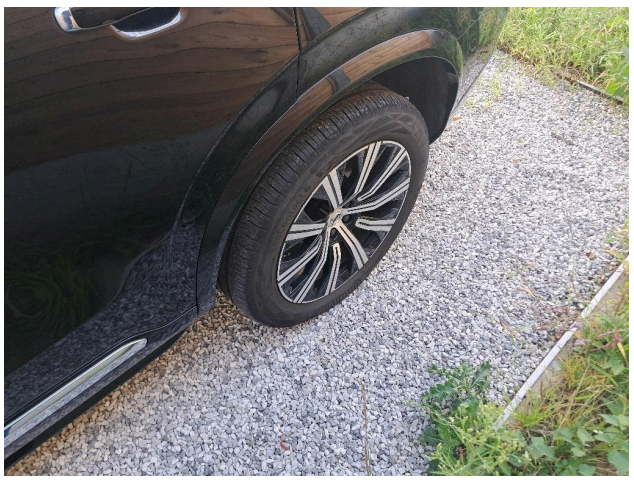
Polished right-hand side aluminum rim .
Scratch(es) left-hand side
- Repair and paint (complete)

Polished ARG alloy
rim with scratches
on the left - Repair and paint (complete
)

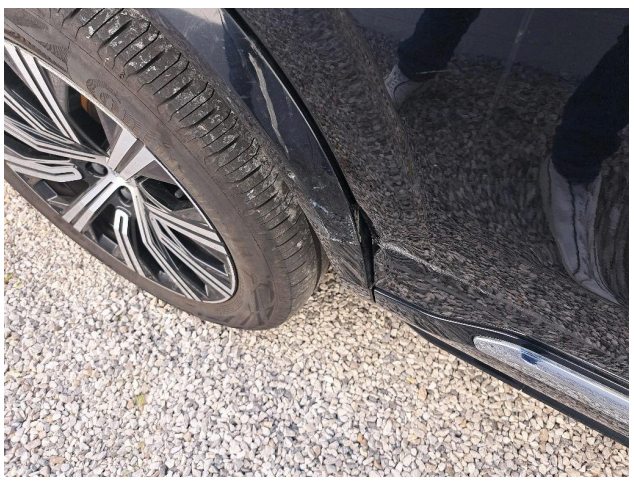
Right rear fender molding

- Dent(s) and scratch(es)
- Replace and

paint

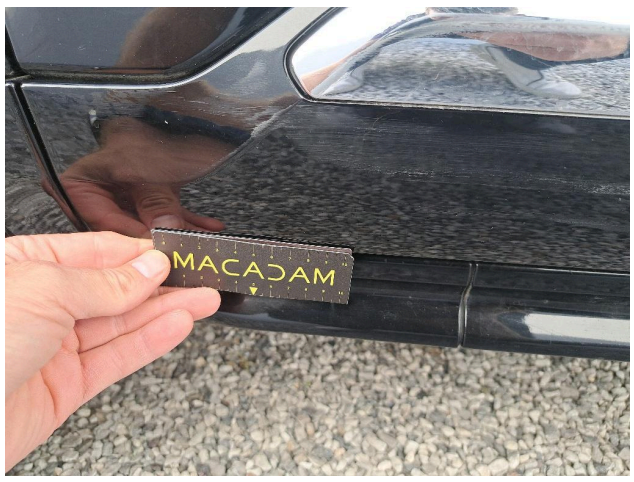
Door molding ARD

Claw(s)

- Replace and paint

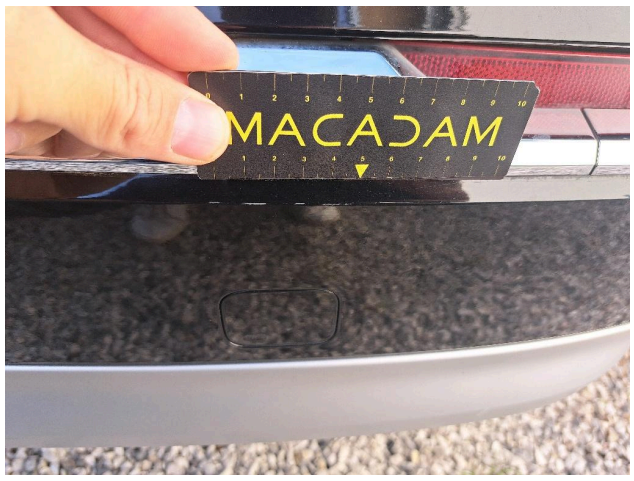
Rear bumper dent

(s) and scratch(es)

Smart repair

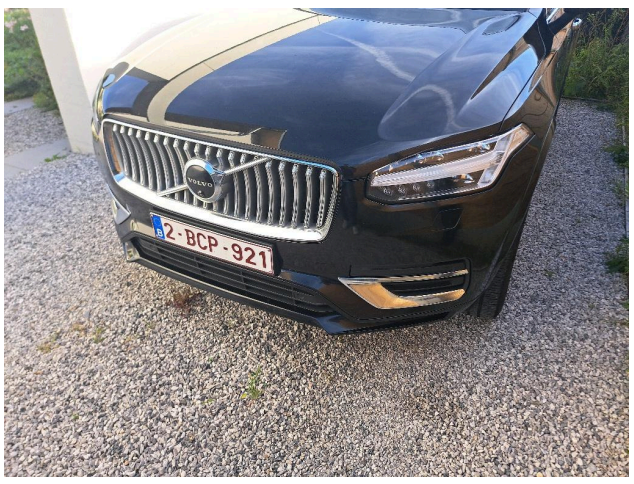
Front bumper, Smart repair
claw(s), front
