ARVAL
BNP PARIBAS GROUP

2CQS320

INSPECTION REPORT

End of contract

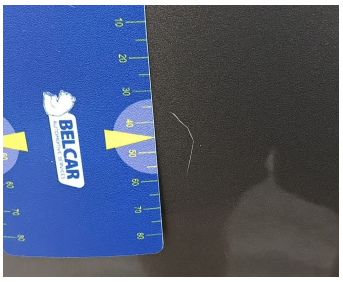
211	Door Front Right // Smart Repair Medium	Y
230	Wing Front right // Smart Repair Small	Y
237	Wing Front right / Trim / Replace	Y
310	Wheel Two Tone Front Left // Repair	N
320	Wheel Two Tone Rear Left // Repair	Y
340	Wheel Two Tone Front Right // Repair	N

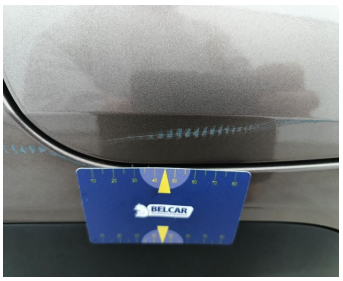
Front / Calendar / Replace-scratch
