Expertise

Protocol number: 48535959
Order No. / Reference: 27206227
Inspection date: 29 Oct 2026

Manufacturer: Opel	Model: Vivaro 2.0 D Cargo L EHZ Autm. Elegance Kasten
VIN: VXEVFEHZ7N7041488

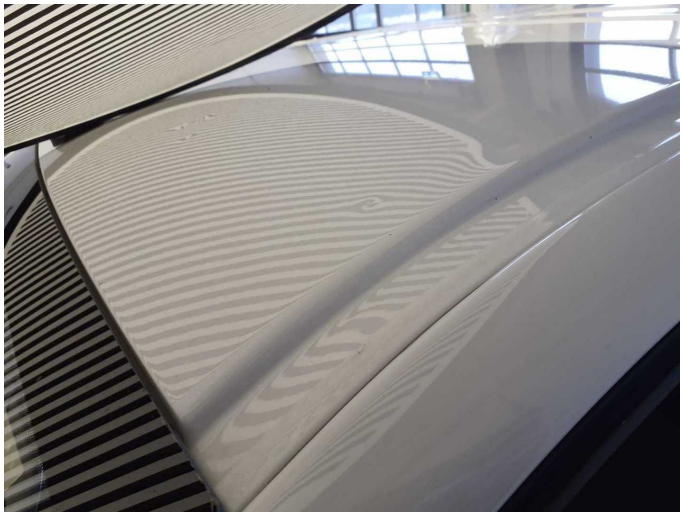
Damage 9: Boot lid / rear door: Rear door - right side - Dent / paintcoat damage - Smart repair

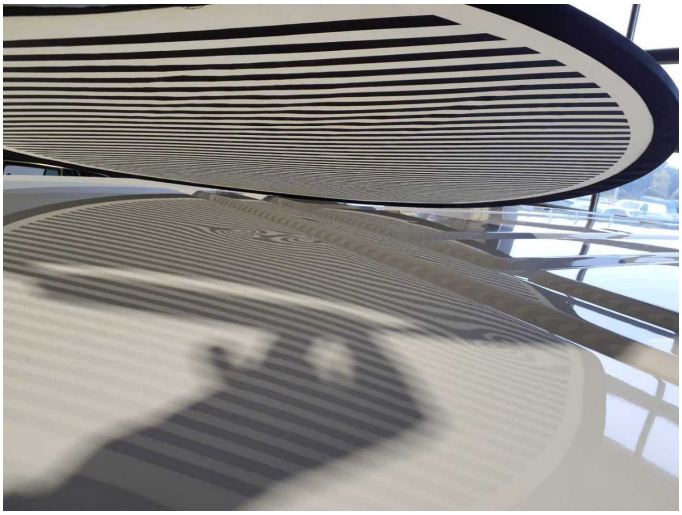
Damage 10: Roof: Roof - dent(s) - Smooth repair work

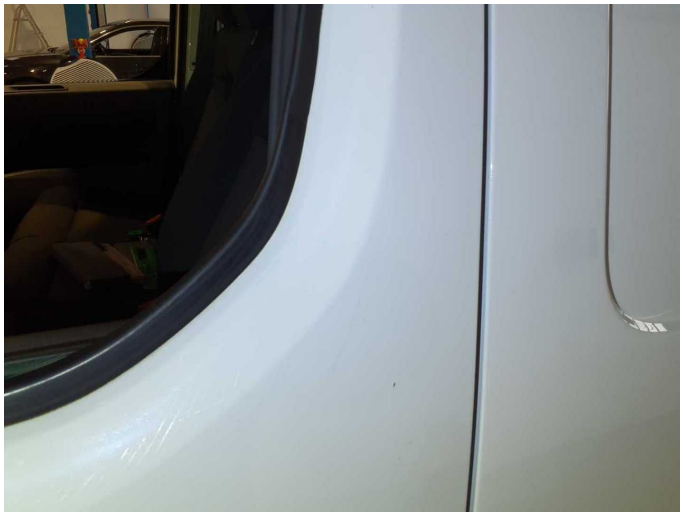
Damage 14: Door - front left side: Door - Scratch(es) - Paint

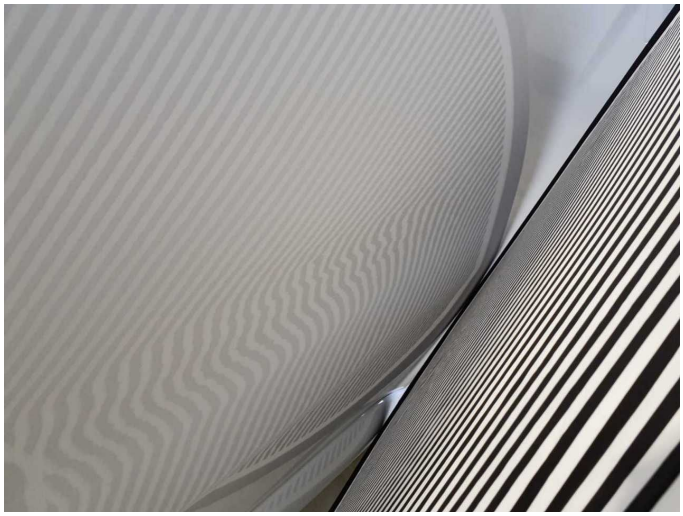
Side panel - rear left side	653 µm

Damage 15: Side panel - rear left side: Side panel (Lack löst sich) - Unprofessionally repaired - Repair and paint

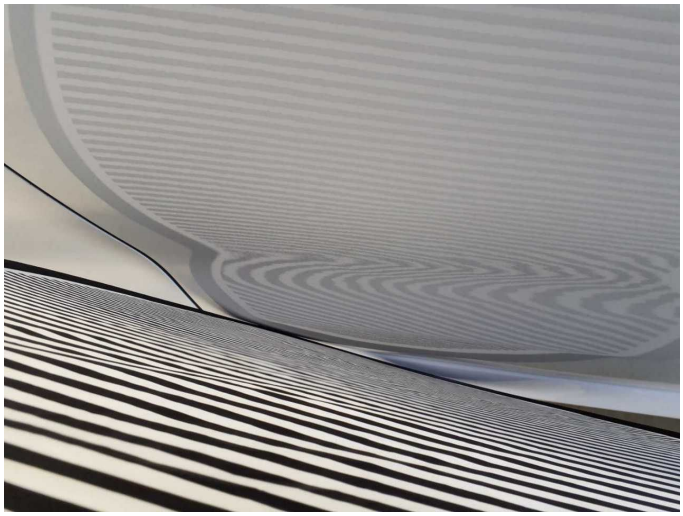
Damage 15: Side panel - rear left side: Side panel (Lack löst sich) - Unprofessionally repaired - Repair and paint

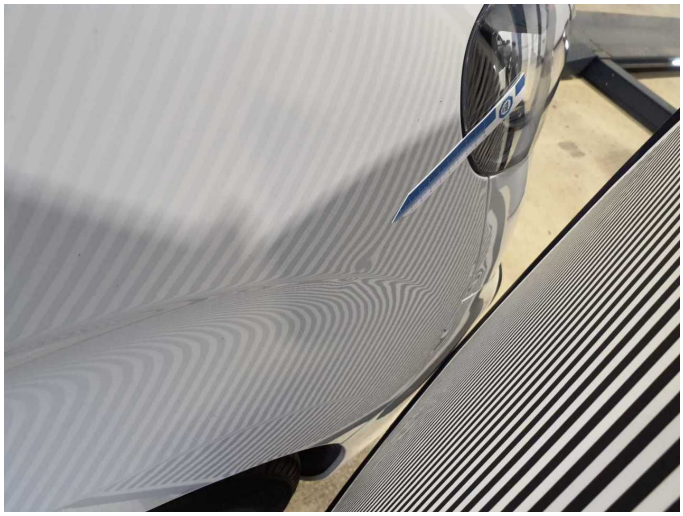
Damage 15: Side panel - rear left side: Side panel (Lack löst sich) - Unprofessionally repaired - Repair and paint

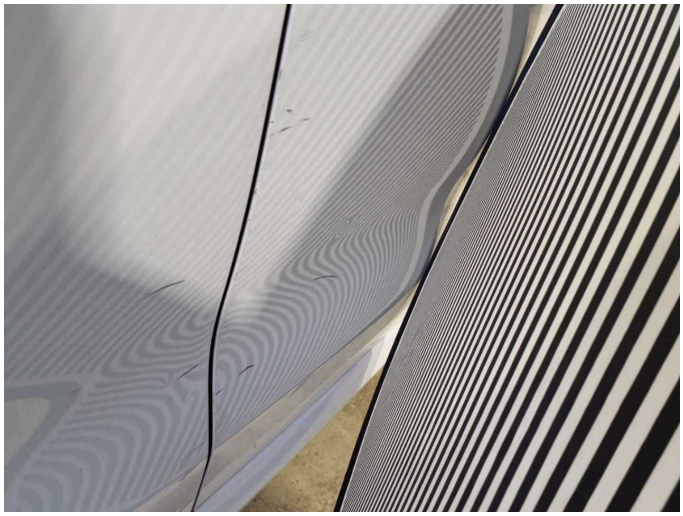
Accident 1: Side right
