Expertise

Protocol number: 48088295
Order No. / Reference: 26824680
Inspection date: 12 Oct 2026

Manufacturer: Seat	Model: Tarraco 2.0 TDI SCR DSG Style
VIN: VSSZZZKN8RW005045

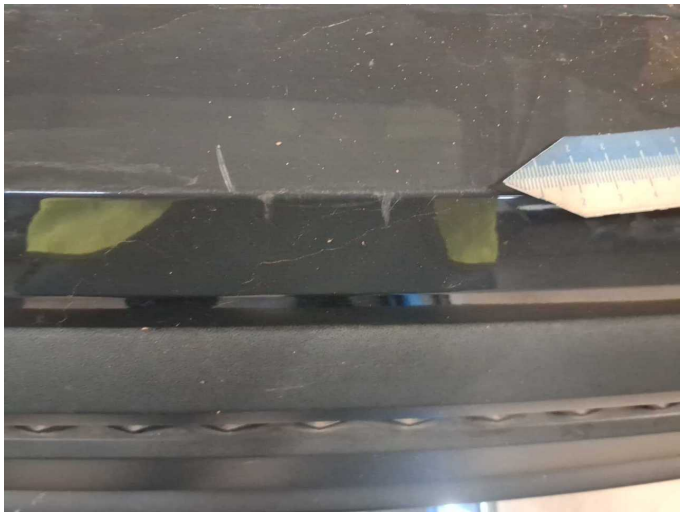
Damage 2: Sill - left side: Sill - Scratch(es) - Smart repair
