VOLVO XC40

Vehicle information

Summary of damages

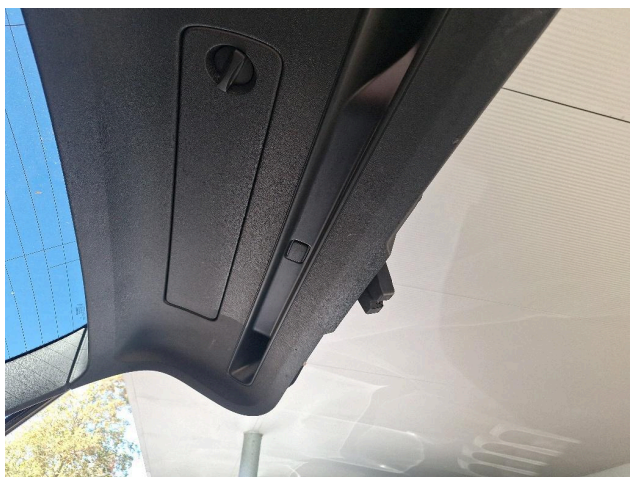
Maintenance, Maintenance , Checking, Interior

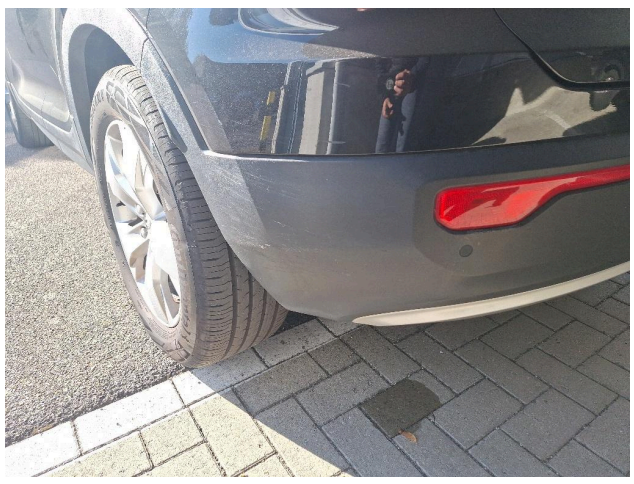
Rear cover trim, Smart repair claw(s), rear

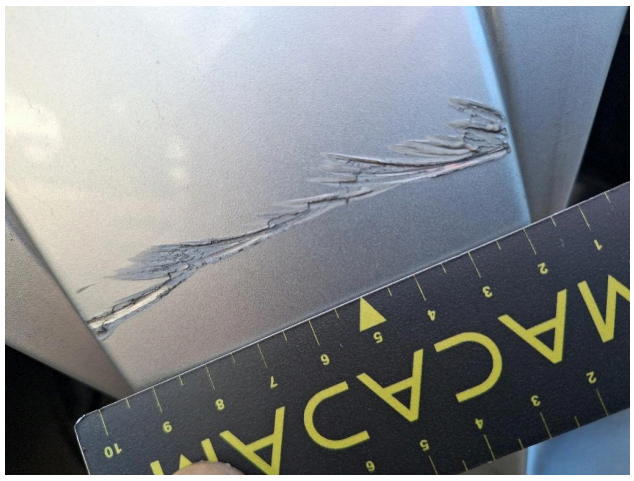
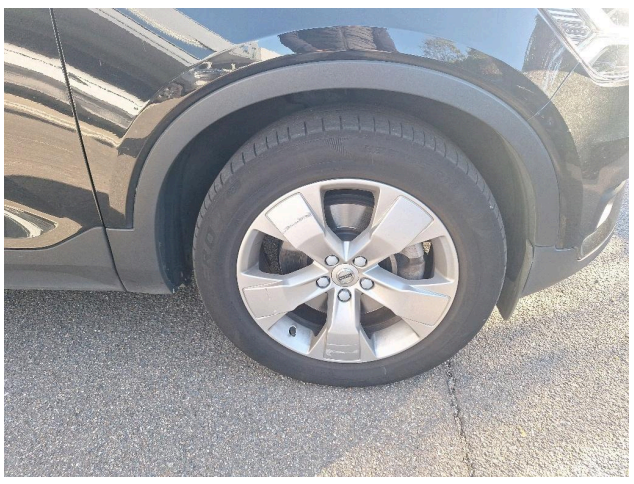
Alloy wheel AVD

Scratch(es)

LI - Repair and paint (complete)

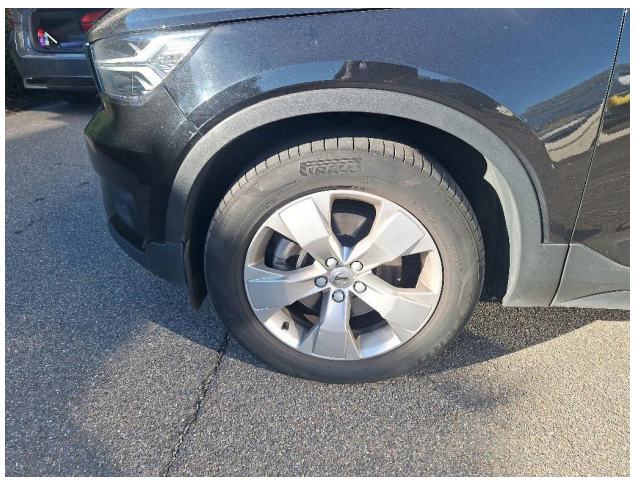
Alloy wheel AVG

Scratch(es)

LI - Repair and paint (complete)
