Expertise

Protocol number: 48405716
Order No. / Reference: 27090707
Inspection date: 28 Oct 2026

Manufacturer: Mercedes-Benz	Model: GLE 350 de 4Matic 9G-TRONIC
VIN: W1N1671171A515360

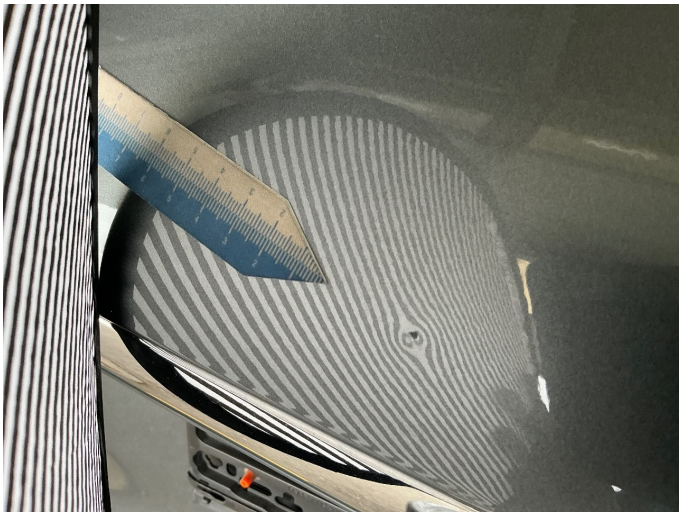
Damage 2: Boot lid / rear door: Boot lid - dent(s) - Smooth repair work

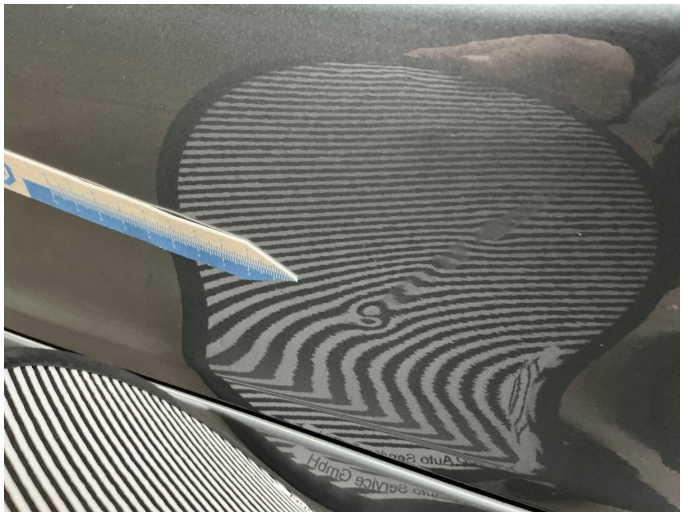
Damage 3: Door - front left side: Door - Dent / paintcoat damage - Smart repair

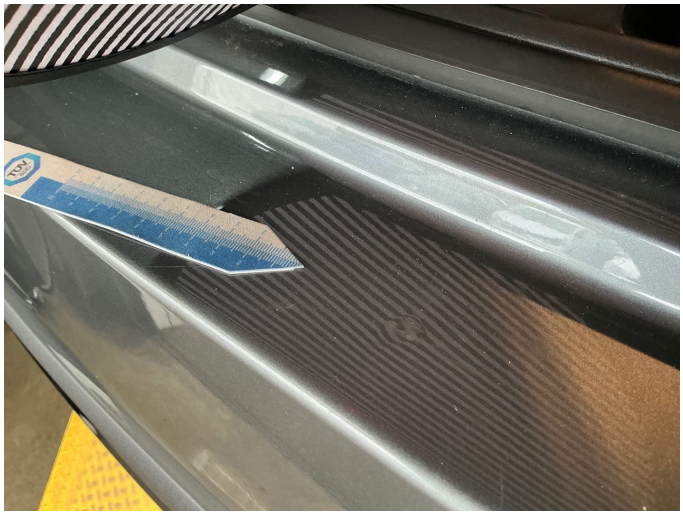
Damage 8: Rear bumper: Rear bumper - Dent / paintcoat damage - Repair and paint
