# Expertise

Protocol number: 48417707
Order No. / Reference: 27219138
Inspection date: 29 Oct 2026

| Manufacturer: Opel | Model: Insignia Sports Tourer 2.0 Diesel Aut. Elegance |
| VIN: W0VZT8EP0N1043098 | |

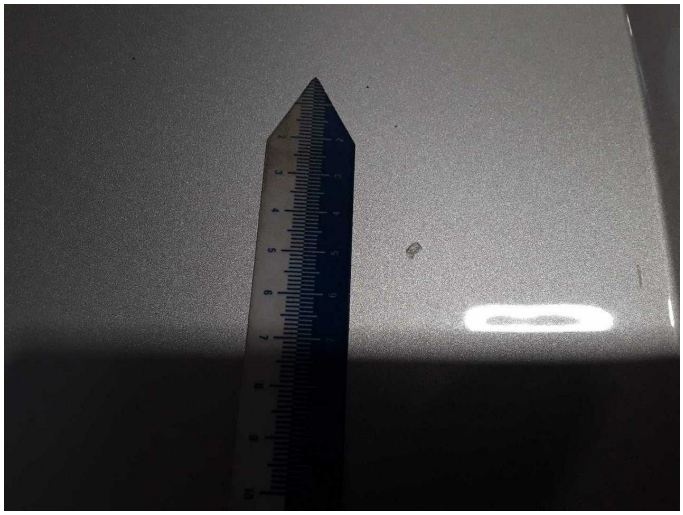
| No. | Component group | Description |
|---|---|---|
| 3 | Bonnet | Bonnet - Stone chips - No deduction |

**Wear and tear 3:** Bonnet: Bonnet - Stone chips - No deduction
