Expertise

Protocol number: 48215335
Order No. / Reference: 27162656
Inspection date: 20 Oct 2026

Manufacturer: Opel	Model: Insignia Sports Tourer 2.0 Diesel Aut. Business
VIN: W0VZT8EP2N1030899

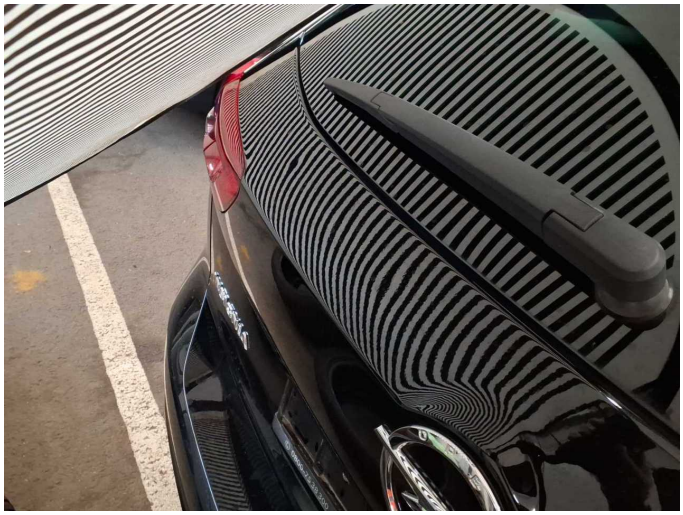
Damage 4: Boot lid / rear door: Boot lid - dent(s) - Smooth repair work

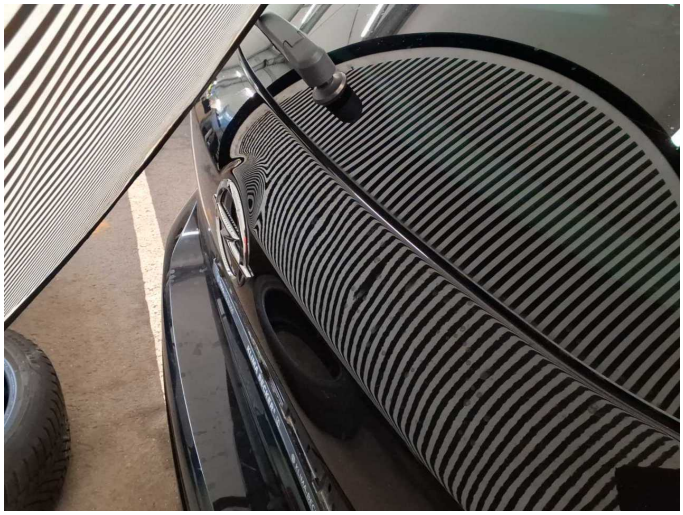
Damage 4: Boot lid / rear door: Boot lid - dent(s) - Smooth repair work

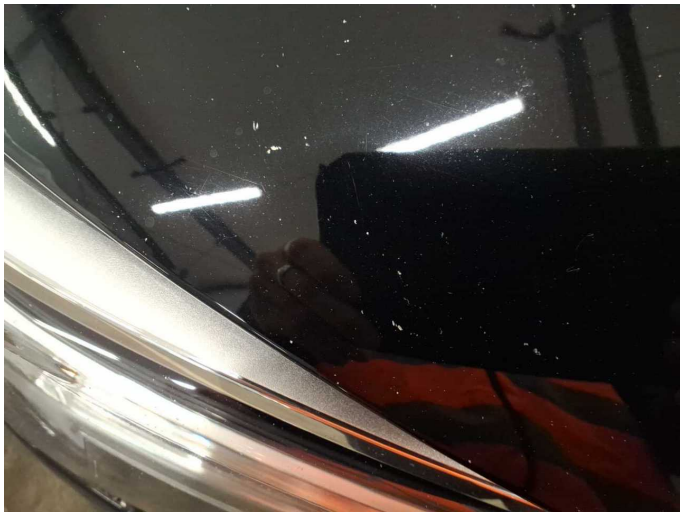
Damage 6: Front bumper: Front bumper - Stone chips - Paint

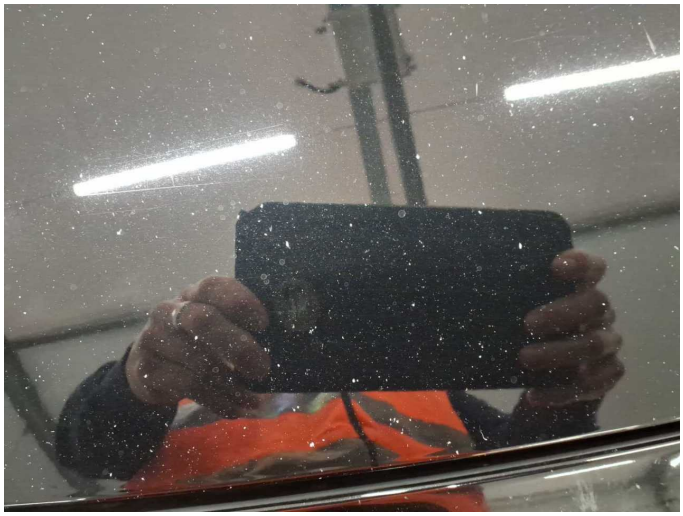
Damage 7: Bonnet: Bonnet - Stone chips - Paint
