Expertise

Protocol number: 48429976
Order No. / Reference: 27211067
Inspection date: 29 Oct 2026

Manufacturer: Mercedes-Benz	Model: GLC 300 d 4Matic 9G-TRONIC AMG Line Plus
VIN: W1N2539191V353650

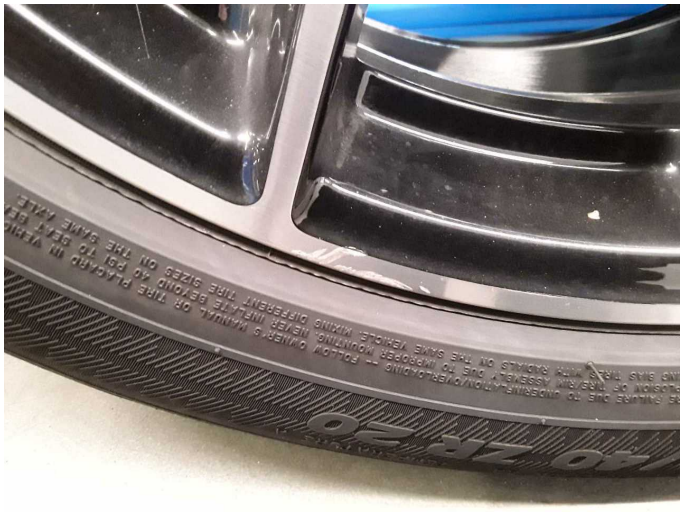
No.	Component group	Description
1	Boot lid / rear door	Boot lid - dent(s) - Smooth repair work
2	Side panel - rear right side	Side panel - Dent / paintcoat damage - Smart repair
3	Wheel / tyres	Alloy rim - rear right side - Scratch(es) - Loss in value
4	Door - rear left side	Door - Scratch(es) - Paint

Damage 1: Boot lid / rear door: Boot lid - dent(s) - Smooth repair work

Damage 2: Side panel - rear right side: Side panel - Dent / paintcoat damage - Smart repair

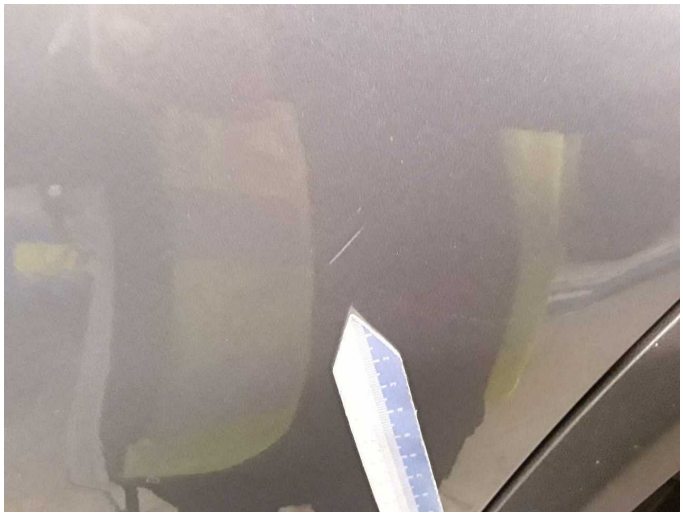
Damage 3: Wheel / tyres: Alloy rim - rear right side - Scratch(es) - Loss in value

Damage 4: Door - rear left side: Door - Scratch(es) - Paint

Wear and tear 1: Door - front right side: Door edge - Scratch(es) - No deduction
