Expertise

Protocol number: 48039938
Order No. / Reference: 27049683
Inspection date: 8 Oct 2026

Manufacturer: Mercedes-Benz	Model: GLB 200 d 8G-DCT Progressive
VIN: W1N4M1CB8PW304573

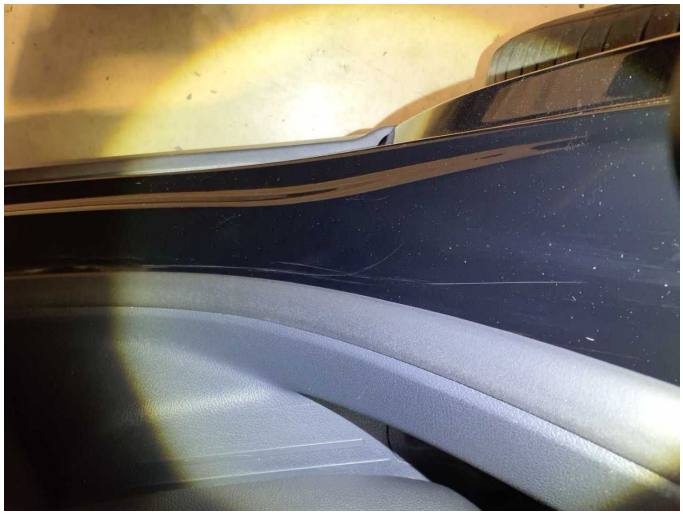
Damage 1: Roof: Roof rail - right side - dent(s) - Smooth repair work

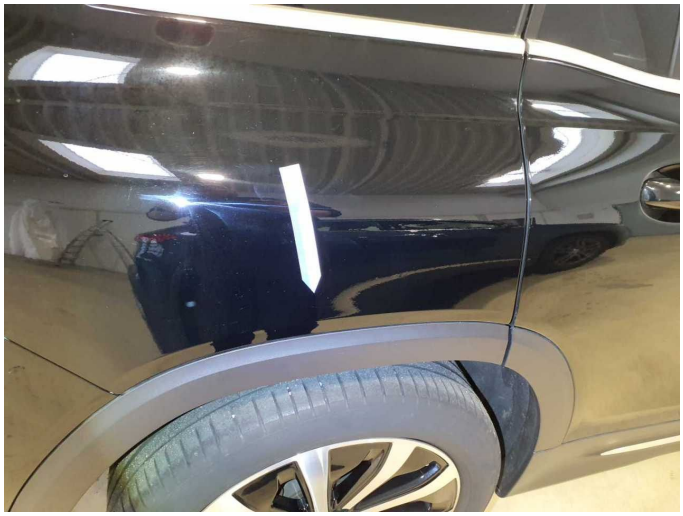
Damage 3: Mudguard - right side: Mudguard - right side - Scratch(es) - Smart repair

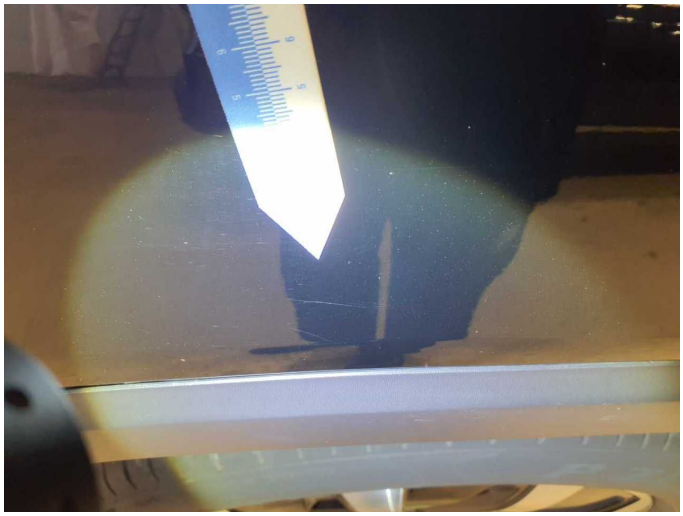
Damage 4: Side panel - rear right side: Side panel - Scratch(es) - Smart repair

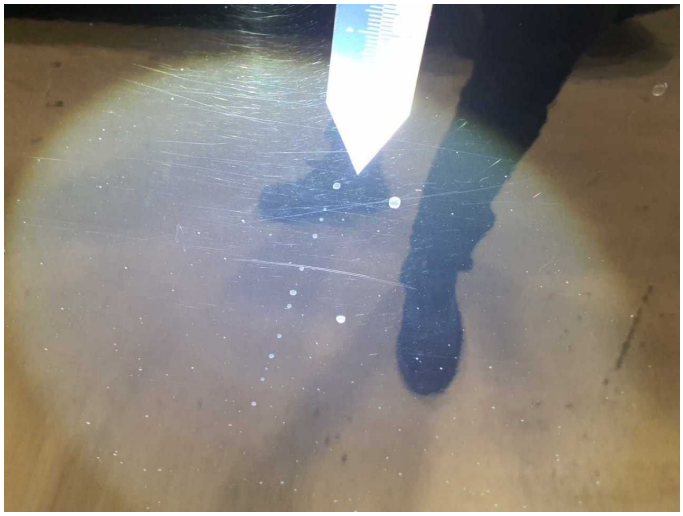
Damage 7: Door - front right side: Door - Scratch(es) - Smart repair

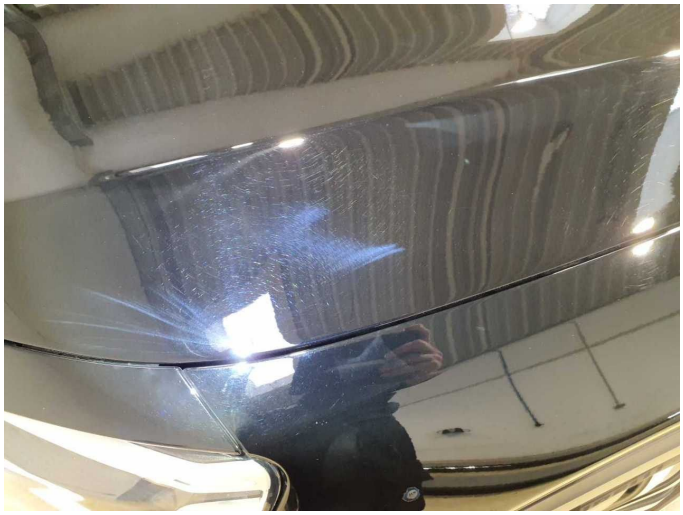
Damage 8: Body: Body (Hologramme) - Conditioning
