Expertise

Protocol number: 48570995
Order No. / Reference: 27251242
Inspection date: 6 Nov 2026

Manufacturer: Ford	Model: Focus Turnier 1.5 EcoBlue Start-Stopp-System Aut. TITANIUM
VIN: WF0PXXGCHPPT27514

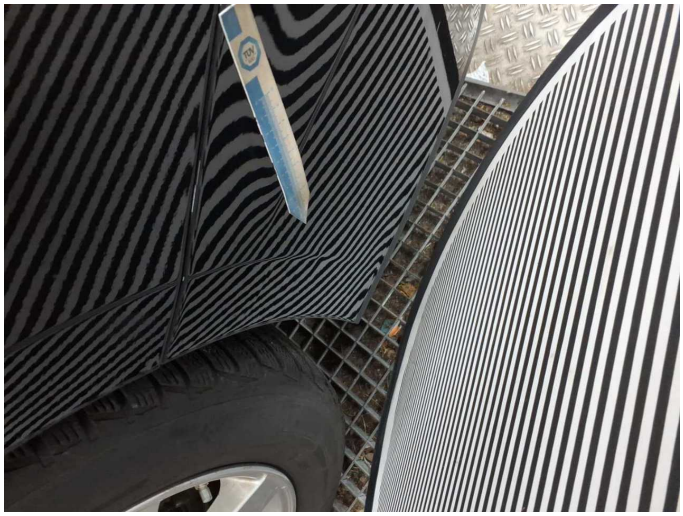
Damage 3: Front bumper: Front bumper - dent(s) - Smart repair
