Expertise

Protocol number: 48621811
Order No. / Reference: 27204705
Inspection date: 4 Nov 2026

Manufacturer: Ford	Model: Transit 350 L4H3 Lkw HA Trend Kasten
VIN: WF0EXXTTRERR71901

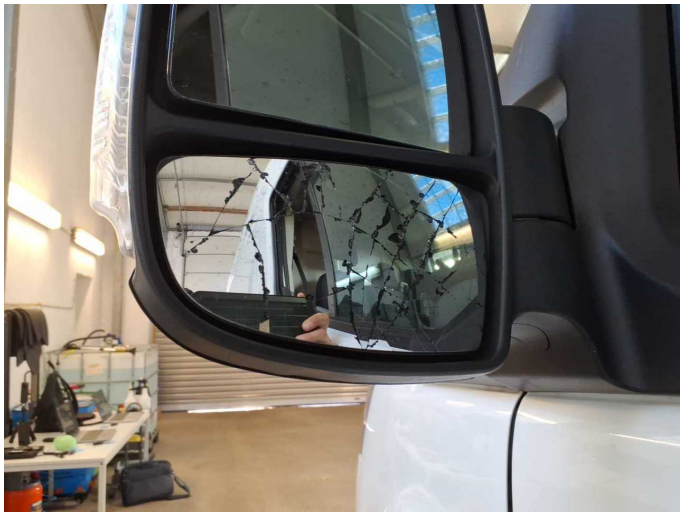
Damage 1: Engine: Engine - Functional / admissibility - Perform diagnosis

Damage 2: Wing mirror - left side: Mirror glass (Unten) - Broken / torn - Replace

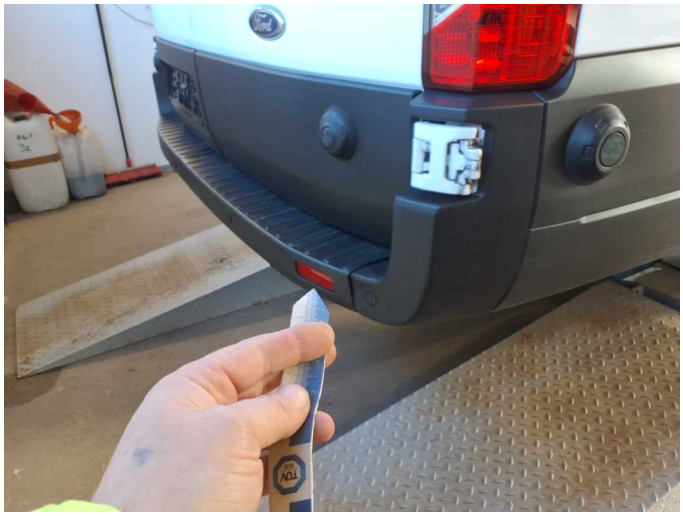
Damage 8: Rear bumper: Rear bumper (verformt, Innen+Außenteil+Rückstrahler) - Scratched - Replace

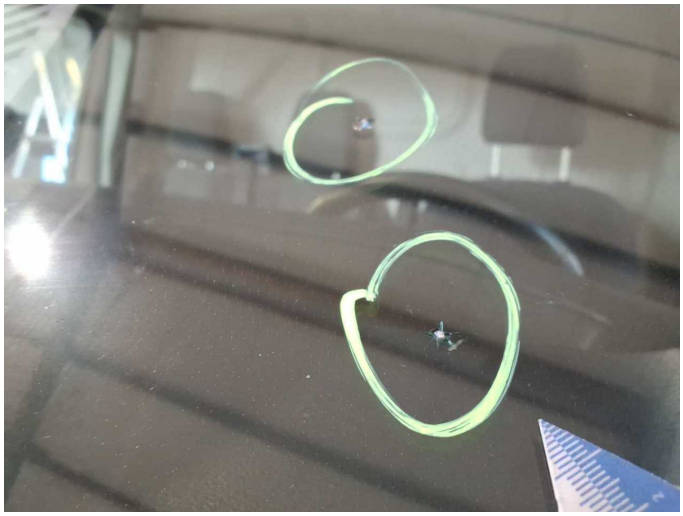
Damage 9: Seat - front: Seat cover - left side (+ Polster) - Broken / torn - Replace

Damage 10: Vehicle glazing: Windscreen (Rissbildung, Sichtfeld) - Stone chips - Replace

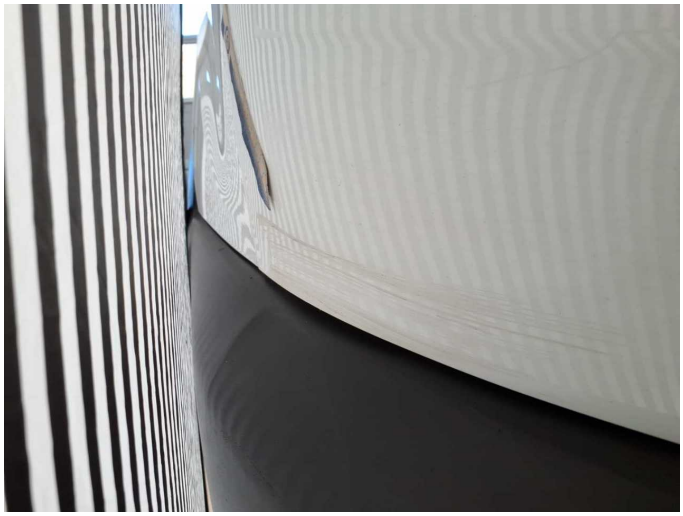
Accident 1: Front
