# Expertise

Protocol number: 48201912
Order No. / Reference: 26926677
Inspection date: 15 Oct 2026

| Manufacturer: Skoda | Model: Octavia 2.0 TDI DSG Style |
| VIN: TMBAJ8NX3PY047881 | |

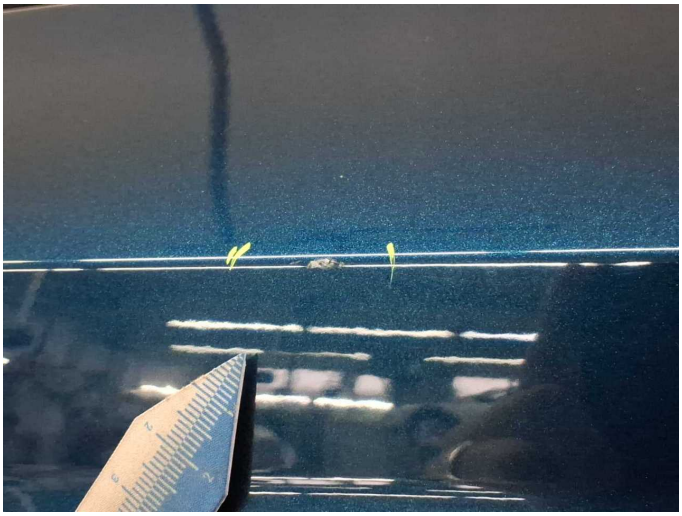
| No. | Component group | Description |
|---|---|---|
| 2 | Side panel - rear left side | Side panel - dent(s) - Smooth repair work |

**Damage 2:** Side panel - rear left side: Side panel - dent(s) - Smooth repair work

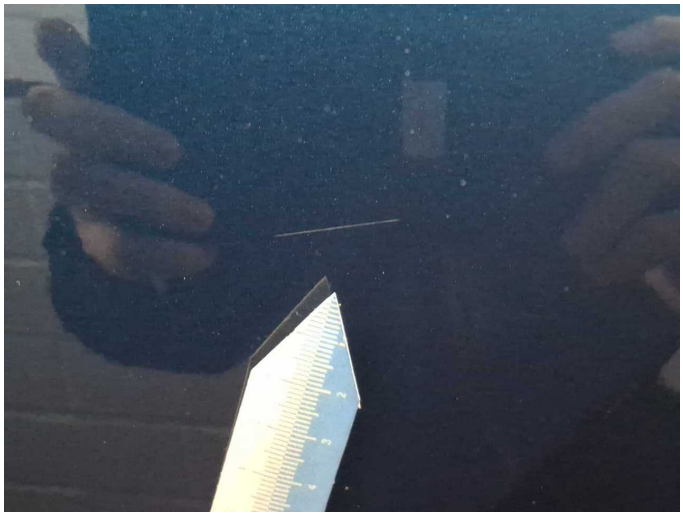
| No. | Component group | Description |
|---|---|---|
| 3 | Door - rear left side | Door - Scratch(es) - Smart repair |

**Damage 3:** Door - rear left side: Door - Scratch(es) - Smart repair

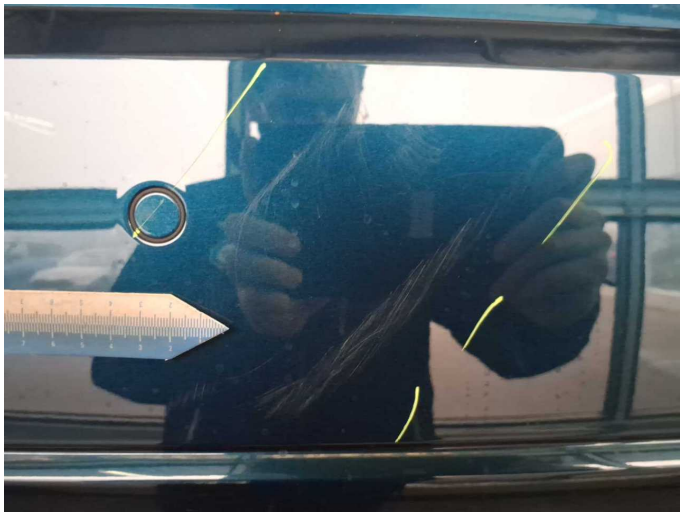
| No. | Component group | Description |
|---|---|---|
| 5 | Front bumper | Front bumper - Scratch(es) - Smart repair |

**Damage 5:** Front bumper: Front bumper - Scratch(es) - Smart repair

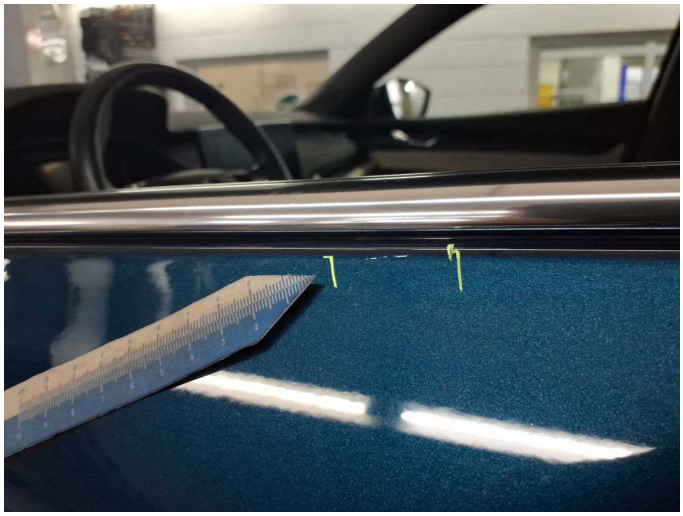
| No. | Component group | Description |
|---|---|---|
| 2 | Door - front left side | Door (Auslegen polieren) - Scratch(es) - No deduction |

**Wear and tear 2:** Door - front left side: Door (Auslegen polieren) - Scratch(es) - No deduction
