Expertise

Protocol number: 47934398
Order No. / Reference: 26913155
Inspection date: 5 Oct 2026

Manufacturer: Volkswagen	Model: Golf Variant 2.0 TDI SCR DSG Style
VIN: WVWZZZCD1RW849502

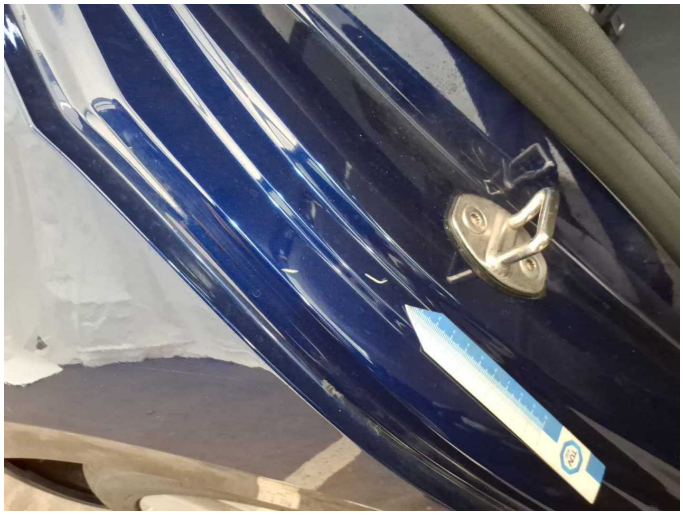
Damage 1: Boot lid / rear door: Boot lid - Glued / labelled - De-glue / neutralise
