TÜV SÜD Auto Partner GmbH
Wiesenring 2
04159 Leipzig

# Expertise

Protocol number: 48405720
Order No. / Reference: 27245153
Inspection date: 30 Oct 2026

| Manufacturer: Mercedes-Benz | Model: Vito 119 CDI 4MATIC Tourer Extralang Aut. PRO |

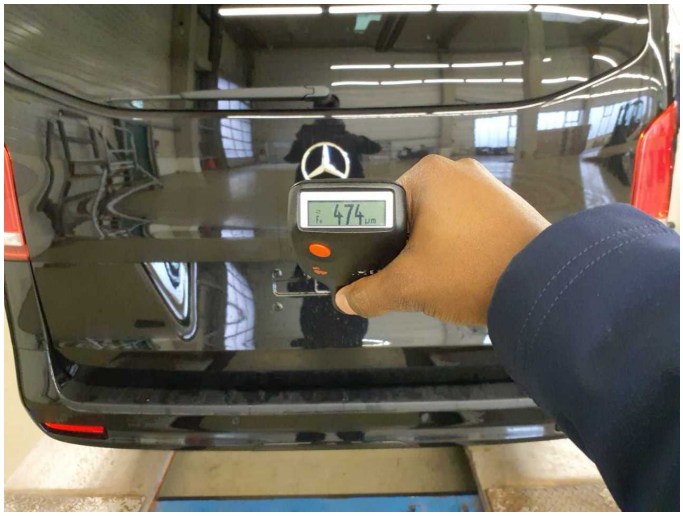
| No. | Repainting |
|---|---|
| 1 | Boot lid / rear door, Side panel - rear right side, Professionally carried out, Invoice of repair done Non-existent |

| Boot lid / rear door | 474 µm | Side panel - rear right side | 313 µm |

**Repainting 1:** Boot lid / rear door, Side panel - rear right side
