Expertise

Protocol number: 48138648
Order No. / Reference: 27094742
Inspection date: 14 Oct 2026

Manufacturer: Volkswagen	Model: Passat Variant 2.0 TDI SCR DSG Business
VIN: WVWZZZ3CZPE077692

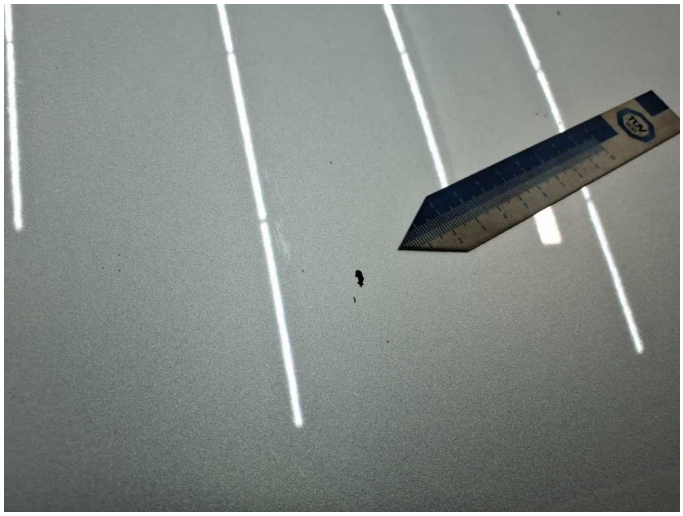
No.	Component group	Description
1	Side panel - rear left side	Side panel - dent(s) - Smart repair
2	Front bumper	Front bumper - Scratched - Smart repair
3	Bonnet	Bonnet - Stone chips - Paint
4	Rear bumper	Rear bumper - Deformed - Replace

Damage 2: Front bumper: Front bumper - Scratched - Smart repair
