Audi

VIN: WAUZZZF33M1096688

Statement details

Inspection loc PARC HÖDLMAYR TONGEREN	**Statement date** 22/10/2026	**Inspection approval date** 23/10/2026

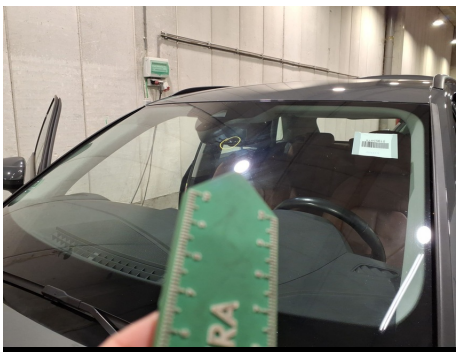
#	Element	Defect	Correction
001	Refill emergency kit / -	Missing	Replace

002	Windscreen / - Camera : Yes / Rain sensor : Yes	Broken	Replace

Refill emergency kit / - / Missing

Windscreen / - / Broken

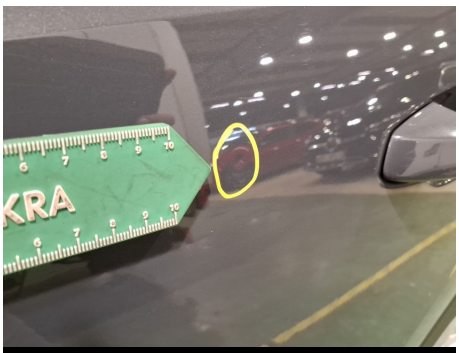
003	Door / Back Left	Dent	Acceptable

004	Bumper / Back Painted : Yes	Scratched	Acceptable

Door / Back Left / Dent

Bumper / Back / Scratched

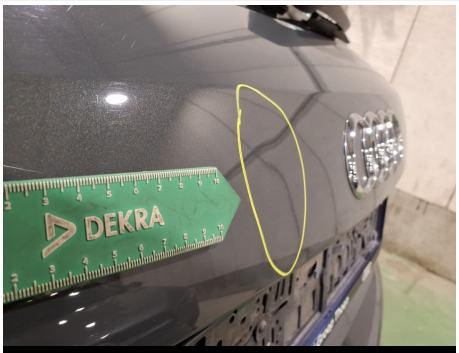
005	Tailgate / Boot door / - [1]	Dent	Smart repair

[1] 3x sous réserve

Tailgate / Boot door / - / Dent

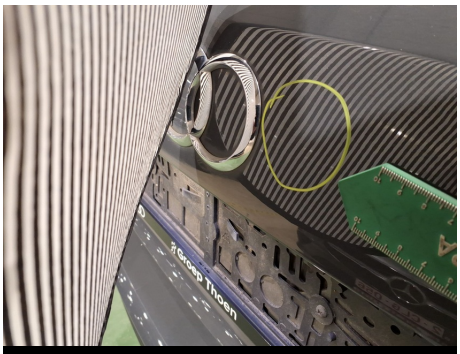
006	Rear windscreen / Back Tinted window : No	Sticker	Removal

007	Interior complete / -	Stained	Cleaning

Tailgate / Boot door / - / Dent

Rear windscreen / Back / Sticker

Interior complete / - / Stained
