Expertise

Protocol number: 48395218
Order No. / Reference: 27190967
Inspection date: 29 Oct 2026

Manufacturer: Opel	Model: Grandland 1.5 D Automatik GS
VIN: W0VZCYHZ5P6036621

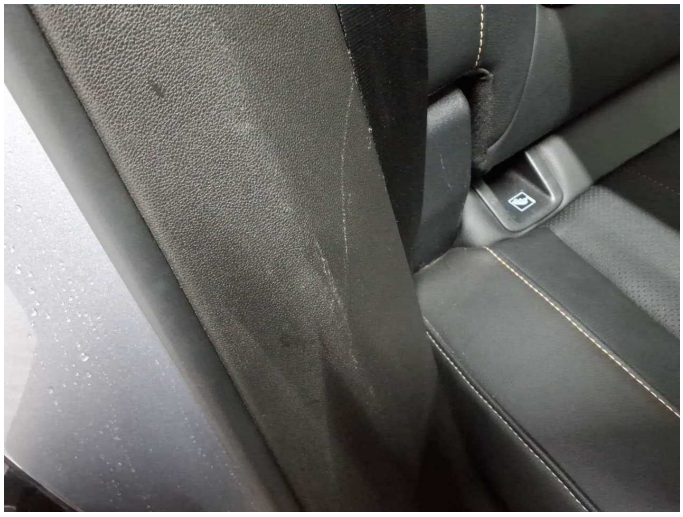
Damage 1: Trim / covers: C-pillar - trim - interior, right side - Scratch(es) - Loss in value

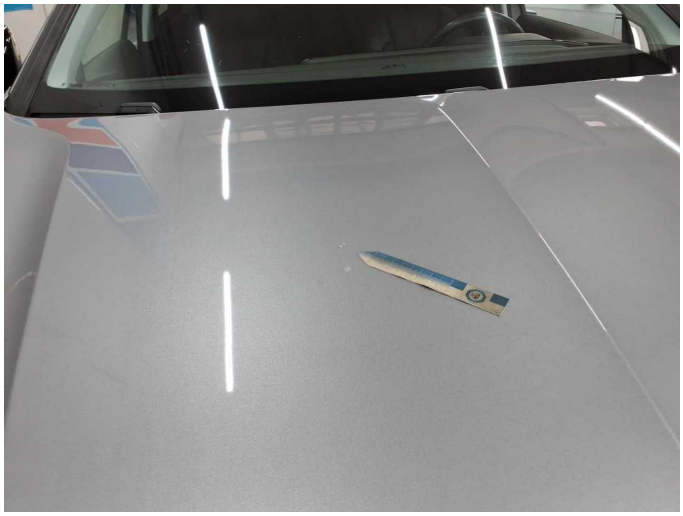
Damage 3: Bonnet: Bonnet (Mit Steinschlag) - Scratch(es) - Paint

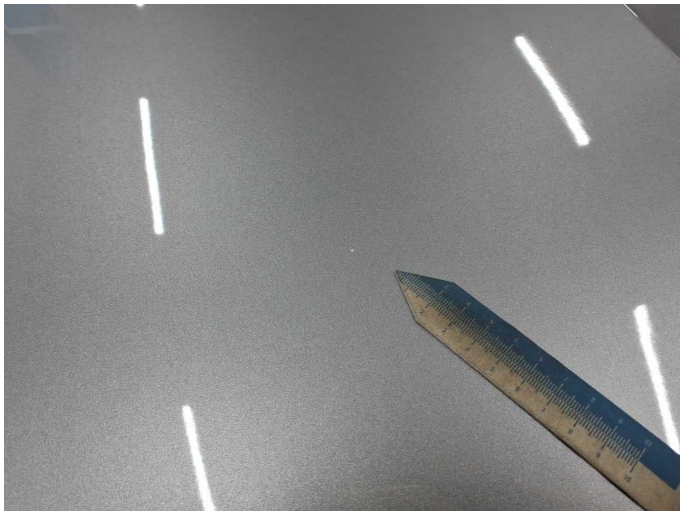
Damage 3: Bonnet: Bonnet (Mit Steinschlag) - Scratch(es) - Paint
