Expertise

Protocol number: 48374936
Order No. / Reference: 27171328
Inspection date: 27 Oct 2026

Manufacturer: Ford	Model: Focus Turnier 1.0 EcoBoost Hybrid Aut. ST-LINE X
VIN: WF0PXXGCHPSC38686

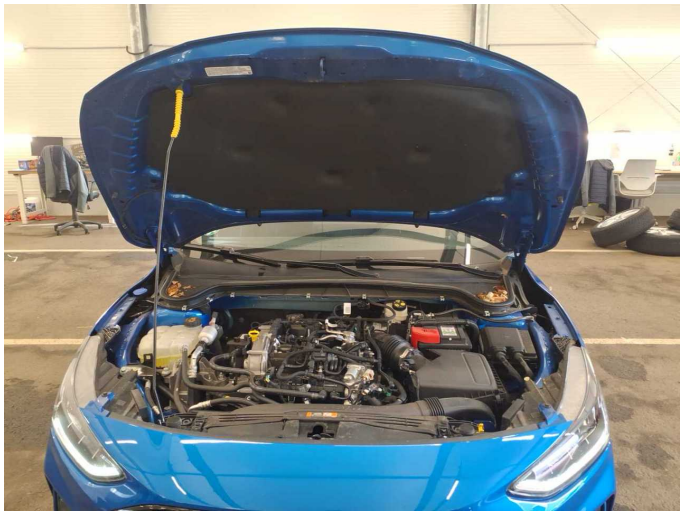
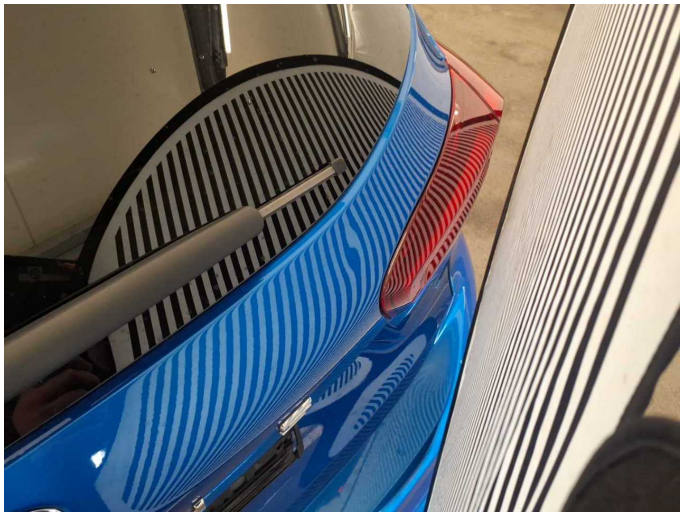
No.	Component group	Description
1	Boot lid / rear door	Boot lid - dent(s) - Smooth repair work

Damage 1: Boot lid / rear door: Boot lid - dent(s) - Smooth repair work
