Expertise

Protocol number: 48209453
Order No. / Reference: 27039033
Inspection date: 16 Oct 2026

Manufacturer: Mercedes-Benz	Model: GLB 200 d 8G-DCT Progressive
VIN: W1N4M1CB9PW303870

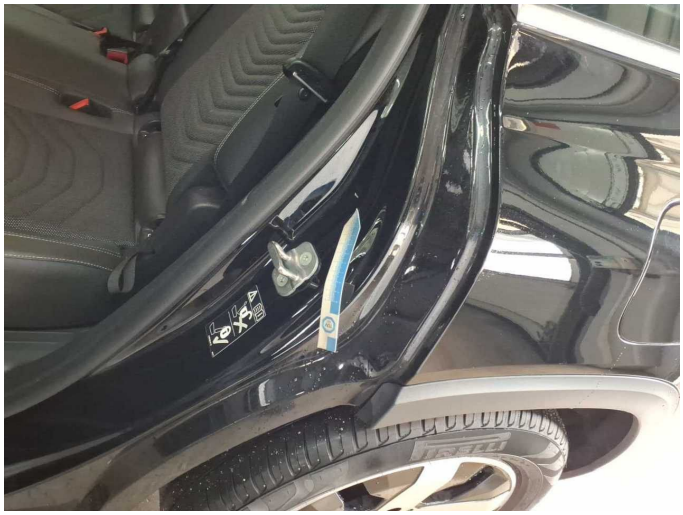
Damage 2: Door - front left side: Door edge - Scratch(es) - Smart repair

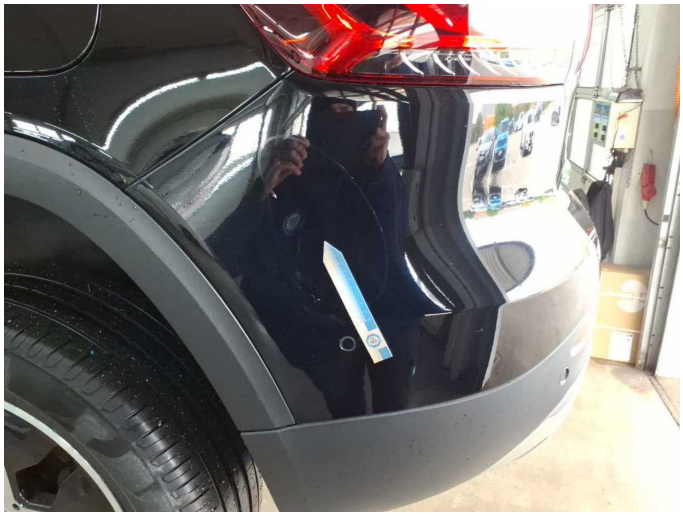
Damage 3: Side panel - rear left side: Sill - Scratch(es) - Smart repair

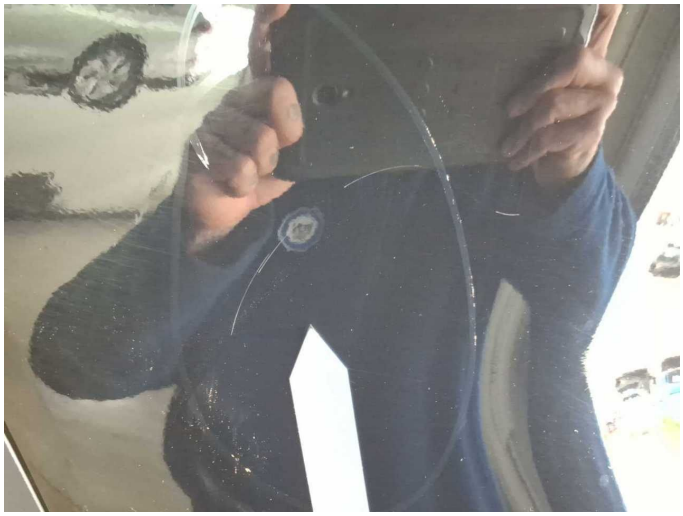
Damage 4: Rear bumper: Rear bumper - Scratch(es) - Paint

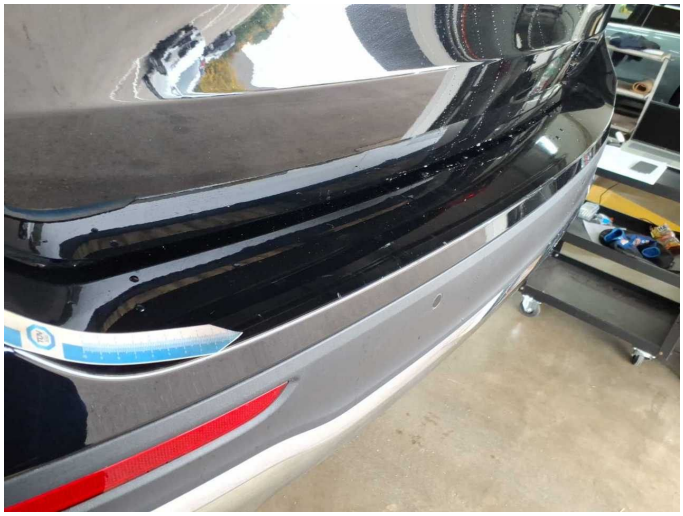
Damage 4: Rear bumper: Rear bumper - Scratch(es) - Paint

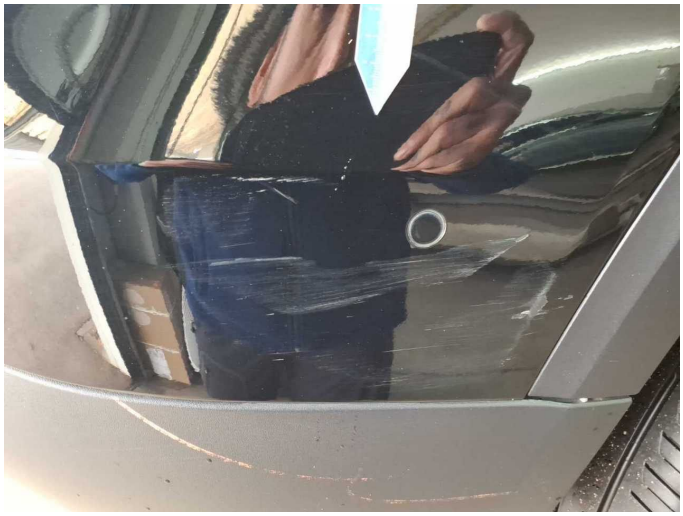
Damage 4: Rear bumper: Rear bumper - Scratch(es) - Paint
