# MERCEDES-BENZ A-CLASS

## Vehicle information

| Brand: | **MERCEDES-BENZ** | License plate: | **2CGM526** |
| Model: | **A-CLASS** | LEVEL: | **W1K1770841V147386** |

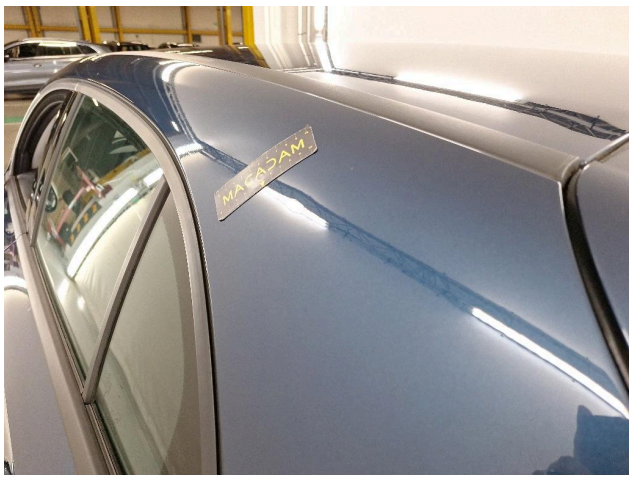
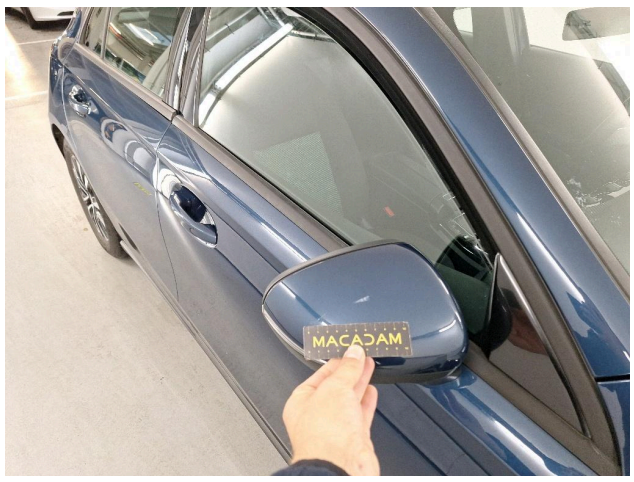
**Bodywork**

Damaged -

Acceptable.
