Expertise

Protocol number: 47843610
Order No. / Reference: 26992556
Inspection date: 29 Sept 2026

Manufacturer: Audi	Model: A4 Avant 40 TDI quattro S tronic S line
VIN: WAUZZZF4XPA021497

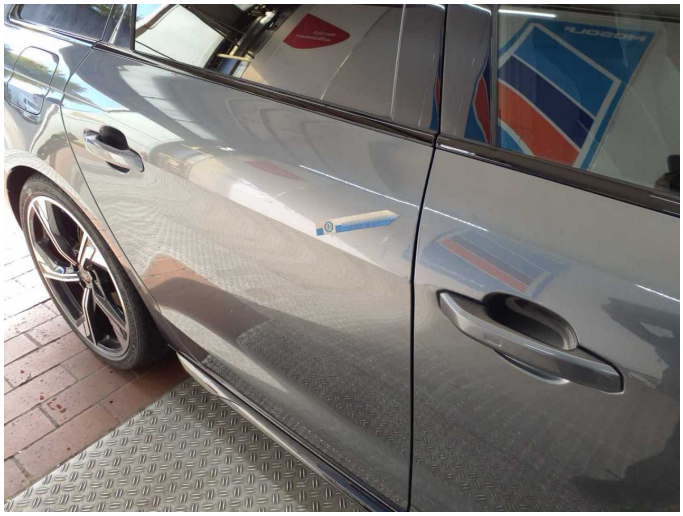
Damage 4: Boot lid / rear door: Boot lid - Glued / labelled - De-glue / neutralise
