Expertise

Protocol number: 48513448
Order No. / Reference: 27213510
Inspection date: 30 Oct 2026

Manufacturer: Opel	Model: Mokka 1.2 DI Turbo Automatik Elegance
VIN: VXKUSHNSSNW057699

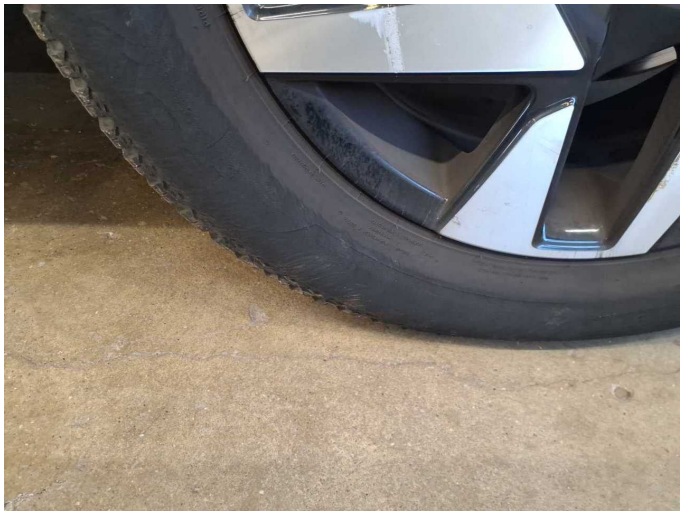
Damage 5: Wheel / tyres: Tyre - front right side - Porous / cracked - Replace

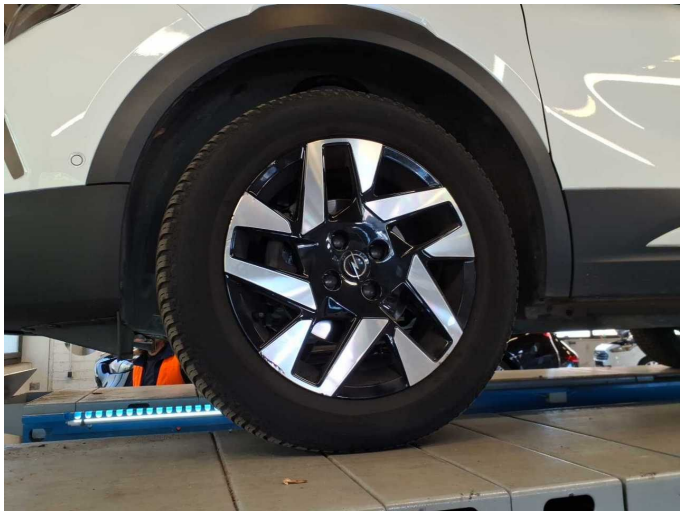
Damage 5: Wheel / tyres: Tyre - front right side - Porous / cracked - Replace

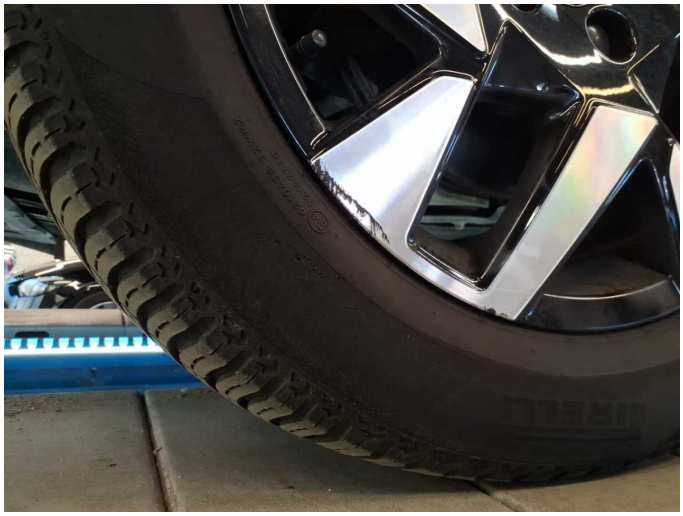
Damage 6: Wheel / tyres: Tyre - front left side - Porous / cracked - Replace

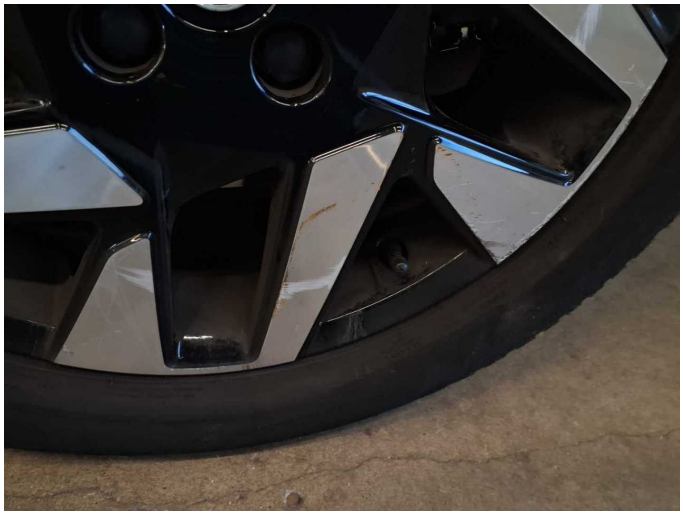
Damage 7: Wheel / tyres: Alloy rim - front right side - Scratched - Replace

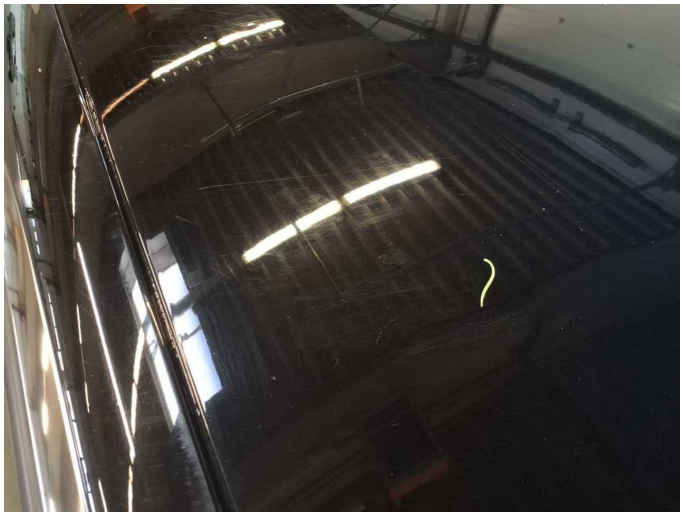
Damage 15: Roof: Roof - Scratch(es) - Paint

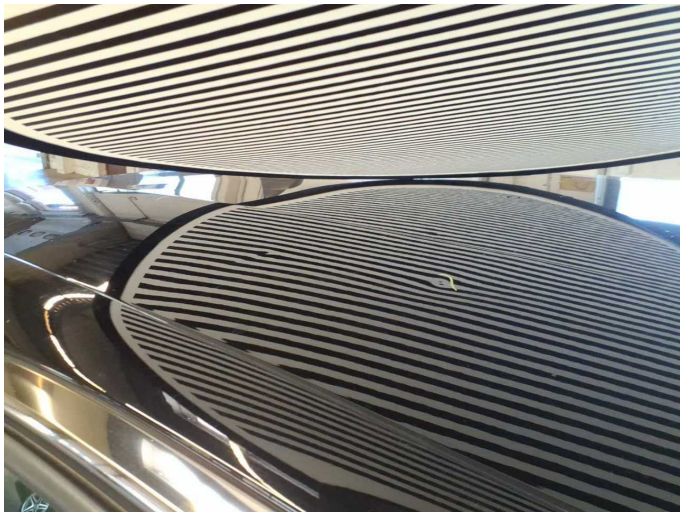
16	Body	Body - Damage by hail - repair according to calculation

Damage 16: Body: Body - Damage by hail - repair according to calculation

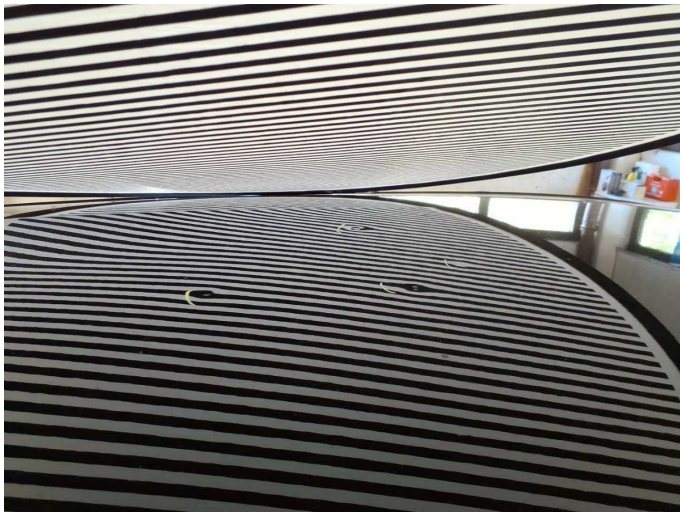
Damage 16: Body: Body - Damage by hail - repair according to calculation

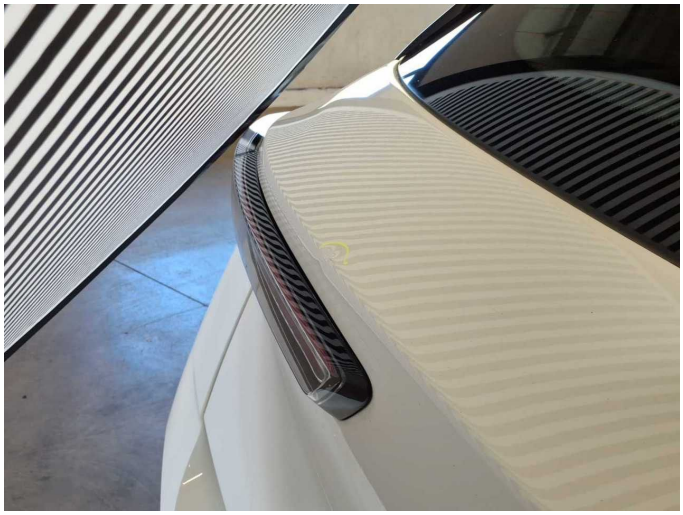
Damage 16: Body: Body - Damage by hail - repair according to calculation

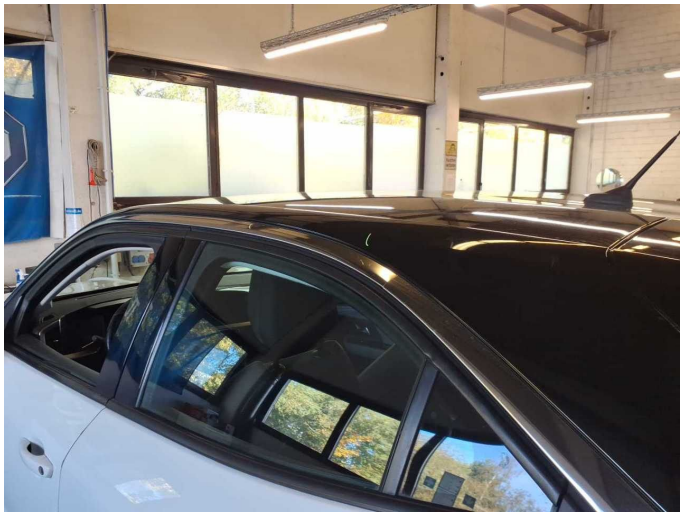
Damage 16: Body: Body - Damage by hail - repair according to calculation
