Expertise

Protocol number: 48451373
Order No. / Reference: 27178369
Inspection date: 2 Nov 2026

Manufacturer: Mercedes-Benz	Model: E 300 e T 9G-TRONIC AMG Line
VIN: W1KZH5DB6PB114436

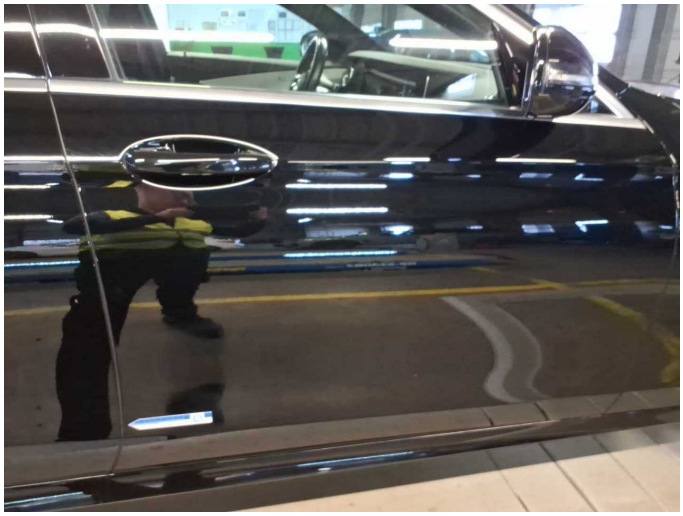
Damage 2: Sill - left side: Sill - Scratch(es) - Smart repair

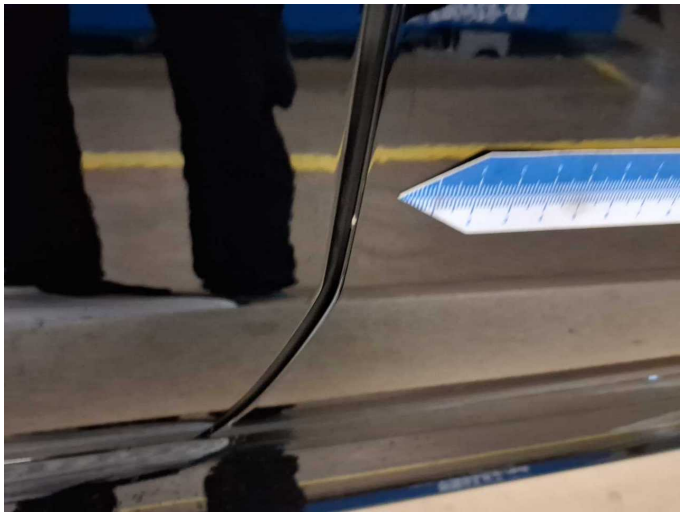
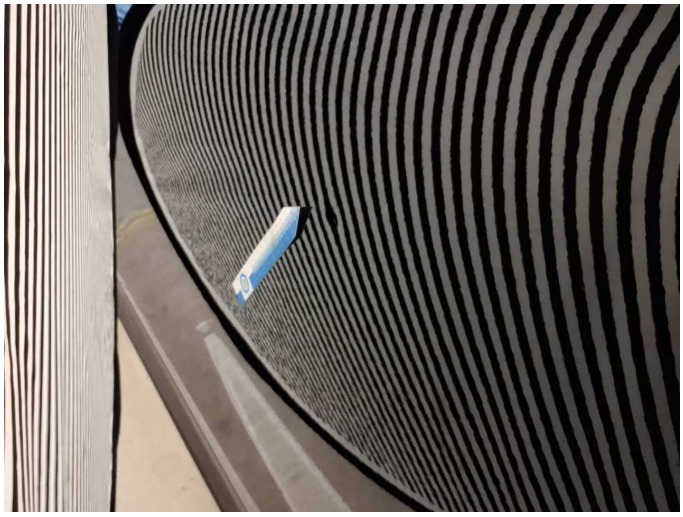
Damage 3: Door - front right side: Door edge - Dent / paintcoat damage - Smart repair

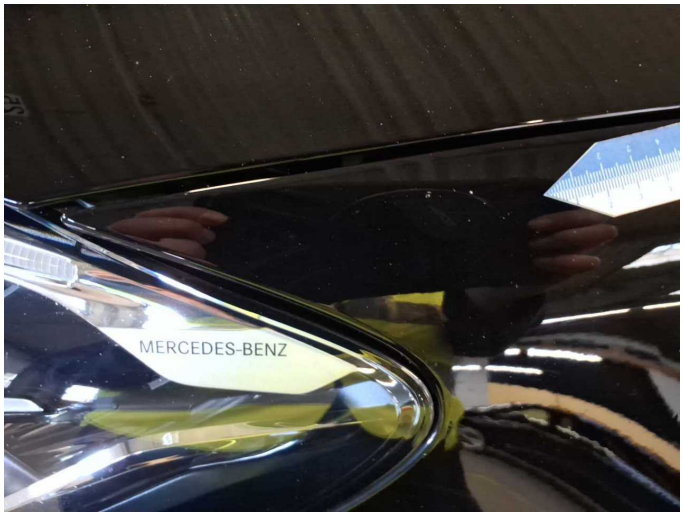
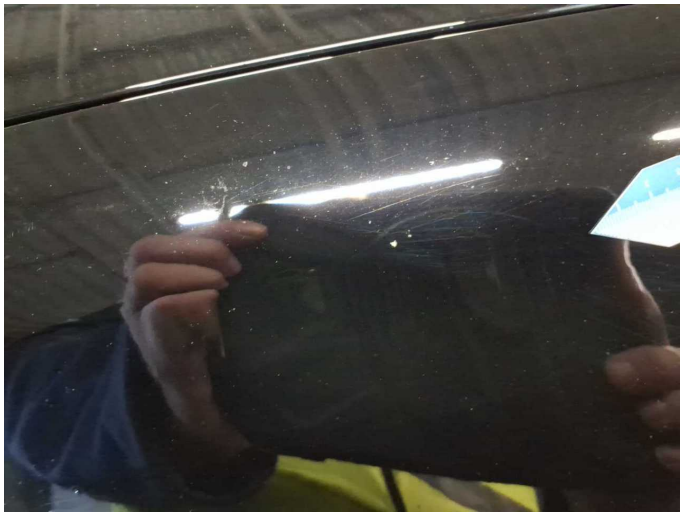
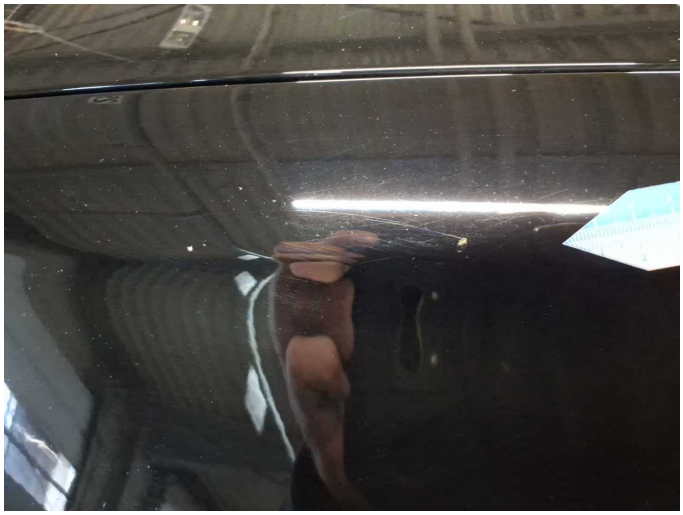
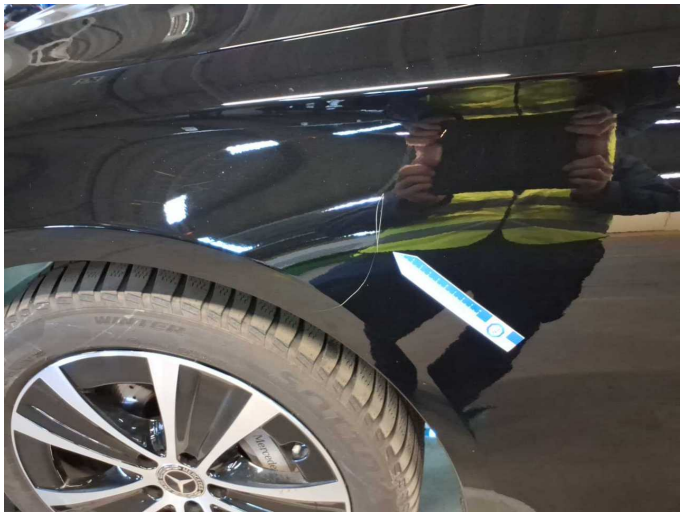
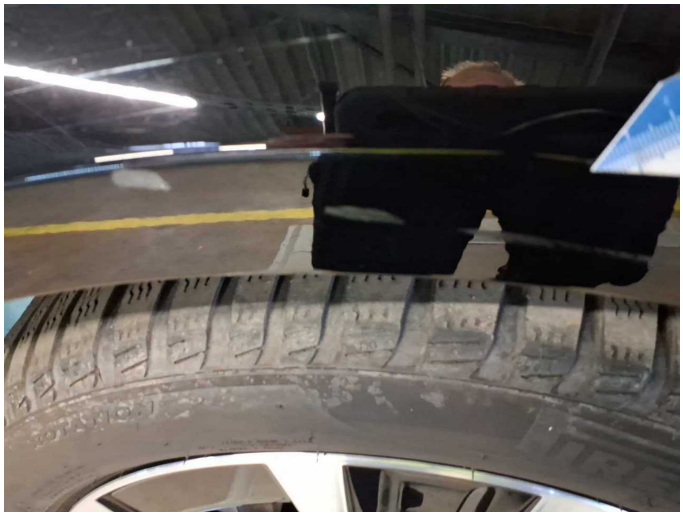
Damage 4: Mudguard - left side: Mudguard - left side (Und kratzer) - Stone chips - Paint

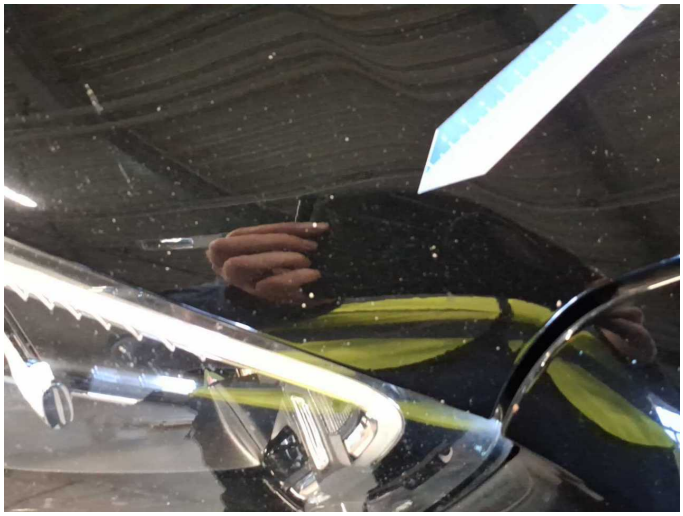
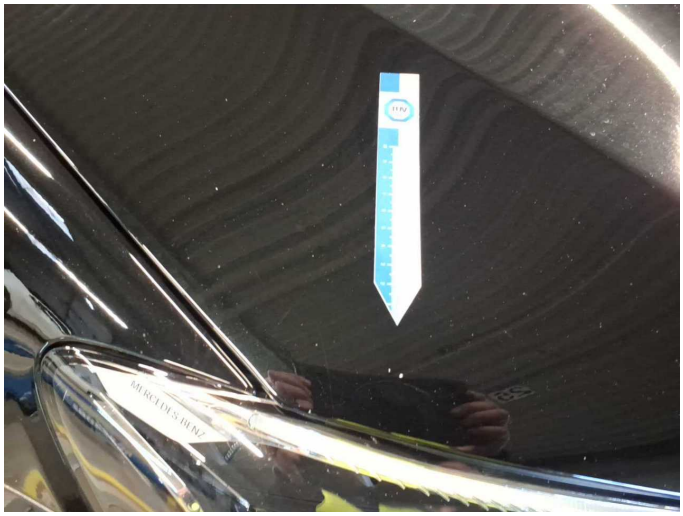
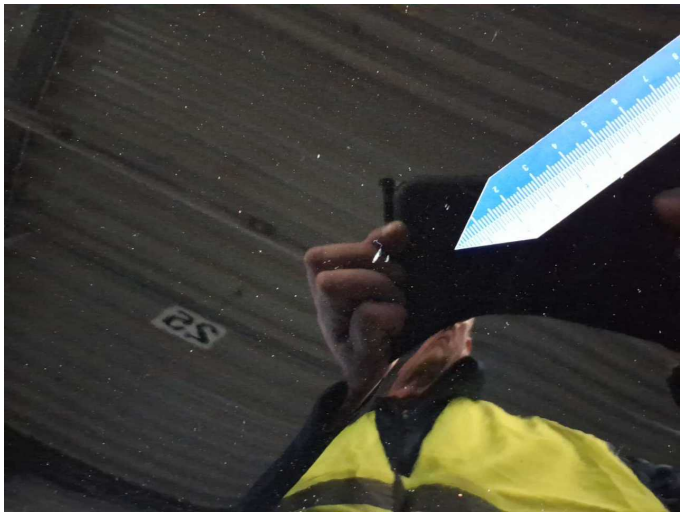
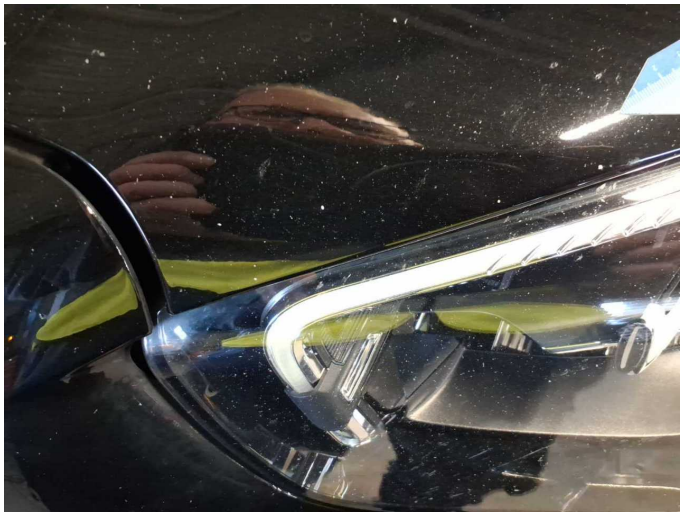
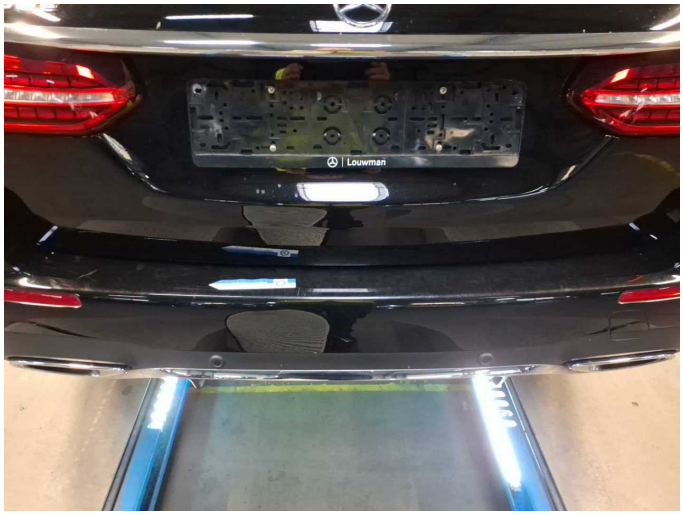
Damage 7: Bonnet: Bonnet (Mehrere) - Stone chips - Paint

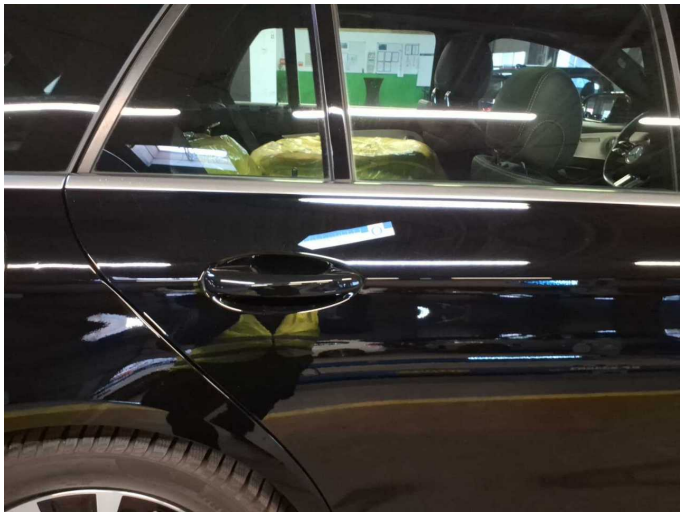
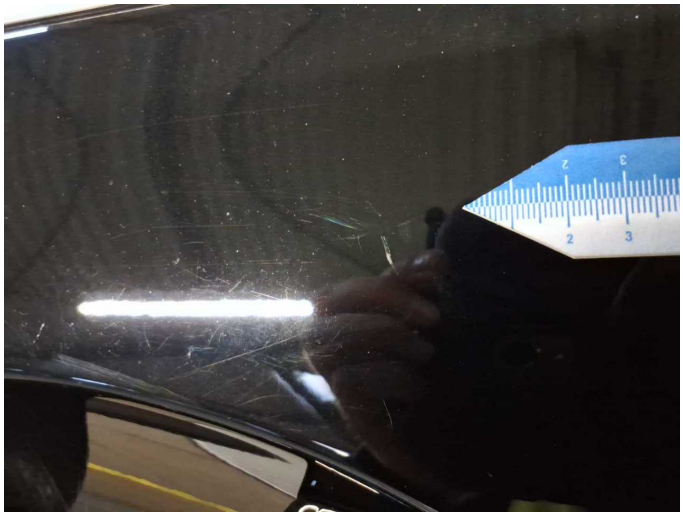
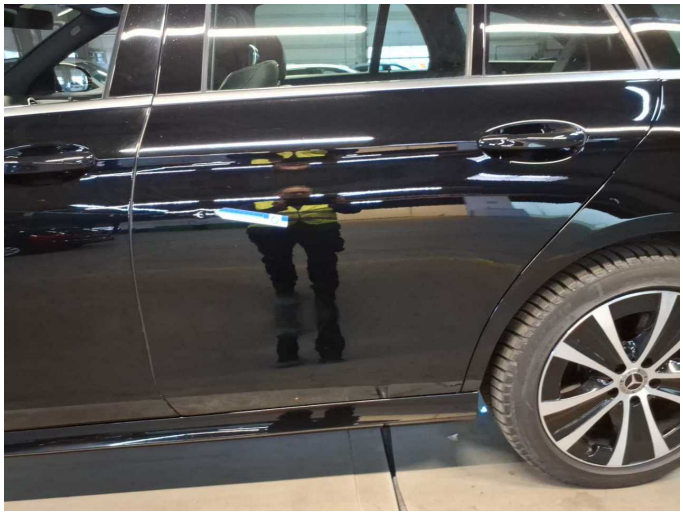
Damage 10: Door - rear right side: Door - Dent / paintcoat damage - Paint
