APPRAISAL REPORT

Driver name:	ASSE I
Make:	FORD
Model / version:	PUMA
Vin:	WF02XXERK2PL31380
Plate:	2EAX510
Mileage:	70545
First registration:	10/08/2023
Color:	Desert Islan

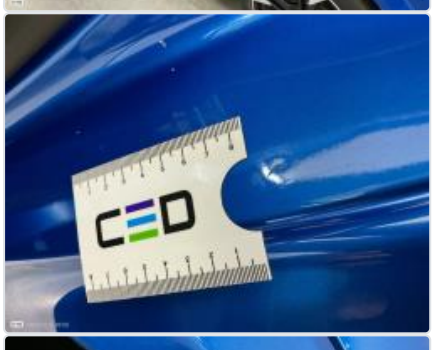
3 - Wing FL - Dent(s) and scratch(es) - Renta®
